SI B13 01 04
Fuel SystemsJuly 2004
Technical Service

Recall Campaign 04V-■ 303: Retaining Clip Retrofit for the Fuel Line Quick Release Coupling

E60 (5 Series) and E63/64 (6 Series) with the N62 engine from September 2003 through March 2004

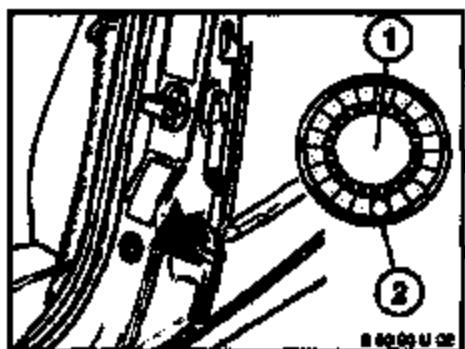
LABEL INSTRUCTIONS

This Recall Campaign has been assigned code number 410. After the vehicle has been checked, and corrected if necessary, obtain a label (SD ????) and:

- a. emboss your BMW dealer warranty number in the middle of the label (1);
- a. punch out code number 410 printed on the label and,
- a. affix the label to the B pillar as shown.
