MITSUBISHI FUSO
TRUCK OF AMERICA, Inc.

Recall Information Bulletin

No: R3120420 **Issued:** 10/21/2004

Re: Cab Tilt Main Hook

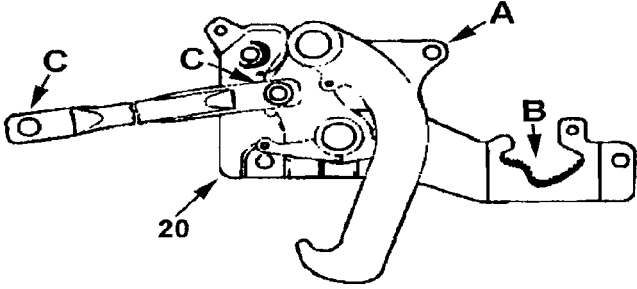
Mitsubishi Fuso Truck of America, Inc. has decided that a defect which relates to motor vehicle safety exists in the cab tilt main hook on certain vehicles. The cab tilt main hook is the latching mechanism that prevents the vehicle's cab from tilting forward during vehicle operation. On affected vehicles, the clearance between the main hook and surrounding components may be insufficient. Repeated normal cab tilting operation could cause the cab tilt system components to become damaged in the area of the cab main hook. If damage occurs, the cab main hook could latch improperly, and in the worst case, the cab could tilt forward during normal vehicle operation, which could result in a crash without warning.

4. Installation Procedures (refer to DIAGRAM 1):

- Install the new Control Lever Bracket (MC964520) **2** loosely, applying adhesive to the Control Lever Bracket Mounting Bolt **17** threads, as described in the Adhesive and Lubricant table above.
- Install the new Main Hook Assembly (MC964511) **20**, tightening the Mounting Bolts **21** as specified in the Tightening Torque table. Apply grease to the sections described in the Adhesive & Lubricant table.
- Install Return Spring **15** on the Main Hook Assembly **20**.
- Installed the new Lock Lever (MC964516) **5**, tightening the Mounting Bolt **6** as specified in the Tightening Torque table.
- Install Return Spring **14** on the Lock Lever **5**.
