TOYOTA CUSTOMER SERVICES

Volume: XII
Number: TC05-003
Date: 02/18/2005
 Action
 Retain
 Information

SUBJECT: SPECIAL SERVICE CAMPAIGN (SSC) – 50C
(2005 MODEL YEAR TACOMA PARKING BRAKE PEDAL CABLE LOCK NUT)

TECHNICAL INSTRUCTIONS

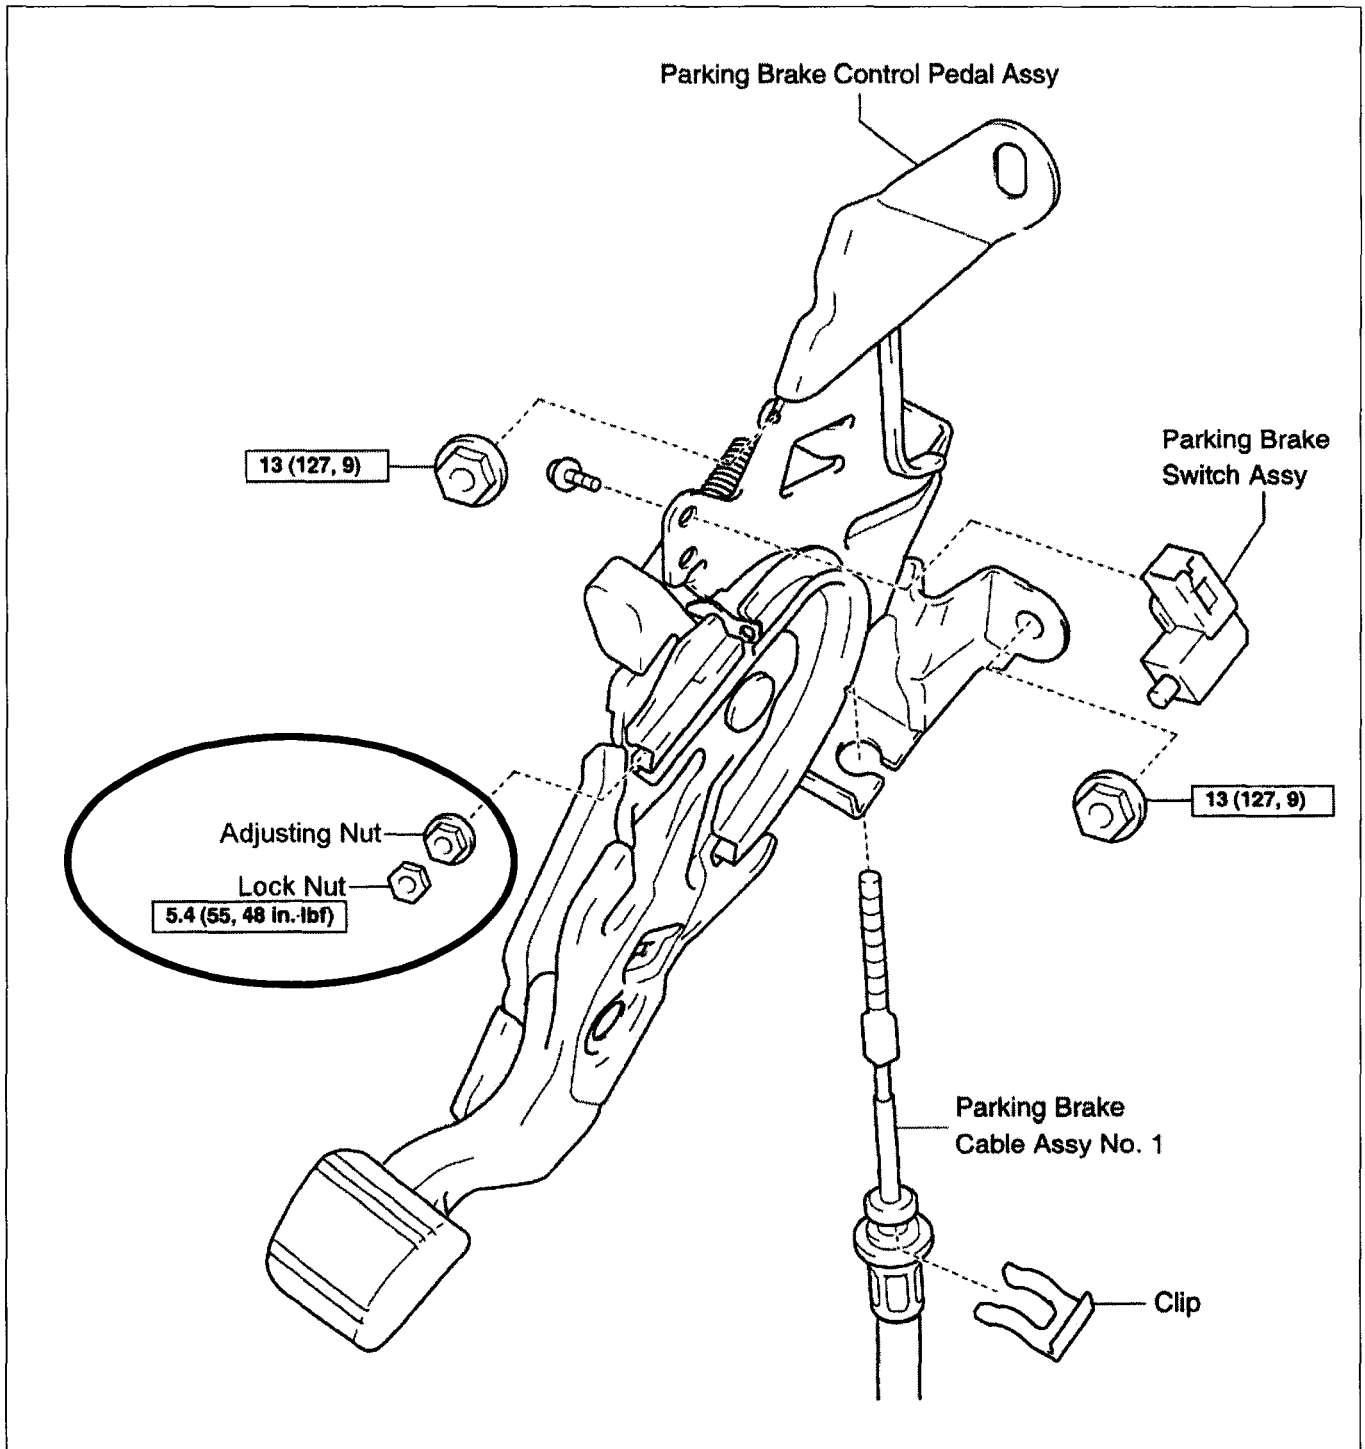
A. PARKING BRAKE PEDAL

A1: On certain 2005 model year Toyota Tacoma vehicles equipped with an automatic transmission, there is a possibility that the parking brake pedal cable lock nut may not have been tightened to the proper torque specification. In this condition, the lock nut may loosen and come off, which will reduce the effectiveness of the parking brake.

- Check that the parking brake pedal cable lock nut A and adjusting nut B are still fastened. If the nut(s) are missing install a new one.

- Using a ruler, measure the remaining thread length of the parking brake pedal cable from lock nut A. The remaining thread length should be between 4 and 6 mm (0.157 to 0.236 in.).
- If it is not within specification, then loosen the parking brake pedal cable lock nut A and turn adjusting nut B using the special tool or an open-end wrench with a thickness of less than 3.5 mm (0.138 in.) until the remaining thread length is within specification.
