TOYOTA CUSTOMER SERVICES

Volume: XII
Number: TC05-009
Date: 04/13/2005
 Action
 Retain
 Information

SUBJECT: SPECIAL SERVICE CAMPAIGN (SSC) – 50E
(CERTAIN 2004 THROUGH EARLY 2005 MODEL YEAR TUNDRA WITH BOTH VSC
AND TRD DUAL EXHAUST SYSTEM)

**2004 THROUGH EARLY 2005 MODEL YEAR TUNDRA
WITH BOTH VSC AND TRD DUAL EXHAUST SYSTEM**

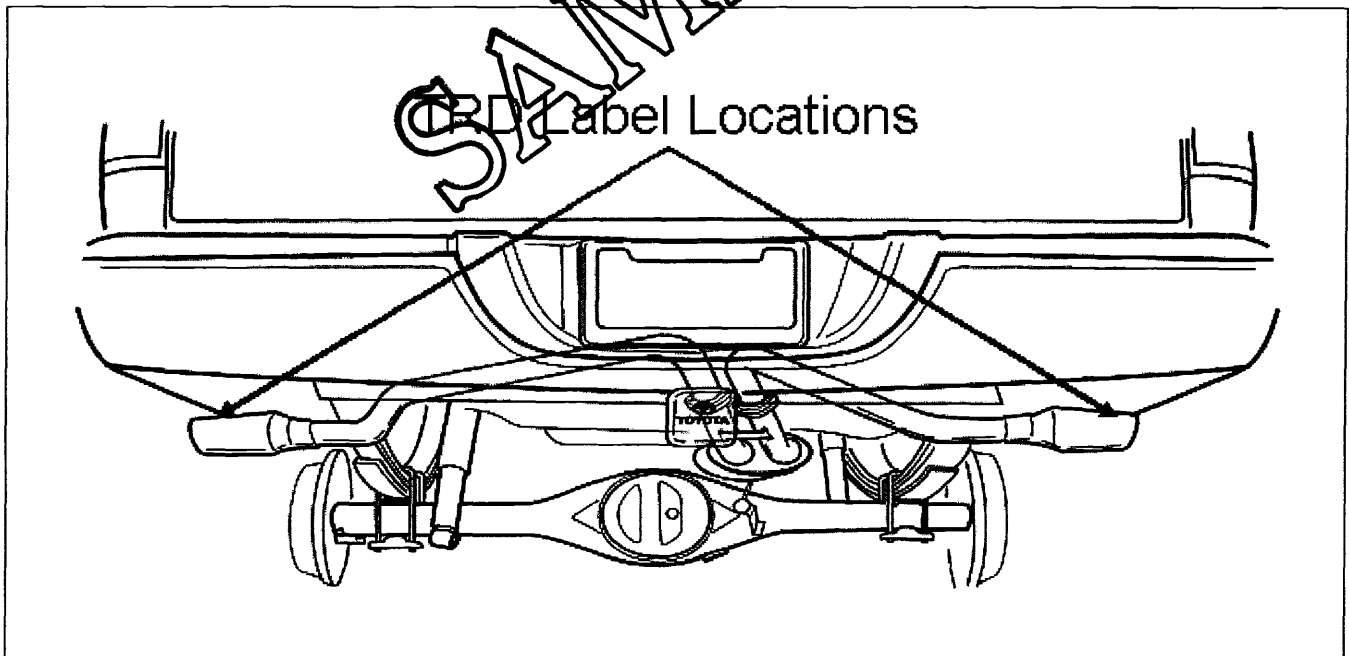
If your vehicle is equipped with a TRD Dual Exhaust System there will be two exhaust outlets (instead of one) and they will have a "TRD" label on top of both exhaust tips located behind each rear wheel.

If your vehicle is equipped with a single exhaust or does not meet the criteria described above, it is **NOT** involved in the SSC. Please fill out the enclosed postage paid form indicating that it is not included in the SSC. If you cannot determine if your vehicle is involved please contact your Toyota dealer for assistance.

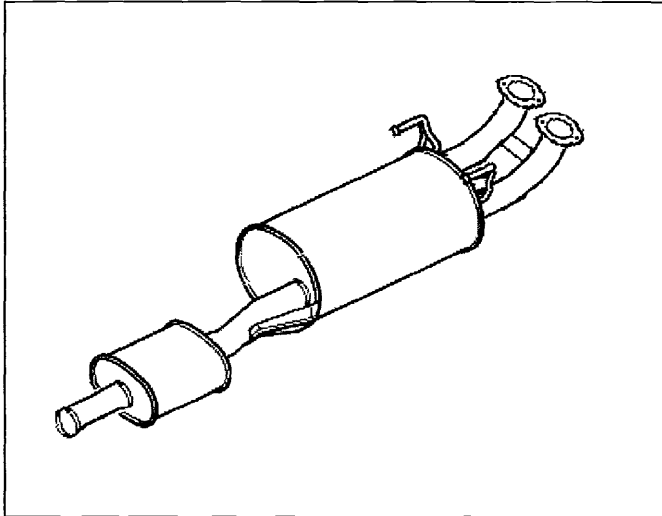
B. DUAL EXHAUST SYSTEM REMOVAL

- (a) Check the left side tailpipe for an exhaust ramp, and that the left and right exhaust pipes overlap at the flange connection, as shown in the illustration.
- (b) If an exhaust ramp is present and the left and right exhaust pipes overlap, the vehicle has the updated TRD Dual Exhaust System installed. **NO** repairs are necessary.
- (c) If an exhaust ramp is **NOT** present and the left and right exhaust pipes **DO NOT** overlap, the vehicle has the affected TRD Dual Exhaust System installed. Continue to the next step for repair procedures

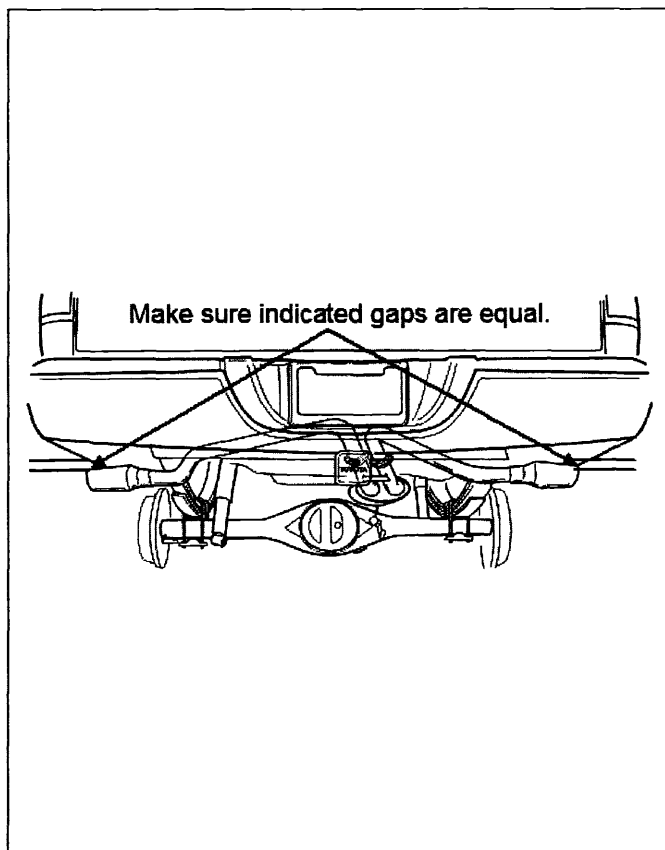
4. CHECK THE RIGHT SIDE TAILPIPE CLEARANCE

- (a) Check the clearance between the top of the right side tailpipe tip and the bottom edge of the truck bed, as shown in the illustration.

Torque Specification:
48 N·m (489 kgf·cm, 35 ft·lbf)

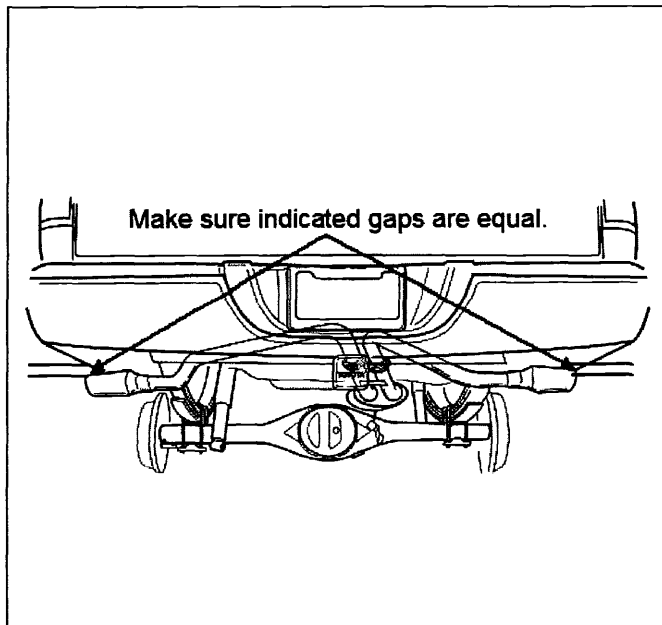
(d) Check the clearance between the top of the left side tailpipe tip and the bottom edge of the truck bed, as shown in the illustration.

Clearance: 25 mm ± 5 mm

(e) Check that the difference between the left and right side tailpipe tip to the bottom edge of the truck bed measurements are within ± 5 mm of each other.

- (f) If these clearances are out of specification, adjust the exhaust hanger mount for the left side tailpipe.
- (g) Loosen the 2 bolts.
- (h) Move the exhaust hanger up or down to adjust the clearance.
- (i) Tighten the 2 bolts.
