**Re: Defect Information Report (FL-442), NHTSA no. 05V-125**  
**Sterling rear axle wheel ends**

**Section 573.6 Defect Information Report**  
**FL-442, NHTSA no. 05V-125**  
**Supplement No.: 1**

March 2005  
FL442A-D  
NHTSA #05V-125

## Subject: Sterling Rear Axle Wheel Bearing Inspection and Adjustment

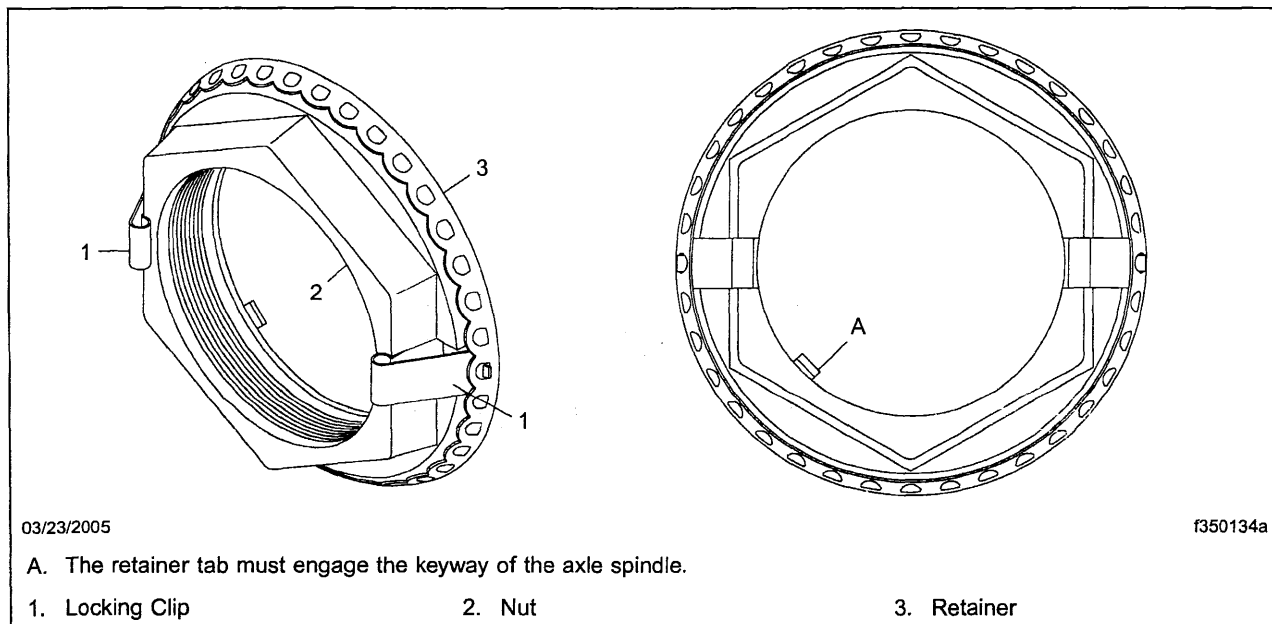
**Fig. 1, Rear Axle Axilok Nut**

11. If the vehicle is equipped with ConMet Preset® hubs, go to "Inspecting ConMet Preset Hubs." These hubs can be identified by the presence of an Axilok® bearing-retaining nut. See **Fig. 1**.

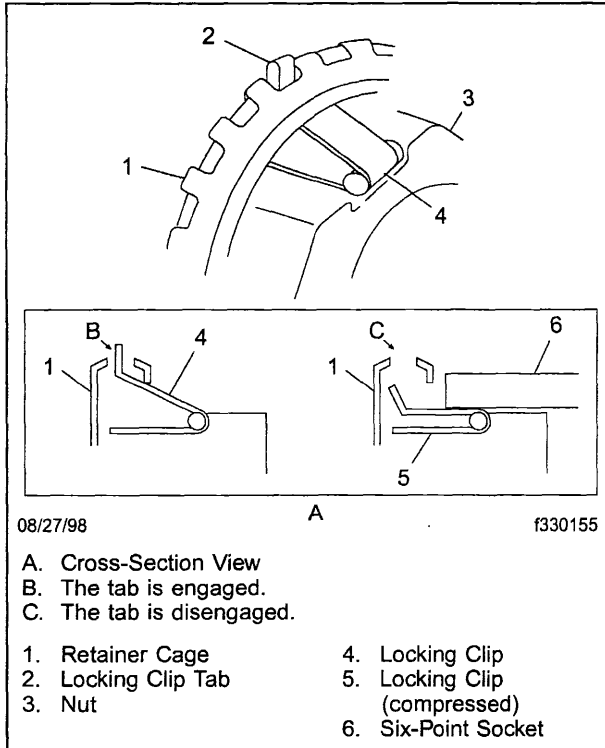
**Fig. 5, Axilok Nut, Checking the Position of the Locking Clip**

- After the nut is installed, always make sure that both locking clips are present and engaged in the retainer cage. See **Fig. 5**. If the locking clips are not engaged, the nut is not locked in position and can rotate freely.

- Never try to repair a damaged Axilok nut; always replace it with a new one.
- Always start an Axilok installation by hand. A good-fitting 6-point socket will completely disengage the nut's locking clips, allowing it to spin freely by hand. See **Fig. 5**. Use an accurately calibrated torque wrench to tighten the nut to its final torque value.

- ### 2. Loosen the Axilok nut to zero torque, then tighten it 300 lbf-ft (407 N·m). Do not back it off.
- ### 3. The nut should lock in place when you remove the wrench. If it does not, advance it until it does. See **Fig. 5**.
- ### 4. Repeat the procedure as necessary for the other hubs.
- ### 5. When all the torques are correct, go to step 12 under "General Procedure."
