**Subject: Recall Campaign UU (05V-154)
1999-2000 Model Year Volkswagen Golf and GTI Vehicles Equipped
with a Gasoline Engine
Inspect Fuel Supply Module for Leaks and Install a Couple Piece (Connector) on
Fuel Line, Replace Fuel Supply Module if Necessary**

**Subject: Safety Recall UU
1999-2000 Model Year Volkswagen Golf and GTI Vehicles Equipped with a Gasoline Engine
Inspect Fuel Supply Module for Leaks and Install a Couple Piece (Connector) on Fuel Line;
Replace Fuel Supply Module if Necessary**

Code: **UU**

**Subject: 1999-2000 Model Year Volkswagen Golf & GTI Vehicles
Equipped with a Gasoline Engine
Inspect Fuel Supply Module for Leaks and Install a Couple Piece
(Connector) on Fuel Line; Replace Fuel Supply Module if Necessary**

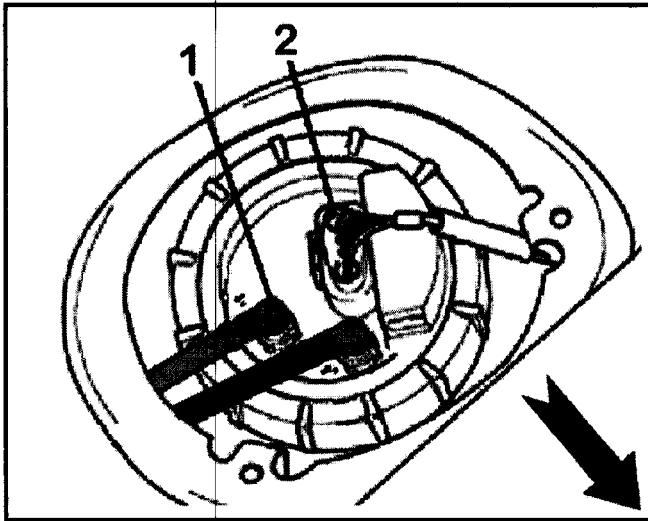
- ⇐ The arrow in the illustration indicates front of vehicle
- ⇐ Press the release button and disconnect the black fuel feed line -1-
- ⇐ Disconnect connector -2-

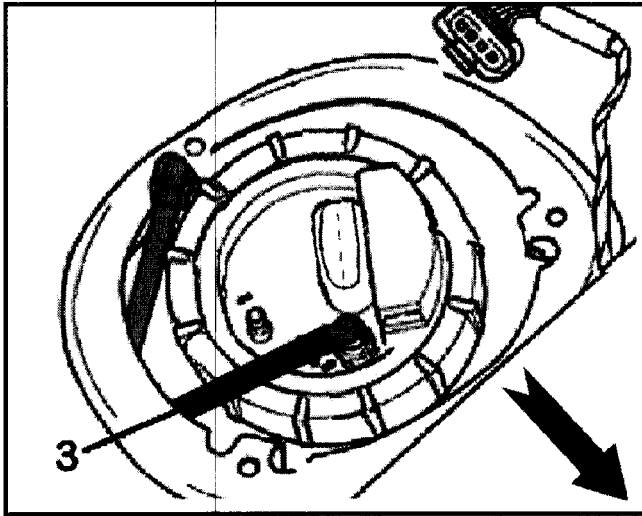
- Use the V.A.G 5190 fuel removal cart and remove fuel from the vehicle
- ⇐ Press the release button and disconnect the blue fuel return line -3-
- Cover fuel line to prevent dirt or debris from entering fuel system

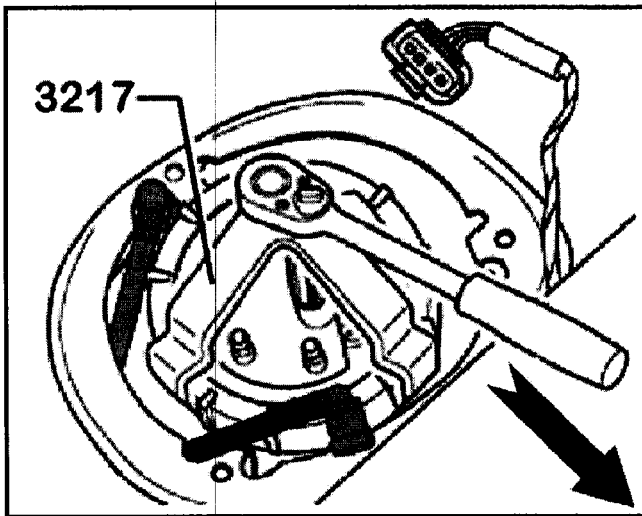
- ⇐ Use 3217 ring nut spanner tool and remove union nut
- Being careful not to bend the fuel level sensor, lift up and remove fuel supply module from the fuel tank with sealing washer and place on a clean bench

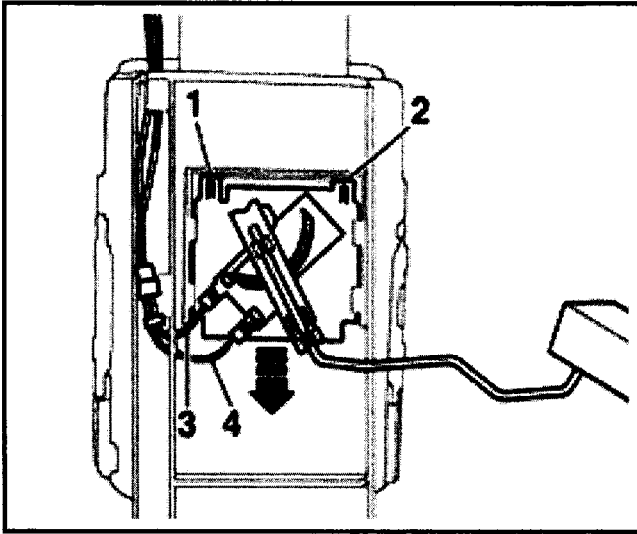
- ⇐ Remove wires -3- & -4- from slots in bracket
- ⇐ Lift up tabs -1- and -2-, slide fuel level sender down and remove from bracket
- ⇐ Release terminals on wires -3- and -4- from fuel level sender and remove terminals

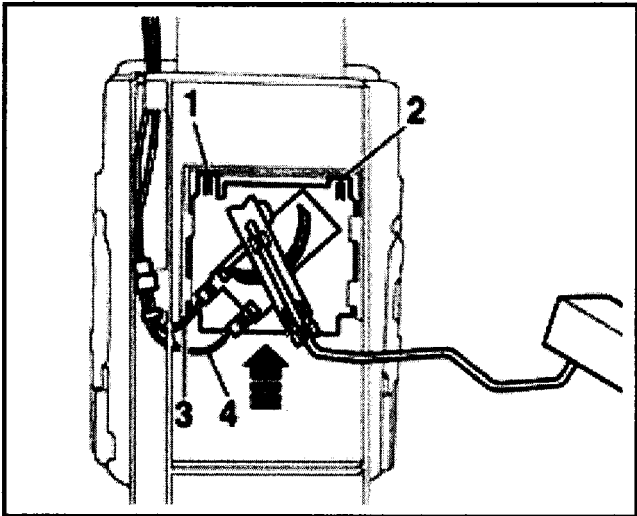
- ⇐ Connect terminals on wires -3- and -4- of new fuel supply module to fuel level sender
- ⇐ Slide fuel level sender upward until tabs -1- and -2- snap into position on bracket
- ⇐ Insert wires -3- and -4- into slots in the bracket
