**Re: Defect Information Report – supplemental information
(FL-448), NHTSA no. 05V-185, Accuride 29644ANP Wheels**

Section 573.6 Defect Information Report
FL-448, NHTSA no. 05V-185
Supplement No.: 1

Subject: Accuride 29644 ANP Aluminum Wheels

October 2005
 FL448A
 NHTSA #05V-185

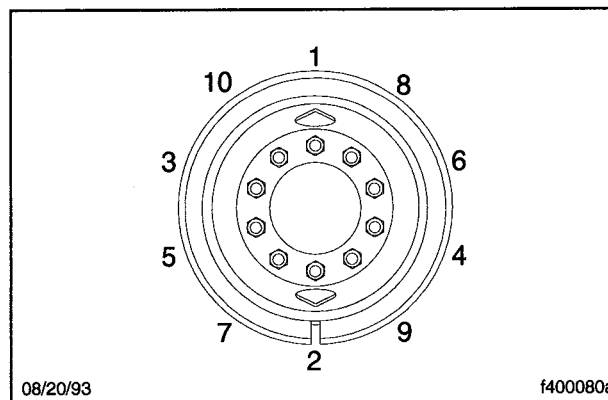
Fig. 8, 10-Stud Disc Wheel Tightening Sequence

Too little wheel nut torque can cause wheel shimmy, wheel damage, stud breakage, and extreme tire tread wear. Too much wheel nut torque can break studs, damage threads, and crack discs in the stud hole area. Use the specified torque values, and follow the tightening sequence in Fig. 8.

- 7.6 Install and hand-tighten the remaining two-piece flange nuts. Tighten the nuts 50 lbf-ft (68 N·m) following the sequence in **Fig. 8**.
- 7.7 Check that the wheel is correctly seated against the hub and on the hub-pilot pads.
- 7.8 Following the sequence in **Fig. 8**, tighten the two-piece flange nuts 450 to 500 lbf-ft (610 to 678 N·m).

- 7.10 After operating the vehicle for 50 to 100 miles (80 to 160 km), retighten the wheel nuts 450 to 500 lbf·ft (610 to 678 N·m). Follow the sequence in **Fig. 8**.
8. Clean a spot on the base label (Form WAR259). The base label is usually located on the passenger-side door about 12 inches (30 cm) below the door latch. Write the campaign number, FL448, on the blank completion sticker (Form WAR260) from the recall kit, and attach it to the base label.
9. Close the hood and remove the chocks from the tires.
