RE: Recall Number 05V-187 Defect Information Report (additional information)  
(Hyundai Campaign 069)

**Subject: Campaign 069 – 2005 MY Elantra and Tiburon – Steering Tie  
Rod Threaded Attachment**

# HYUNDAI Technical Service Bulletin

Group	CAMPAIGN
	Number	05-01-005
Subject	Date	MAY, 2005
	Model	2005 ELANTRA, 2005 TIBURON

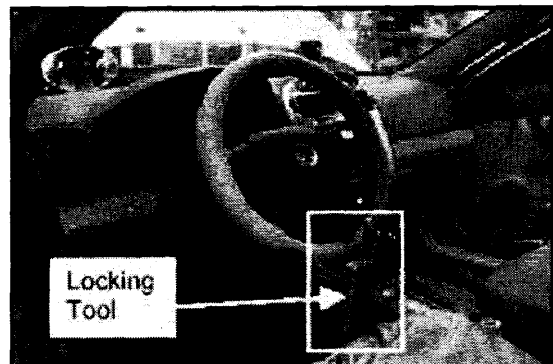
**NOTE:** It is important that the steering wheel is locked. Not doing this may cause damage to the air bag clock spring.

1. Turn the ignition to the OFF position.
2. Drain the power steering fluid as described in the shop manual.
3. Lock the steering wheel with a locking tool.
