August 17, 2005

SUBJECT: Safety Recall 05S34: Supplement #3
Certain 2004 Model Year F250/350/450/550, Excursion, and E350/450 Vehicles
Equipped with 6.0L Diesel
Fuel Injector Control Module Wiring Harness Repair

Safety Recall 05S34-S3
Certain 2004 Model Year F250/350/450/550, Excursion, and E350/450 Vehicles
Fuel Injector Control Module Wiring Harness Repair

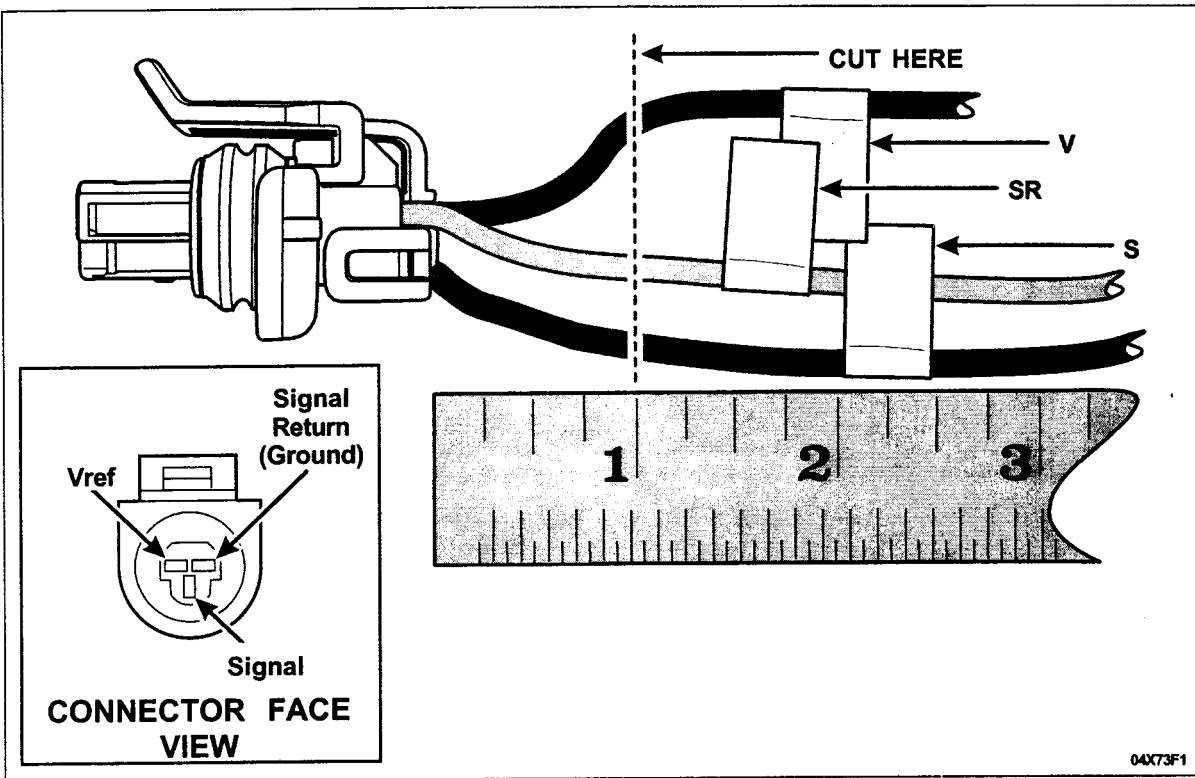
FIGURE 5

3. **CAUTION: The replacement connector has only one (1) color wire, so location identification is crucial for a proper repair.**

Identify each wire leading to the connector (Vref, Ground and Signal). Note the locations of each wire relative to the connector face view provided. Place the identification tags at least a few inches away from the connector. See Figure 5.

4. Cut the wires about 25 mm (1 inch) behind the connector on the vehicle harness **MAKING SURE TO LEAVE THE IDENTIFYING TAGS ON THE HARNESS** and retain the old connector for reference. See Figure 5.

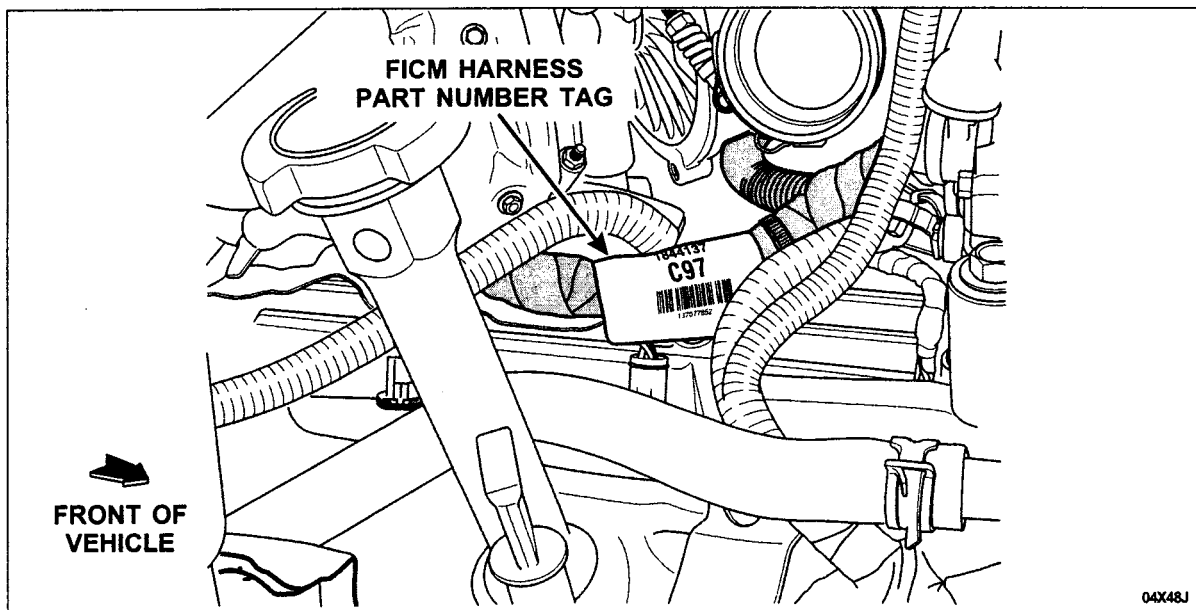
FIGURE 1

NEW NOTE: The part number on the tag shows the International® part number for the FICM harness. It differs from Ford Motor Company part numbers. The International® part number is a string of numbers that should end in **C97**. C97 will be larger than the other numbers on the harness tag.

1. If necessary, disconnect the hot-side charge air cooler (CAC) duct (passenger side of the vehicle) from the turbocharger outlet duct cuff.
2. Inspect the FICM harness for a part number tag. If present, it will be located between two (2) of the fuel injector harness takeouts. See Figure 1.

- If no tag is present, continue with this inspection.
- If the tag is present but the part number ends in anything but C97, continue with this inspection.
- If the tag is present and the part number ends in C97, no FICM harness service is required. Reinstall the CAC duct and proceed to Road Test Procedure in this Attachment IV.

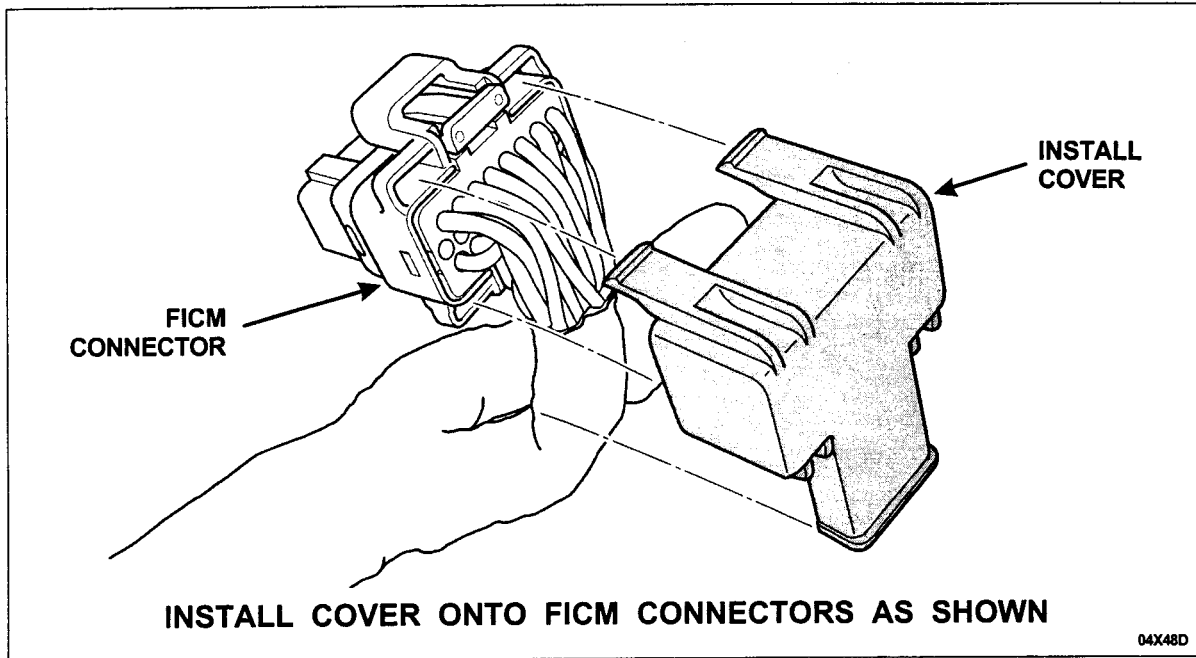
FIGURE 5

This program involves inspecting the fuel injector harness, at the fuel injection control module (FICM), for chafing caused by the harness rubbing against the intake manifold or rocker cover assembly bolt heads. If only a light amount of chafing has occurred (tape is worn through, the silver shielding and possibly the wire insulation are visible), install protective shields to prevent further damage. If more extensive chafing has occurred (copper wire strands are visible), the harness must be replaced.

1. Install the harness connector covers onto **both** FICM injector harness connectors by carefully bending the wires coming out of the connector and snapping the cover in place. See Figure 5.

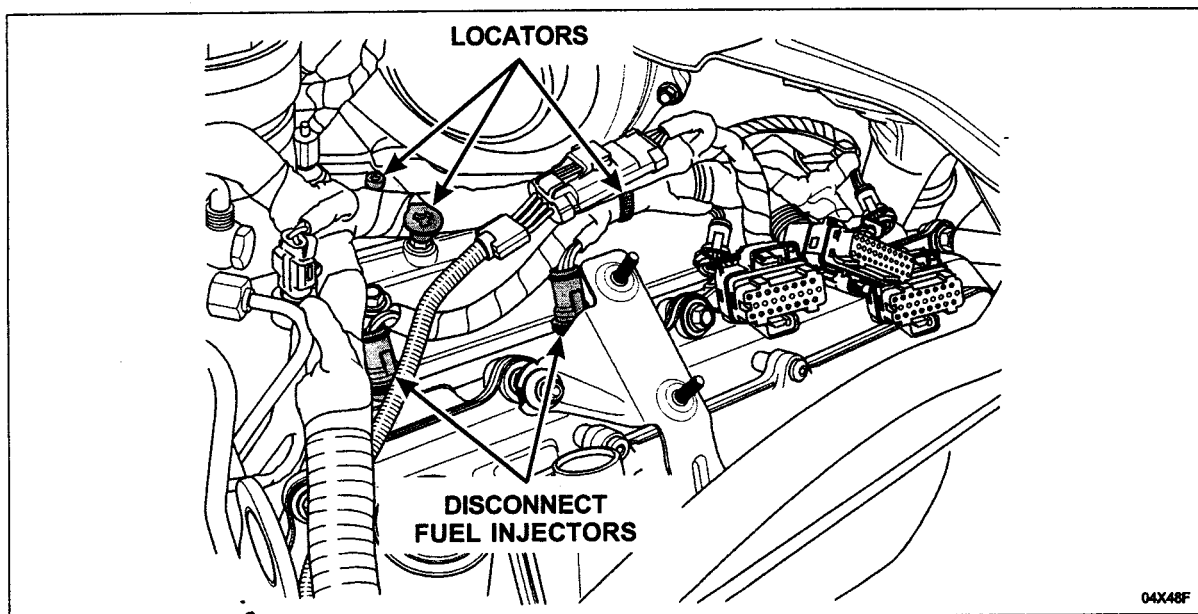
FIGURE 7

NOTE: FICM Harness Replacement must only be performed if copper strands have been exposed caused by chafing of the wires inside the harness.

1. **CAUTION: While removing the ground stud nut, hold the stud/intake manifold bolt from turning. If the stud/bolt is not held, the intake manifold bolt may loosen causing the ground wire to twist and eventually break.**

2. Disconnect the remaining two (2) fuel injectors on the driver side along with three (3) wire harness locators (two [2] located along the fuel injector manifold assembly and one located under the turbocharger). See Figure 7.

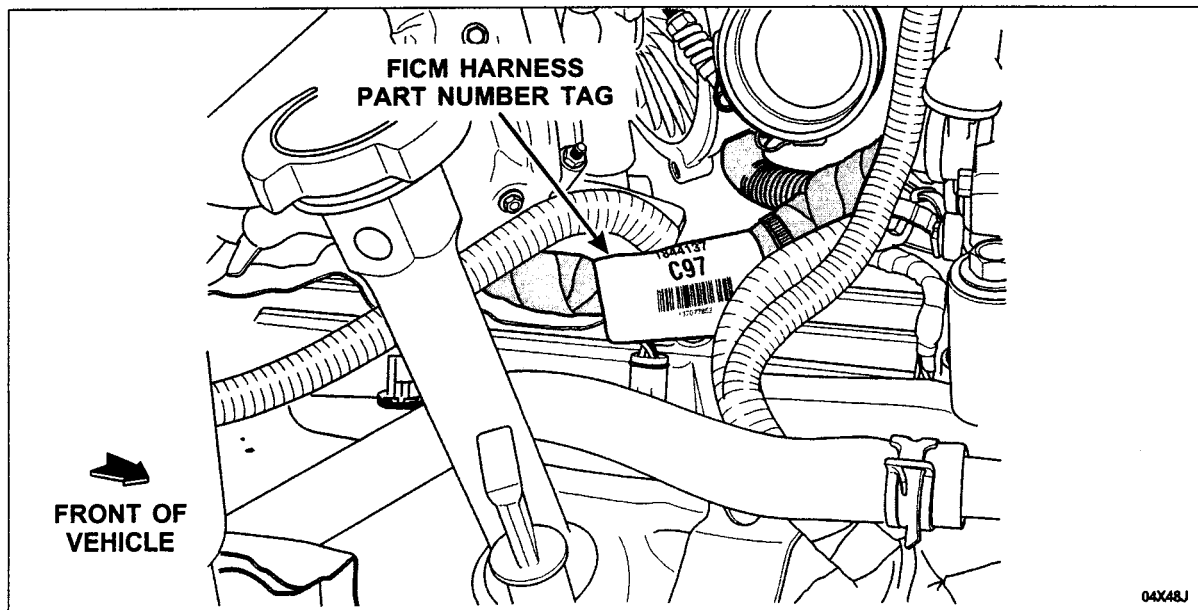
FIGURE 1

NEW NOTE: The part number on the tag shows the International® part number for the FICM harness. It differs from Ford Motor Company part numbers. The International® part number is a string of numbers that should end in C97. C97 will be larger than the other numbers on the harness tag.

1. If necessary, disconnect the hot-side charge air cooler (CAC) duct (passenger side of the vehicle) from the turbocharger outlet duct cuff.
2. Inspect the FICM harness for a part number tag. If present, it will be located between two (2) of the fuel injector harness takeouts. See Figure 1.

- If no tag is present, continue with this inspection.
- If the tag is present but the part number ends in anything but C97, continue with this inspection.
- If the tag is present and the part number ends in C97, the only FICM harness service required is replacement of the ICP sensor connector. Proceed to Sensor Connector Replacement in this Attachment V.

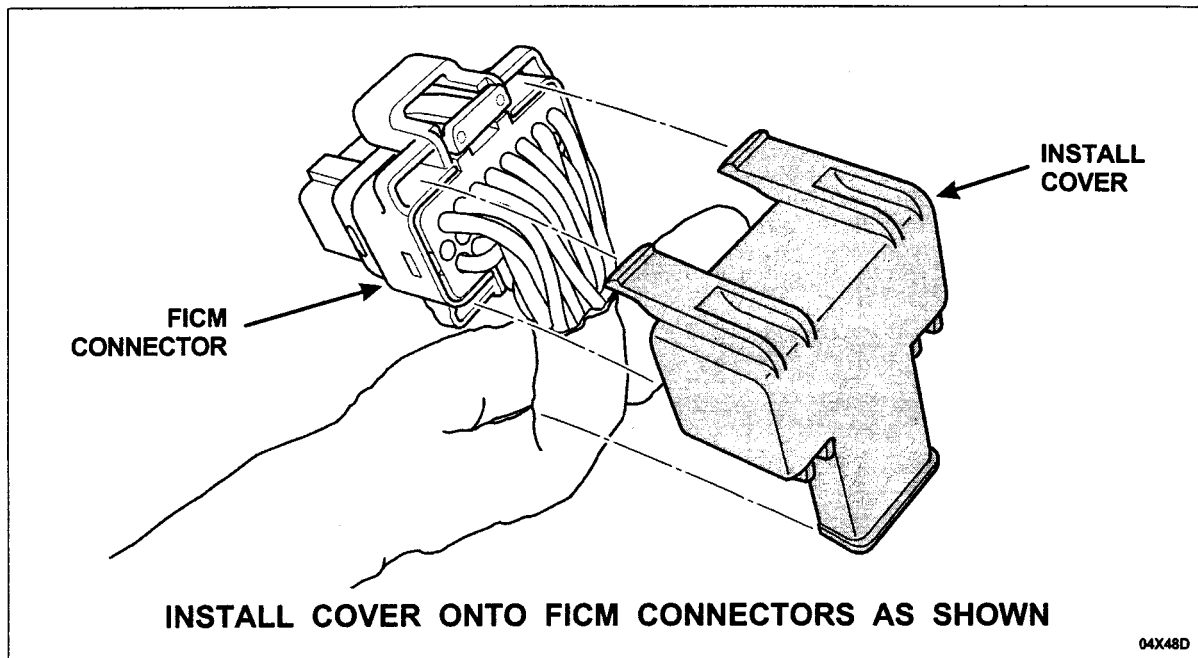
FIGURE 5

This program involves inspecting the fuel injector harness, at the fuel injection control module (FICM), for chafing caused by the harness rubbing against the intake manifold or rocker cover assembly bolt heads. If only a light amount of chafing has occurred (tape is worn through, the silver shielding and possibly the wire insulation are visible), install protective shields to prevent further damage. If more extensive chafing has occurred (copper wire strands are visible), the harness must be replaced. This program also involves replacing the injector control pressure (ICP) sensor connector assembly. The harness connector is replaced utilizing the Rotunda Wire Splice Tool Kit 164-R5903.

1. Install the harness connector covers onto **both** FICM injector harness connectors by carefully bending the wires coming out of the connector and snapping the cover in place. See Figure 5.

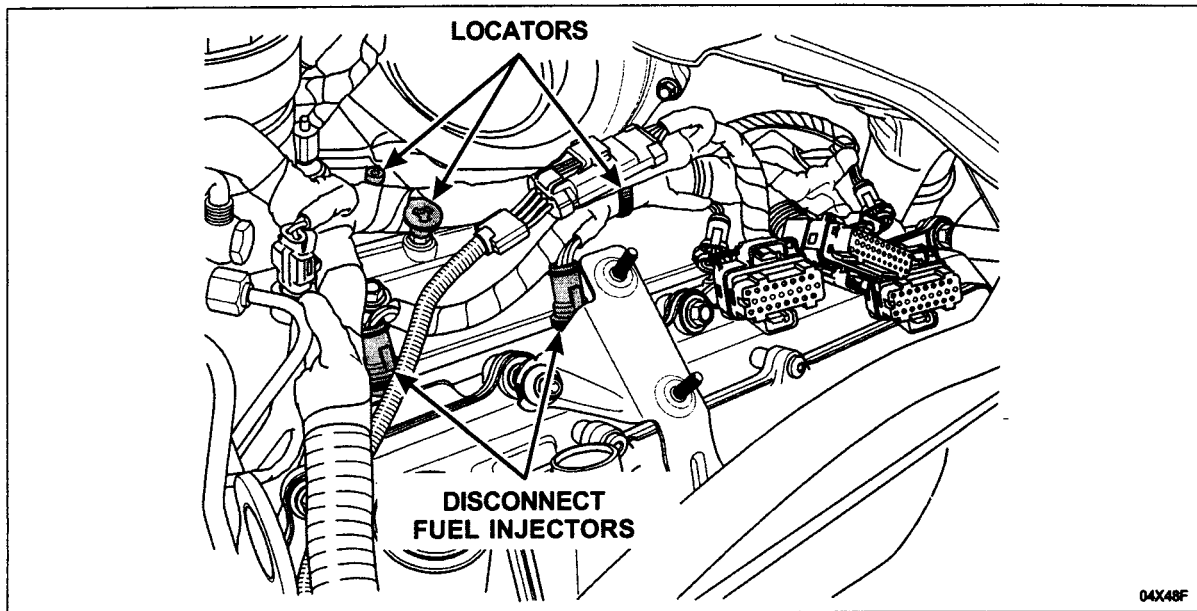
FIGURE 7

NOTE: FICM Harness Replacement must only be performed if copper strands have been exposed caused by chafing of the wires inside the harness.

1. **CAUTION: While removing the ground stud nut, hold the stud/intake manifold bolt from turning. If the stud/bolt is not held, the intake manifold bolt may loosen causing the ground wire to twist and eventually break.**

2. Disconnect the remaining two (2) fuel injectors on the driver side along with three (3) wire harness locators (two [2] located along the fuel injector manifold assembly and one [1] located under the turbocharger). See Figure 7.

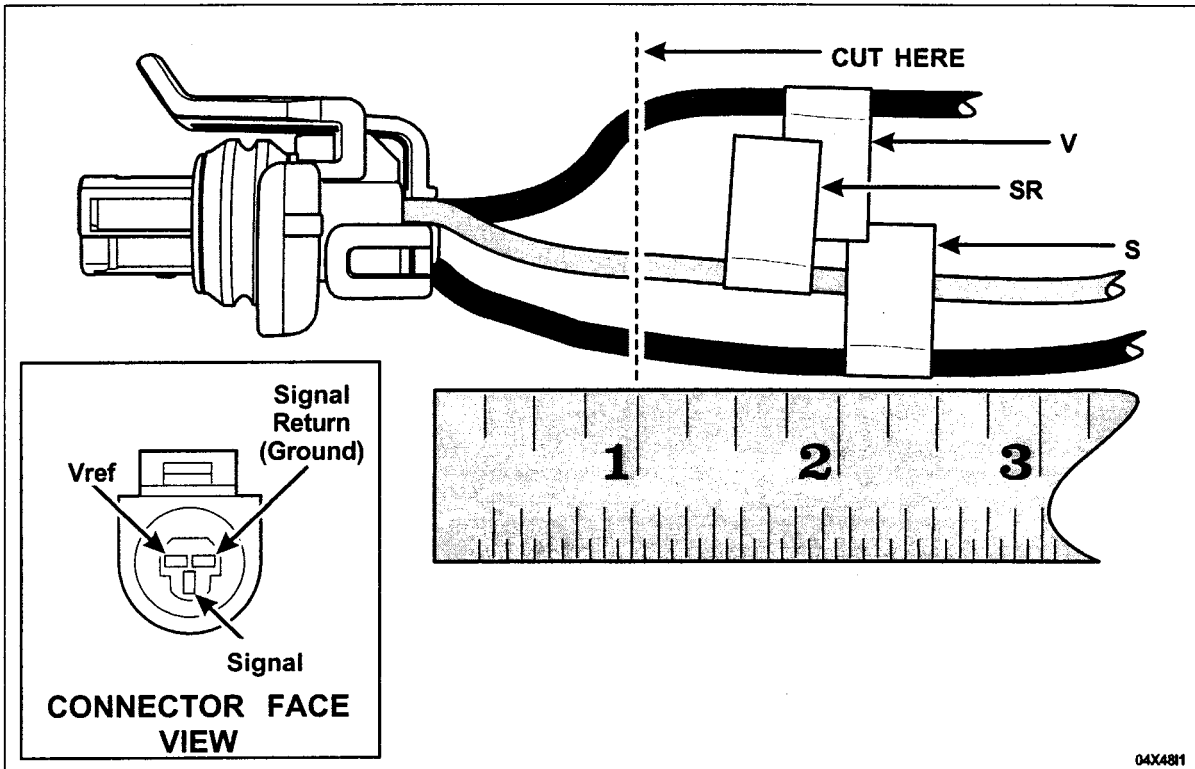
FIGURE 10

3. **CAUTION: The replacement connector has only one color wire, so location identification is crucial for a proper repair.**

Identify each wire leading to the connector (Vref, Ground and Signal). Note the locations of each wire relative to the connector face view provided. Place the identification tags at least a few inches away from the connector. See Figure 10.

4. Cut the wires about 25 mm (1 inch) behind the connector on the vehicle harness **MAKING SURE TO LEAVE THE IDENTIFYING TAGS ON THE HARNESS** and discard the old connector. See Figure 10.
