Frank M. Ligon  
Director  
Service Engineering Operations  
Ford Customer Service Division

July 5, 2005

**SUBJECT:** Safety Recall 05S34: Supplement #1  
Certain 2004 Model Year F250/350/450/550, Excursion, and E350/450 Vehicles  
Equipped with 6.0L Diesel  
Fuel Injector Control Module Wiring Harness Repair

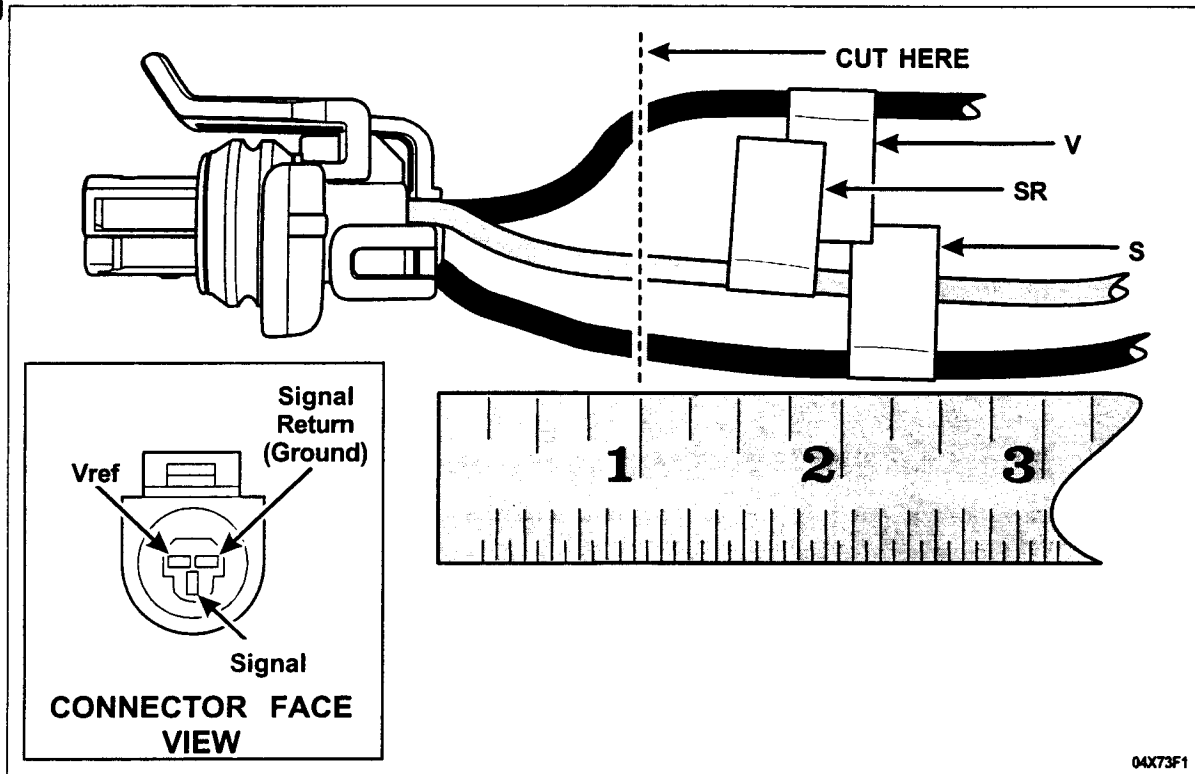
FIGURE 5

3. **CAUTION:** The replacement connector has only one (1) color wire, so location identification is crucial for a proper repair.

Identify each wire leading to the connector (Vref, Ground and Signal). Note the locations of each wire relative to the connector face view provided. Place the identification tags at least a few inches away from the connector. See Figure 5.

4. Cut the wires about 25 mm (1 inch) behind the connector on the vehicle harness **MAKING SURE TO LEAVE THE IDENTIFYING TAGS ON THE HARNESS** and retain the old connector for reference. See Figure 5.

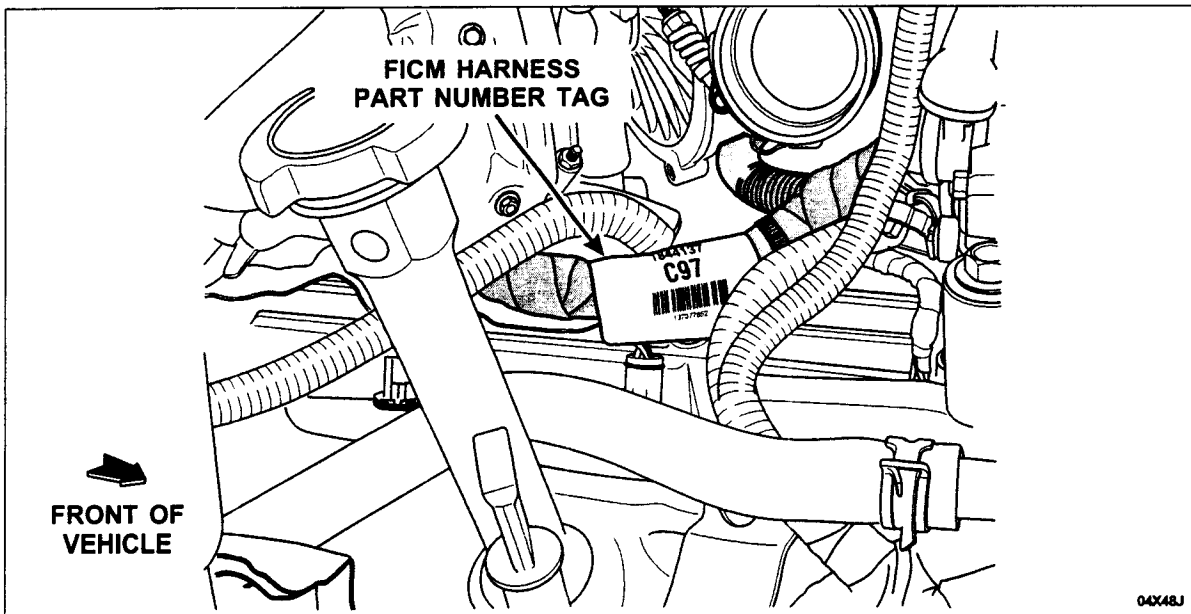
FIGURE 1

This program involves inspecting the fuel injector harness, at the fuel injection control module (FICM), for chafing caused by the harness rubbing against the intake manifold or rocker cover assembly bolt heads. If only a light amount of chafing has occurred (tape is worn through, the silver shielding and possibly the wire insulation are visible), install protective shields to prevent further damage. If more extensive chafing has occurred (copper wire strands are visible), the harness must be replaced.

1. If necessary, disconnect the hot-side charge air cooler (CAC) duct (passenger side of the vehicle) from the turbocharger outlet duct cuff.
2. Inspect the FICM harness for a part number tag. If present, it will be located between two (2) of the fuel injector harness takeouts. See Figure 1.

**NEW** NOTE: The part number on the tag shows the International® part number for the FICM harness. It differs from Ford Motor Company part numbers. The International® part number is a string of numbers that should end in **C97**. C97 will be larger than the other numbers on the harness tag.

- If no tag is present, continue with this inspection.
- If the tag is present but the part number ends in anything but C97, continue with this inspection.
- If the tag is present and the part number ends in C97, no FICM harness service is required. Reinstall the CAC duct and proceed to Road Test Procedure in this Attachment IV.

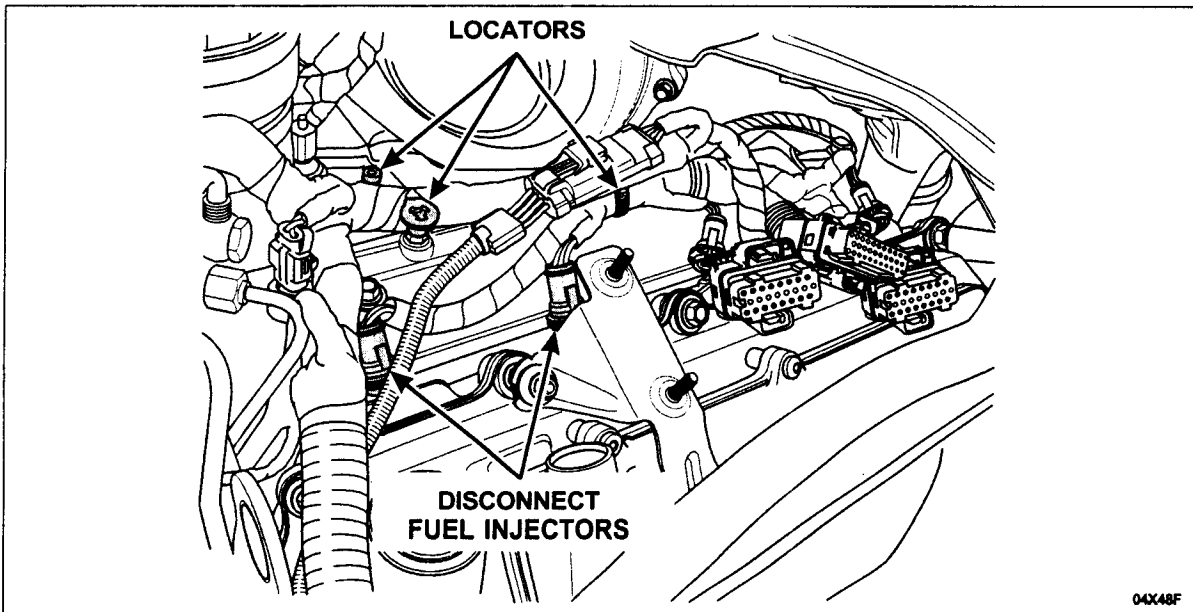
FIGURE 7

NOTE: FICM Harness Replacement must only be performed if copper strands have been exposed caused by chafing of the wires inside the harness.

2. Disconnect the remaining two (2) fuel injectors on the driver side along with three (3) wire harness locators (two [2] located along the fuel injector manifold assembly and one located under the turbocharger). See Figure 7.

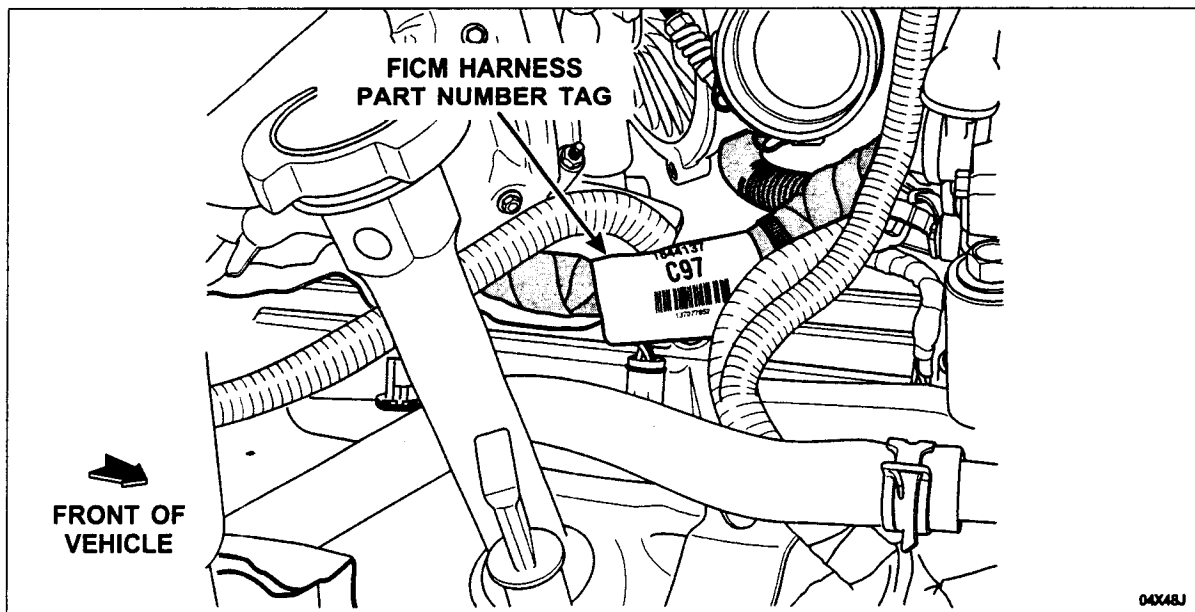
FIGURE 1

This program involves inspecting the fuel injector harness, at the fuel injection control module (FICM), for chafing caused by the harness rubbing against the intake manifold or rocker cover assembly bolt heads. If only a light amount of chafing has occurred (tape is worn through, the silver shielding and possibly the wire insulation are visible), install protective shields to prevent further damage. If more extensive chafing has occurred (copper wire strands are visible), the harness must be replaced. This program also involves replacing the injector control pressure (ICP) sensor connector assembly. The harness connector is replaced utilizing the Rotunda Wire Splice Tool Kit 164-R5903.

1. If necessary, disconnect the hot-side charge air cooler (CAC) duct (passenger side of the vehicle) from the turbocharger outlet duct cuff.
2. Inspect the FICM harness for a part number tag. If present, it will be located between two (2) of the fuel injector harness takeouts. See Figure 1.

**NEW** NOTE: The part number on the tag shows the International® part number for the FICM harness. It differs from Ford Motor Company part numbers. The International® part number is a string of numbers that should end in C97. C97 will be larger than the other numbers on the harness tag.

- If no tag is present, continue with this inspection.
- If the tag is present but the part number ends in anything but C97, continue with this inspection.
- If the tag is present and the part number ends in C97, the only FICM harness service required is replacement of the ICP sensor connector. Proceed to Sensor Connector Replacement in this Attachment V.

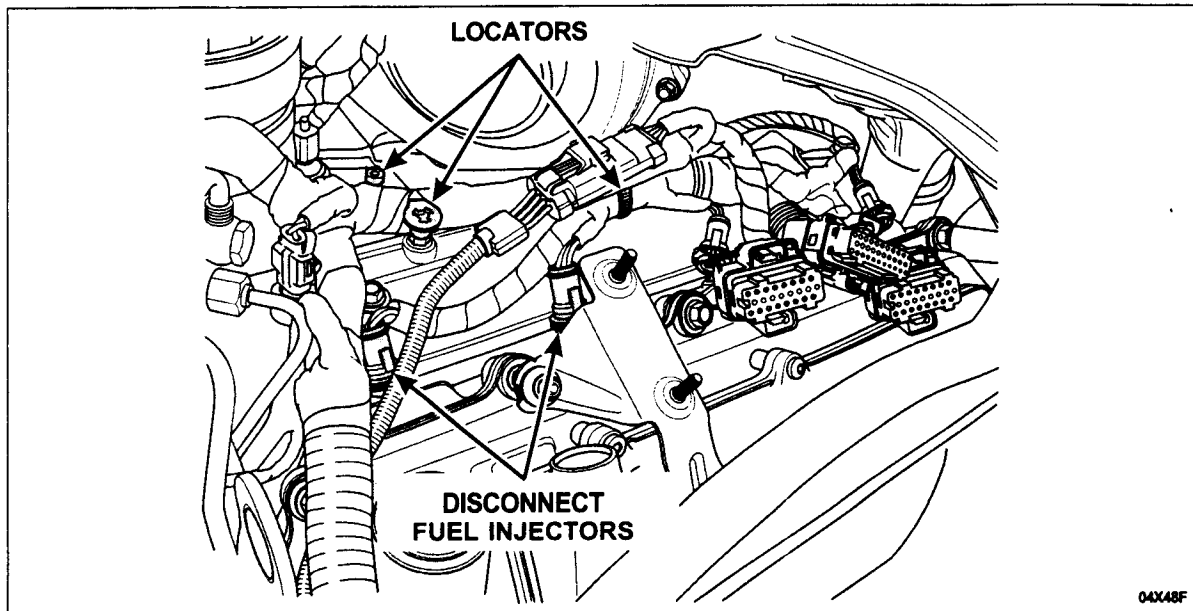
FIGURE 7

NOTE: FICM Harness Replacement must only be performed if copper strands have been exposed caused by chafing of the wires inside the harness.

2. Disconnect the remaining two (2) fuel injectors on the driver side along with three (3) wire harness locators (two [2] located along the fuel injector manifold assembly and one located under the turbocharger). See Figure 7.

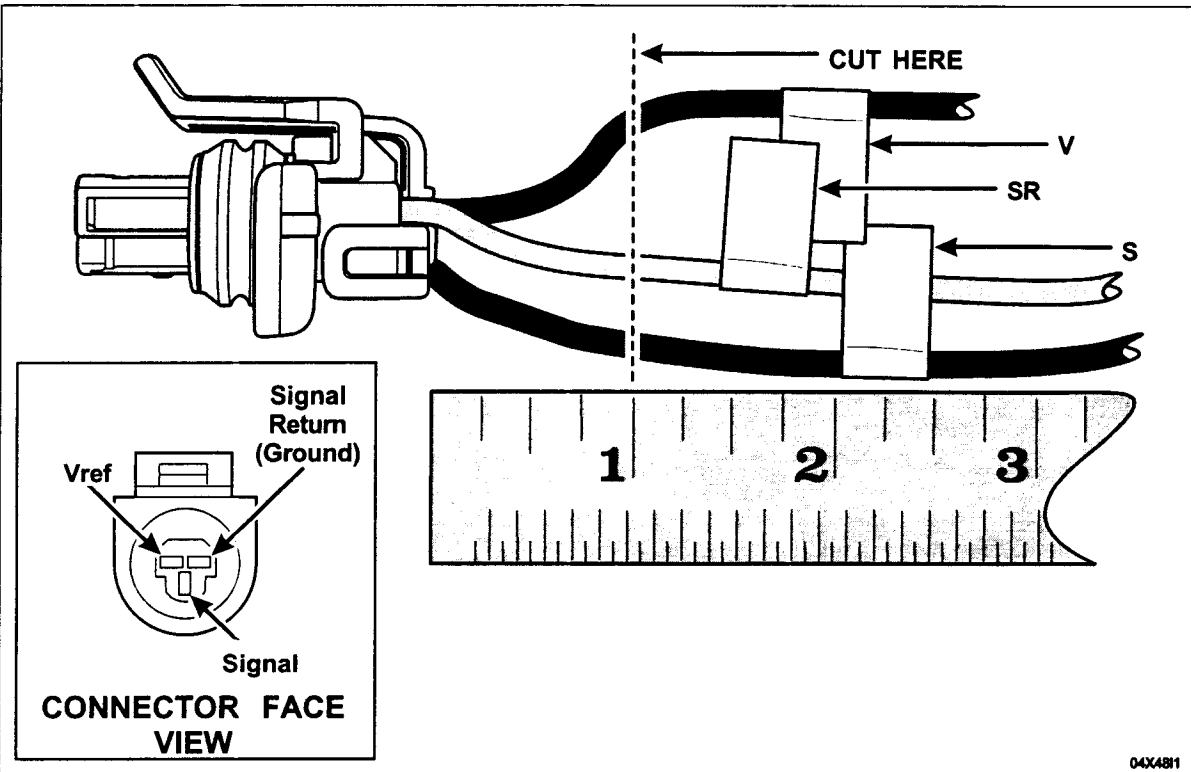
FIGURE 10

3. **CAUTION: The replacement connector has only one color wire, so location identification is crucial for a proper repair.**

Identify each wire leading to the connector (Vref, Ground and Signal). Note the locations of each wire relative to the connector face view provided. Place the identification tags at least a few inches away from the connector. See Figure 10.

4. Cut the wires about 25 mm (1 inch) behind the connector on the vehicle harness **MAKING SURE TO LEAVE THE IDENTIFYING TAGS ON THE HARNESS** and discard the old connector. See Figure 10.
