- TO:** All U.S. Ford and Lincoln Mercury Dealers
- SUBJECT:** Safety Recall 05S34: Supplement #2
Certain 2004 Model Year F250/350/450/550, Excursion, and E350/450 Vehicles
Equipped with 6.0L Diesel
Fuel Injector Control Module Wiring Harness Repair

REASON FOR THIS SAFETY RECALL

Safety Recall 05S34-S2
Certain 2004 Model Year F250/350/450/550, Excursion, and E350/450 Vehicles
Fuel Injector Control Module Wiring Harness Repair

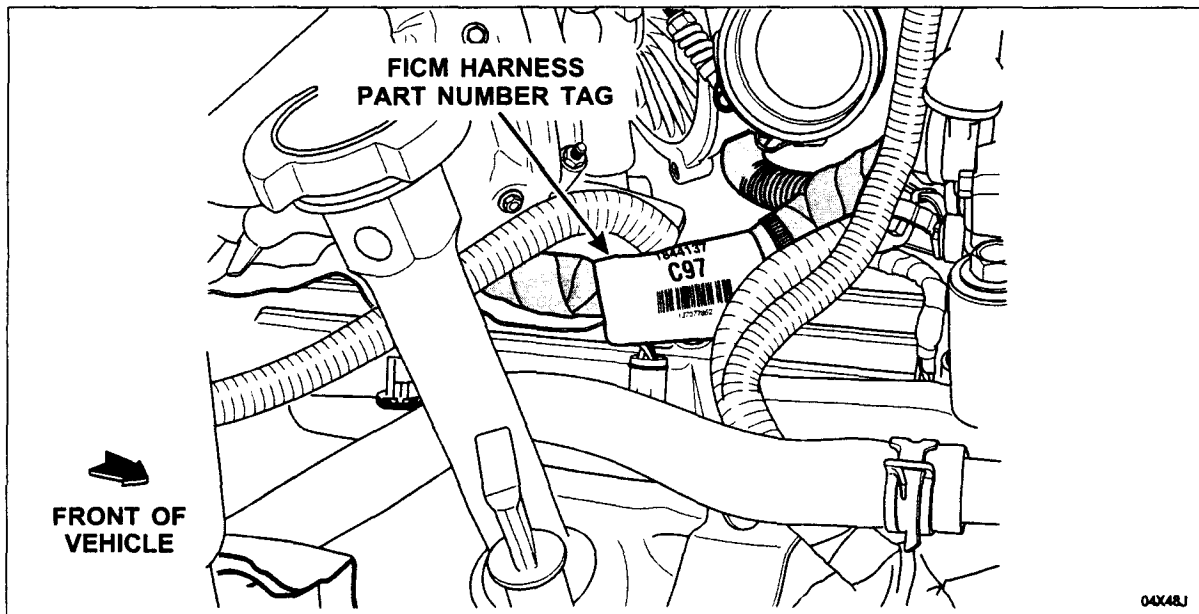
FIGURE 1

This program involves inspecting the fuel injector harness, at the fuel injection control module (FICM), for chafing caused by the harness rubbing against the intake manifold or rocker cover assembly bolt heads. If only a light amount of chafing has occurred (tape is worn through, the silver shielding and possibly the wire insulation are visible), install protective shields to prevent further damage. If more extensive chafing has occurred (copper wire strands are visible), the harness must be replaced.

1. If necessary, disconnect the hot-side charge air cooler (CAC) duct (passenger side of the vehicle) from the turbocharger outlet duct cuff.
2. Inspect the FICM harness for a part number tag. If present, it will be located between two (2) of the fuel injector harness takeouts. See Figure 1.

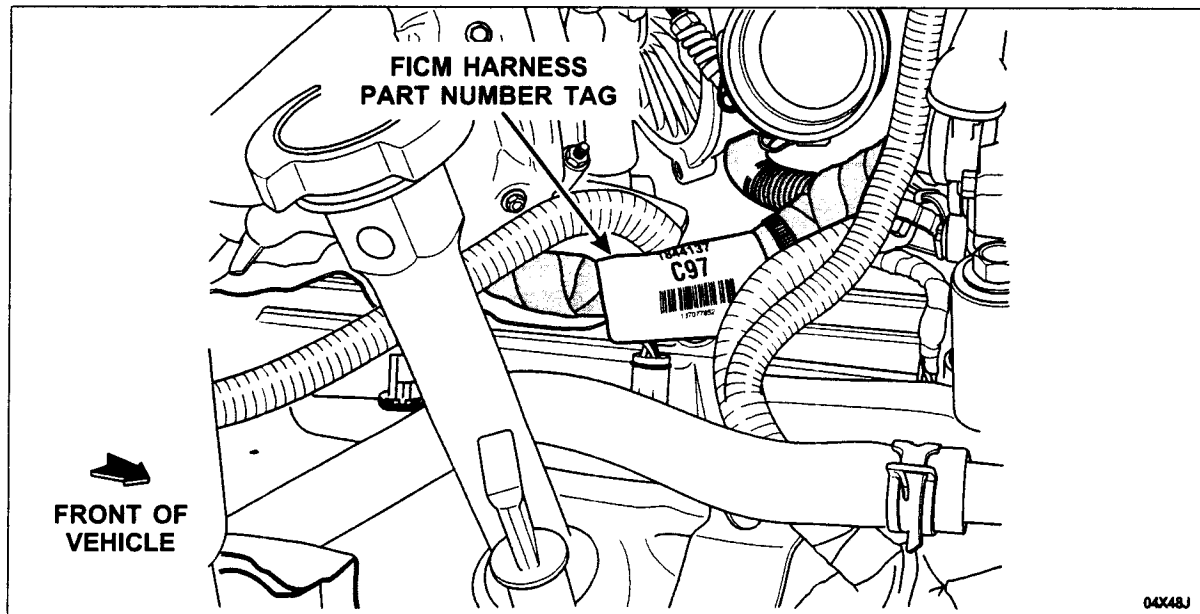
FIGURE 1

This program involves inspecting the fuel injector harness, at the fuel injection control module (FICM), for chafing caused by the harness rubbing against the intake manifold or rocker cover assembly bolt heads. If only a light amount of chafing has occurred (tape is worn through, the silver shielding and possibly the wire insulation are visible), install protective shields to prevent further damage. If more extensive chafing has occurred (copper wire strands are visible), the harness must be replaced. This program also involves replacing the injector control pressure (ICP) sensor connector assembly. The harness connector is replaced utilizing the Rotunda Wire Splice Tool Kit 164-R5903.

1. If necessary, disconnect the hot-side charge air cooler (CAC) duct (passenger side of the vehicle) from the turbocharger outlet duct cuff.
2. Inspect the FICM harness for a part number tag. If present, it will be located between two (2) of the fuel injector harness takeouts. See Figure 1.
