# TOYOTA CUSTOMER SERVICES

Volume: XII  
Number: TC05-014  
Date: 06/27/2005  
 Action  
 Retain  
 Information

SUBJECT: SPECIAL SERVICE CAMPAIGN (SSC) – 50I  
2005 MY TACOMA REGULAR CAB BENCH SEAT WIRE HARNESS

**SPECIAL SERVICE CAMPAIGN 50I**

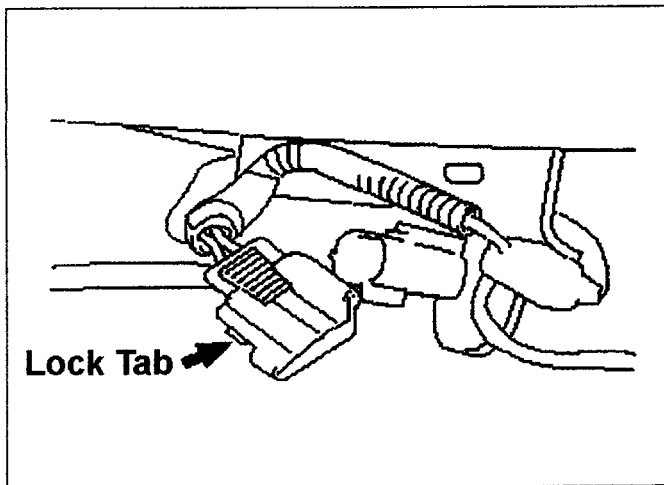
3. LOCATE THE BENCH SEAT FLOOR WIRE HARNESS

- (c) Slide the bench seat to the rearmost position.
- (d) Locate the floor wire harness and connector under the seat on the driver's side, closest to the front edge of the seat cushion.

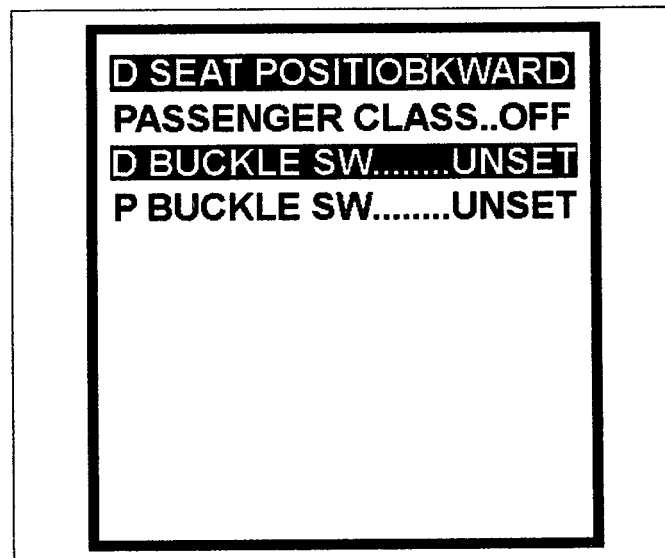
### (Test #1)

- (a) Move the bench seat to the rearmost position.
- (b) Buckle the driver's seat belt.
- (c) Confirm that the scan tool displays the data shown below and in the illustration.

- "D SEAT POSITIOBKWARD"  
(Driver's seat is in the backward position).
- "D BUCKLE SW.....SET"  
(Driver's seat belt buckle switch is set/buckled).

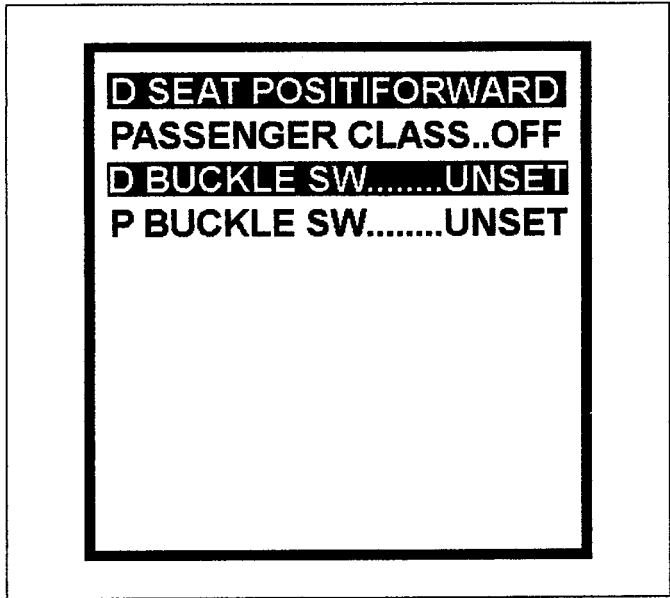
### (Test #2)

- (a) Leave the bench seat in the rearmost position.
- (b) Unbuckle the driver's seat belt.
- (c) Confirm that the scan tool displays the data shown below and in the illustration.

- "D SEAT POSITIOBKWARD"  
(Driver's seat is in the backward position).
- "D BUCKLE SW.....UNSET"  
(Driver's seat belt buckle switch is unset/unbuckled).

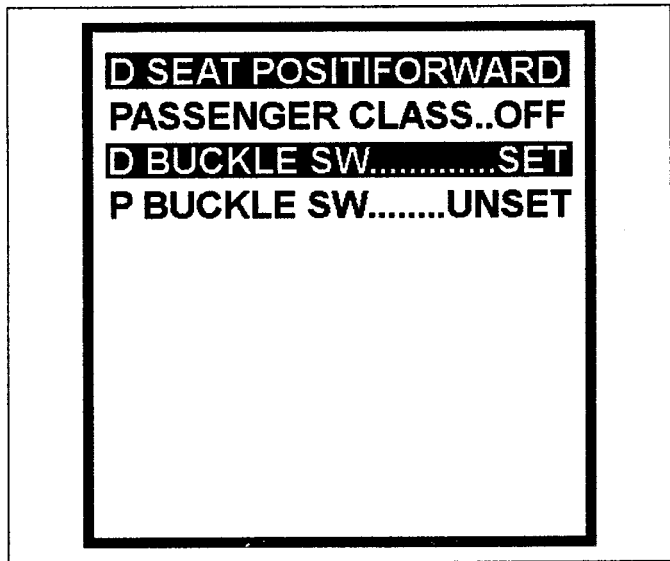
**(Test #3)**

- (a) Move the bench seat to the foremost position.
- (b) Leave the driver's seat belt unbuckled.
- (c) Confirm that the scan tool displays the data shown below and in the illustration.
  - "D SEAT POSITIFORWARD" (Driver's seat is in the forward position).
  - "D BUCKLE SW.....UNSET" (Driver's seat belt buckle switch is unset/unbuckled).
