**Subject: Recall Campaign M1 (05V-305)
2005 Model Year Volkswagen New Jetta Vehicles
Inspect Engine Compartment Fuel Supply Line and Clamp and Replace if
Necessary**

Subject: Safety Recall M1
2005 Model Year Volkswagen New Jetta Vehicles Equipped with a 2.5L Gasoline Engine
Inspect Engine Compartment Fuel Supply Line Clamp and Replace if Necessary

Safety Recall Circular

**Subject: 2005 Model Year Volkswagen New Jetta Vehicles
with a 2.5L Gasoline Engine
Inspect Engine Compartment Fuel Supply Line Clamp
and Replace if Necessary**

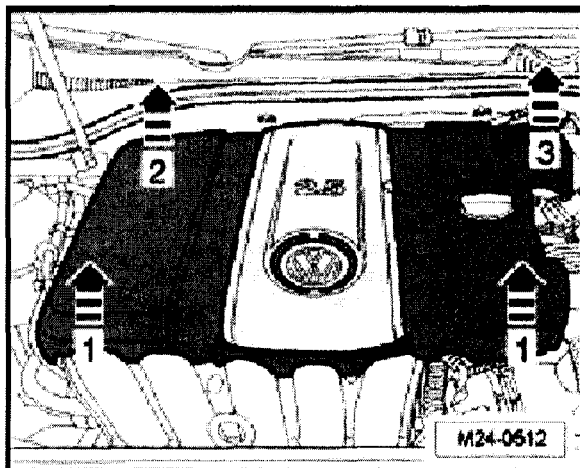
Section A – Check Fuel Feed Hose and Spring Clip

- Perform the following four checks. If any one check is not met proceed to Section B and replace fuel feed hose spring clip

- Switch ignition off and open hood
- ⇐ Pull engine cover out of retainers first at front -arrow 1-, then at right rear -arrow 2- and lastly at left rear -arrow 3-
- Carefully pivot engine cover out from rear area
- ⇐ Lift left side -arrow 1 and 2- of engine cover up to allow inspection of fuel feed hose to fuel rail connection without disconnecting MAF sensor or air intake tube
