# TOYOTA CUSTOMER SERVICES

Volume: XII  
Number: TC05-017  
Date: 07/19/2005  
 Action  
 Retain  
 Information

SUBJECT: SPECIAL SERVICE CAMPAIGN (SSC) – 50L  
2004 THROUGH MID-2005 MY SIENNA MIDDLE ROW SEATBELT BEZEL

**SPECIAL SERVICE CAMPAIGN 50L**

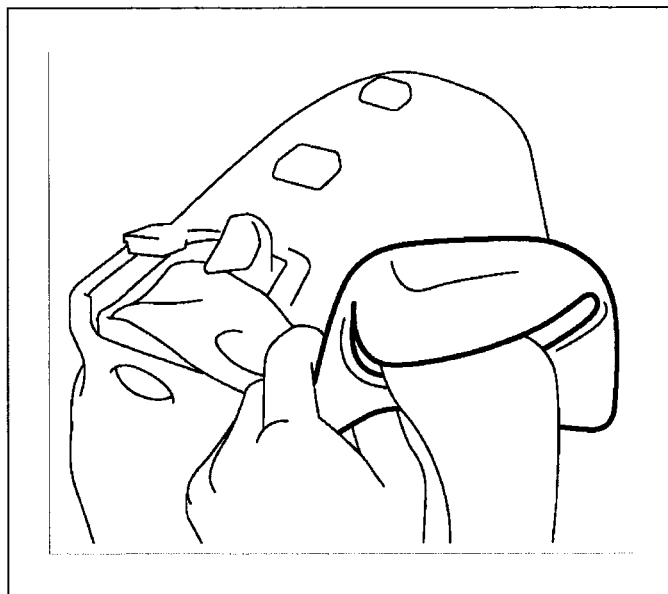
#### 1. REMOVE THE MIDDLE ROW SEATBELT BEZEL

In the middle row seating position in certain 2004 and 2005 model year Sienna vehicles, there is a possibility that the shoulder portion of the seatbelt may bind in the bezel trim piece (Seatbelt Bezel). The affected Seatbelt Bezel is located on the shoulder portion of the seat in the right side seat of the seven passenger models and the center seating position in the eight passenger models. In the worst case, if the seatbelt binds in the bezel, there is a possibility that extra slack may exist in the seatbelt which could result in an improperly restrained occupant and may lead to increased likelihood of injury in the event of a crash. Until the recall repair is completed, vehicle occupants sitting in the affected seating positions should verify the shoulder belt portion of the seatbelt is retracting smoothly. If the seatbelt binds, it may be unbound by pulling the seatbelt outward.

- (a) Remove the headrest
- (b) Remove the side clip.
- (c) Remove the screw.
- (d) Using the nylon pry tools, disengage the claws for the front clip.
- (e) Apply firm pressure to the back side of the seatbelt bezel where the claw is located. While applying pressure to this area push up to disengage the seatbelt bezel from the claw.
- (f) Remove the seatbelt bezel from the seat.
- (g) Remove the seatbelt from the seatbelt bezel by sliding it through the slit.
