# VEHICLE RECALL

## SC304

**Date:** 03/16/06 (Supersedes SC304 dated 02/22/06)

**Subject:** Front Axle Brake Cam Lubrication — CXN and CHN Model Chassis

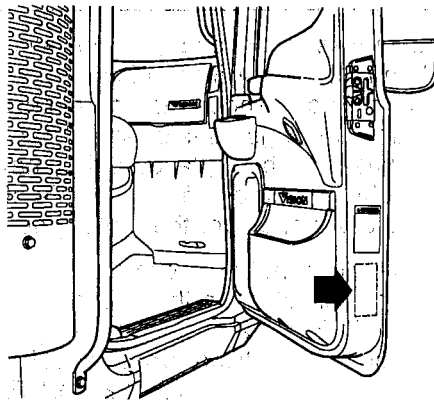
**Figure 1 — Campaign Label Location**

Before proceeding, check the campaign status in the MACKnet system to see if the campaign has already been completed. Campaign status can also be checked by looking at the Campaign Completion Label located on the lower edge of the passenger-side door. If the campaign has been completed, the campaign number (SC304) and the completion date should be written on the label.
