**Re: Defect Information Report – supplemental information
(FL-466), NHTSA no. 05V-550, Visteon Wiper Motor on Sterling**

Section 573.6 Non-Compliance Information Report
FL-466, Visteon Wiper Motor on Sterling; NHTSA no. 05V-550
Supplement No.: 02

Subject: Visteon Windshield Wiper Motors

Windshield Wiper Motor Inspection and Replacement Procedure

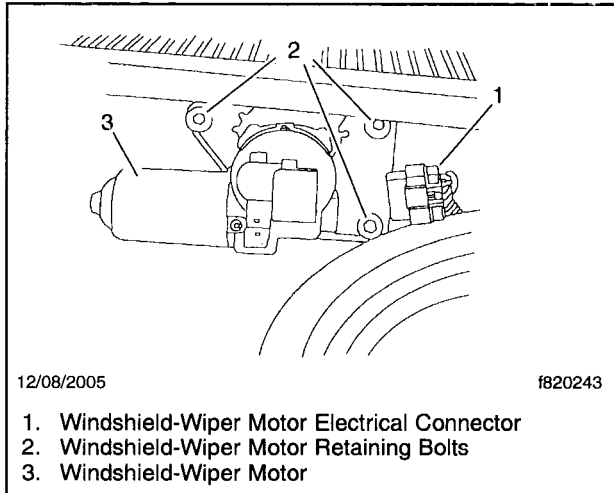
Fig. 6, Windshield Wiper Motor

Certain windshield wiper motor drives may stop functioning due to a lack of grease on the internal gears. In certain conditions, this will impair visibility and a vehicle crash could occur if the vehicle is not stopped safely.

If the date falls between September 1, 2005, and October 14, 2005, replace the wiper motor using the following instructions.
