Subject: Special Service Campaign (SSC) 5LC - 2006 IS 250 AWD Accelerator Pedal

TECHNICAL INSTRUCTIONS

SSC 5LC

Early 2006 IS 250 AWD Accelerator Pedal

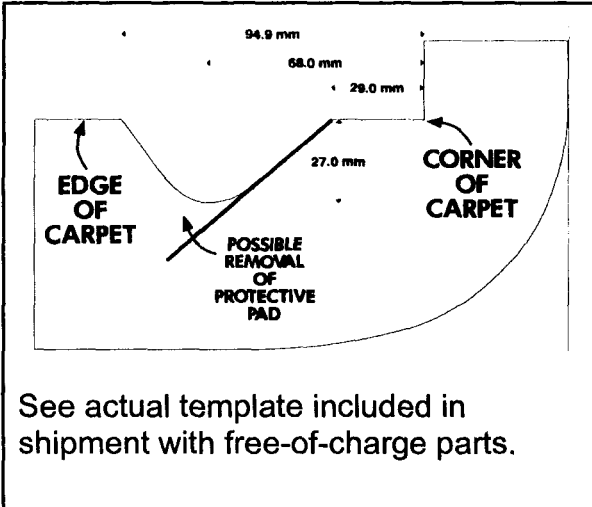
- Due to variations in the placement of the plastic pad in the carpet, there may be slight variations in the area where the modification will occur.
- The Parking Brake Cable is behind this area of the carpet; please make sure that you do not damage this cable during the carpet modification.
- A Styrofoam pad is also behind the carpet. Please take care not to cut this as well.
- Based upon the production date, the plastic pad location may be slightly lower.

3. CARPET MODIFICATION WITH SPECIAL TEMPLATE

- Be sure to read all cautions in the Technical Instructions.
- Place the template on the carpet and cut the plastic pad accordingly. Once completed, go to step 5, Install the new accelerator pedal.
- If you do not have the template, proceed to step 4, Carpet modification without the template.

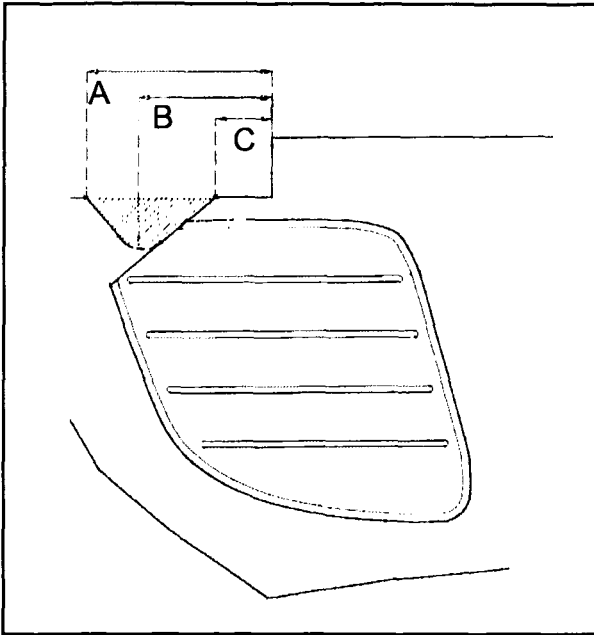
The parking brake cable is located behind the carpet, do not cut the cable.

- (e) Using the razor cut the carpet as shown on the illustration.
- (f) Remove the sectioned area of the carpet and discard.
