06V-414  
(10 pages)

RE: 2007 Mitsubishi Eclipse and Eclipse Spyder Gear Shift Key Lock Cable

SUBJECT:		No: <b>SR-06-005</b>	
<b>GEAR SHIFT KEY INTERLOCK CABLE — SAFETY RECALL CAMPAIGN</b>		DATE: <b>November, 2006</b>	
		MODEL: <b>See below</b>	
CIRCULATE TO:	<input type="checkbox"/> GENERAL MANAGER	<input checked="" type="checkbox"/> PARTS MANAGER	<input checked="" type="checkbox"/> TECHNICIAN
<input checked="" type="checkbox"/> SERVICE ADVISOR	<input checked="" type="checkbox"/> SERVICE MANAGER	<input checked="" type="checkbox"/> WARRANTY PROCESSOR	<input type="checkbox"/> SALES MANAGER

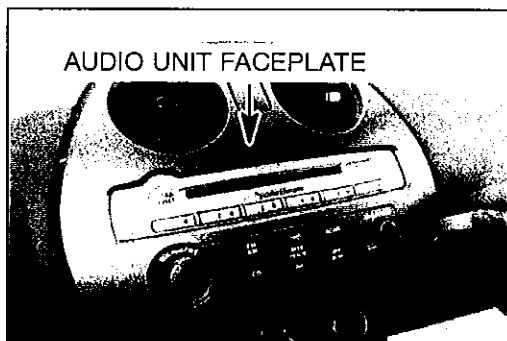
1. Using a trim stick, carefully remove the audio unit faceplate.

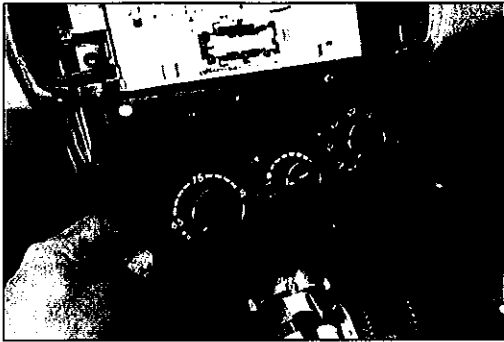
2. Unsnap the HVAC panel and allow it to hang by the harness to the right of the console.
3. Pull up on the parking brake handle.
