**Re: PART 573 NOTICE RE MCI G4500 TAG AXLE SWING ARM RECALL PLAN**

Safety Defect and Noncompliance Report Guide for Vehicles  
PART 573 Defect and Noncompliance Report

# Service Bulletin No.212

<b>MODEL</b> G4500 Series Coaches	<b>TYPE</b> Field Change Program	<b>SECTION/GROUP</b> 2B - Trailing Axle	<b>DATE</b> Dec. 04, 2003
<b>SUBJECT</b> TAG AXLE WELD REWORK			
<b>CONDITIONS</b>

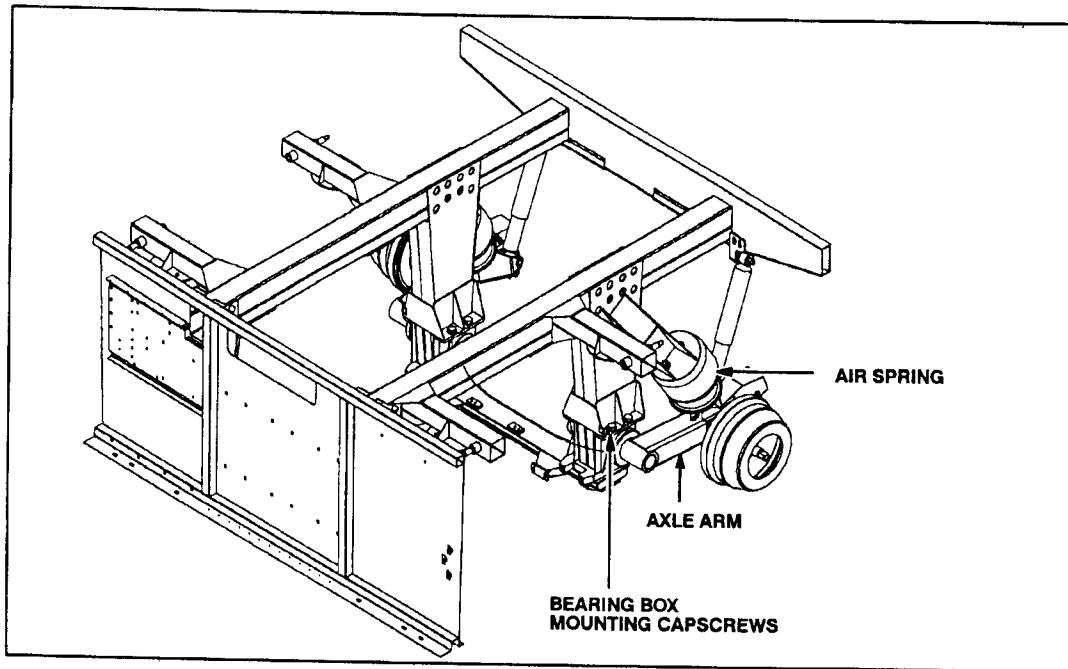
**Figure 3.**

7. Visually inspect the tag axle arm assembly for cracks.

22. Install new tag axle arm and bearing box assembly, taking care not to allow oil to drain from bearing box. Torque the bearing box mounting capscrews ( 4 ) to 300–310 lb–ft. ( Figure 3 ).
