**Re: PART 573 NOTICE RE MCI G4500 TAG AXLE SWING ARM RECALL PLAN**

Safety Defect and Noncompliance Report Guide for Vehicles  
**PART 573 Defect and Noncompliance Report**

# Service Bulletin No.212

MODEL <b>G4500 Series Coaches</b>	TYPE <b>Field Change Program</b>	SECTION/GROUP <b>2B- Trailing Axle</b>	DATE <b>Dec. 04, 2003</b>
SUBJECT <b>TAG AXLE WELD REWORK</b>			
CONDITIONS

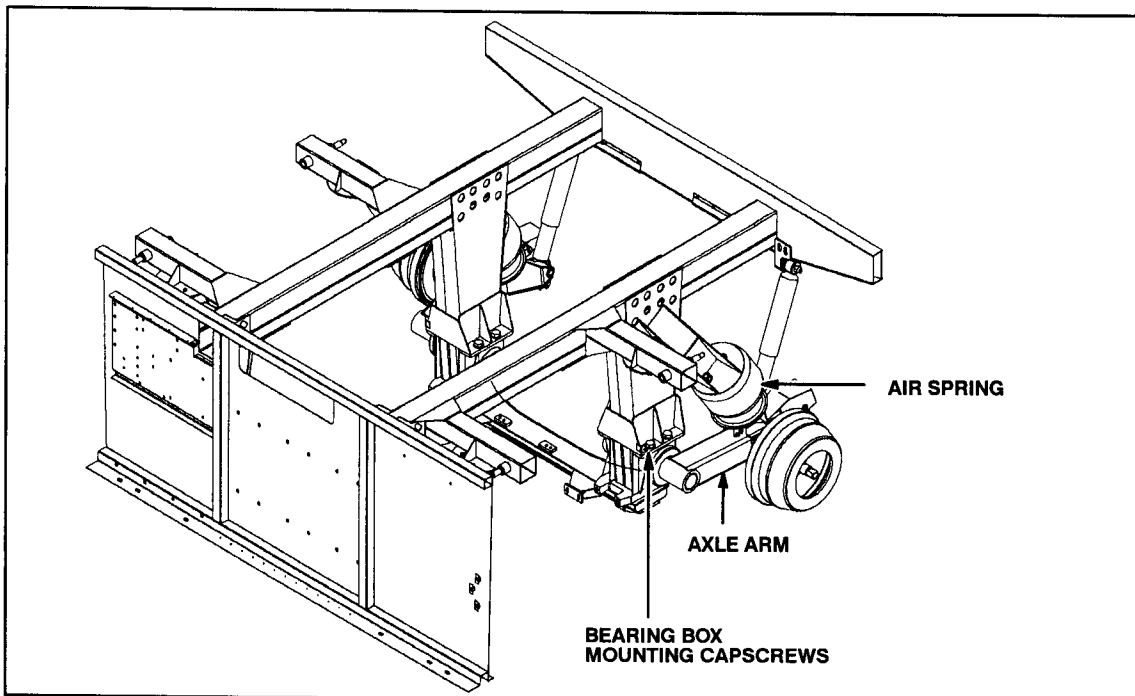
Figure 3.

7. Visually inspect the tag axle arm assembly for cracks.

22. Install new tag axle arm and bearing box assembly, taking care not to allow oil to drain from bearing box. Torque the bearing box mounting capscrews ( 4 ) to 300–310 lb–ft. ( Figure 3 ).
