**Special Service Campaign (SSC) 60F
2004 Through 2005 Highlander And Early 2006 Highlander HV
Center Console (Floor Carpet Cover) Retaining Clips
*****URGENT*******

Volume: XIII
Number: TC06-010
Date: 07/11/2006
 Action
 Retain
 Information

SPECIAL SERVICE CAMPAIGN 60F

2004 THROUGH 2005 HIGHLANDER AND
EARLY 2006 HIGHLANDER HV

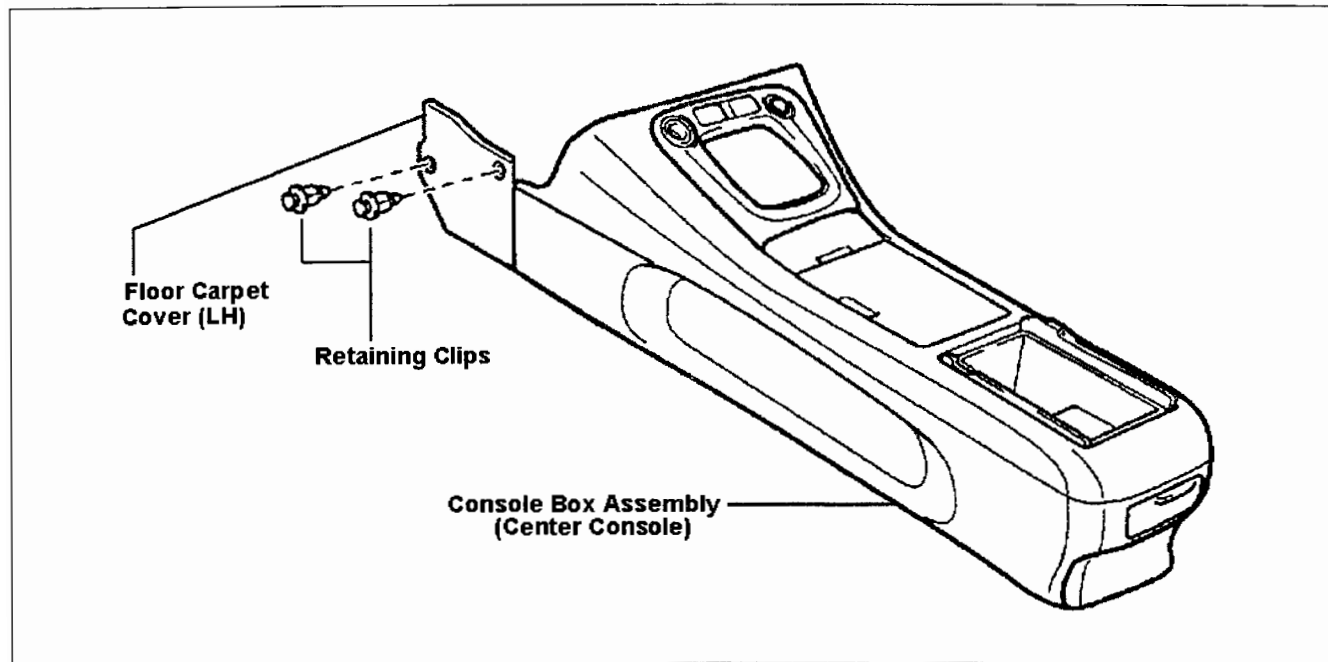
IV. COMPONENTS

In certain 2004 through 2005 model year Highlander and early 2006 model year Highlander Hybrid (HV) vehicles, due to improper installation, the two Retaining Clips for the driver's side forward Center Console (Floor Carpet Cover) can become loose. If both clips separate from the Floor Carpet Cover, the cover may lean toward the accelerator pedal, causing interference with the accelerator pedal rod.

This campaign will entail the replacement of the two driver's side Floor Carpet Cover Retaining Clips with improved ones.
