Re: Defect Information Report (FL-468), NHTSA 06V-006

Section 573.6 Non-Compliance Information Report
FL-468, VIP Steering Wheel NHTSA no. 06V-006
Supplement No.: 4

Subject: VIP Steering Wheels

Models Affected: Specific Freightliner Century S/T, Columbia, and Coronado vehicles built between October 1, 2000, and January 1, 2005, with certain Vehicle Improvement Products (VIP) steering wheels.

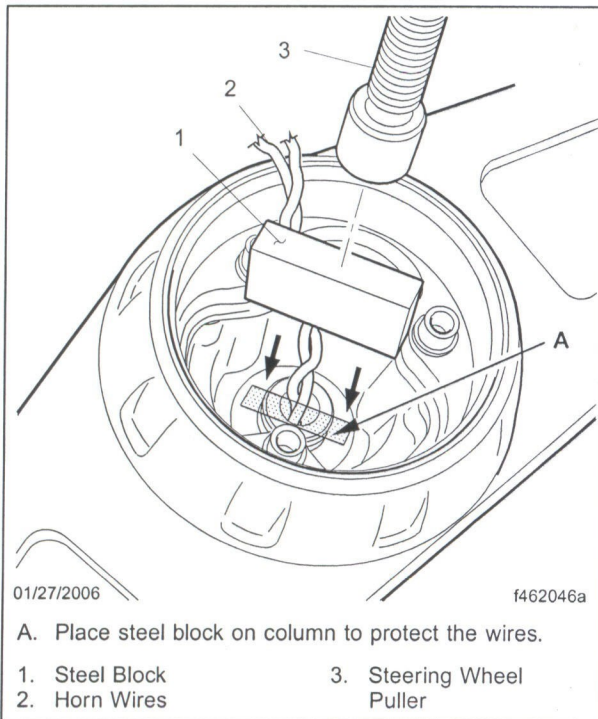
Fig. 3, Steering Wheel Removal

IMPORTANT: Be careful when you are removing the steering wheel, or you could damage the horn wires. A steel block measuring approximately 1-5/8 x 5/8 x 1/4 inch (41 x 16 x 6.4 mm) can be used with the puller to protect the wires during steering wheel removal. See Fig. 3.

A. Place steel block on column to protect the wires.

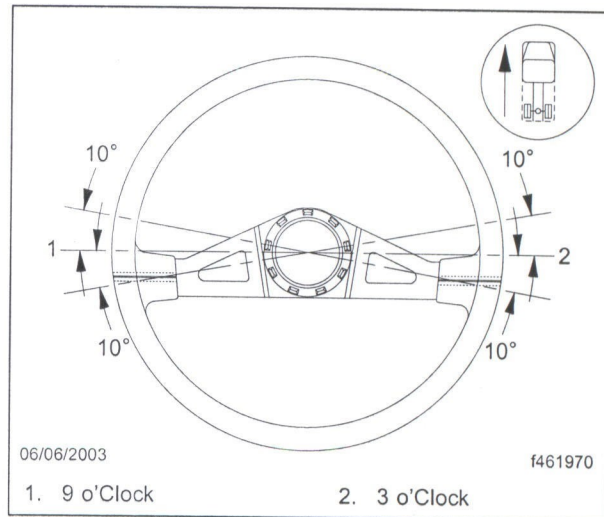
Fig. 4, Steering Wheel Centered

5. With the reliable feature on the steering wheel (as determined in step 2) aligned with the mark on the column, place the new steering wheel on the steering column. Make sure that the steering wheel is within 10 degrees of center as shown in Fig. 4. Insert the horn ground wires (from the center of the steering column shaft) through the center of the new wheel nut. Install the wheel nut and tighten 55 to 65 lbf ft (75 to 88 N m).
