Date: April 3, 2006
Subject: 06019 \ Product Safety Recall
Tailgate Support Cable Replacement
Models: 1999-2000 Chevrolet Silverado
1999-2000 GMC Sierra
To: All Chevrolet and GMC Dealers
Attention: Service Manager, Parts Manager and Warranty Administrator

Recall Bulletin

PRODUCT SAFETY RECALL

SUBJECT: Tailgate Support Cable Replacement

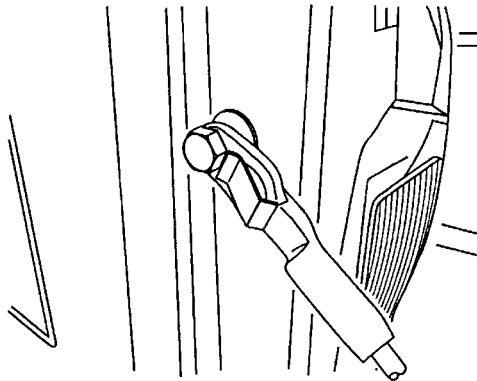
1537874

1. Open the rear tailgate and support it as necessary.

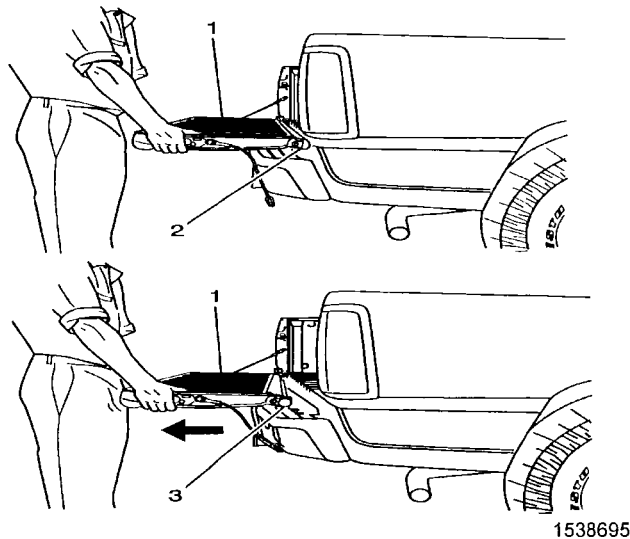
1. Release (unhook) the RIGHT side tailgate support cable from the pickup box again.
2. With the tailgate (1) completely open as shown in the upper part of the illustration, pull the RIGHT SIDE of the tailgate rearward as shown in the lower illustration. Do not pull on the left side of the tailgate.
 - If the tailgate hinge (2) will NOT disengage from the pickup box on the right side, no repair is needed to the hinge. Proceed to the section titled, "Support Cable Replacement," and replace any support cables that HAD sealant in the earlier inspection. If neither of the support cables require replacement, no further action is required.
 - If the tailgate hinge (3) will disengage from the pickup box on the right side, proceed to the next step.

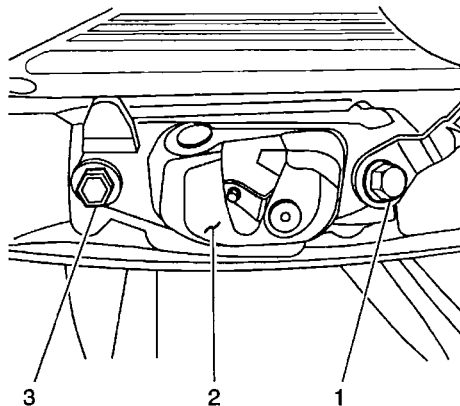
1537875

1. Loosen the bolt (1) that attaches the opposite end of the support cable to the latch assembly (2).
 - If the toothed nut is present, you will only be able to loosen the bolt partially from the latch. If this condition is encountered, proceed to the next step.
 - If the toothed nut is not present, proceed to Step 6.

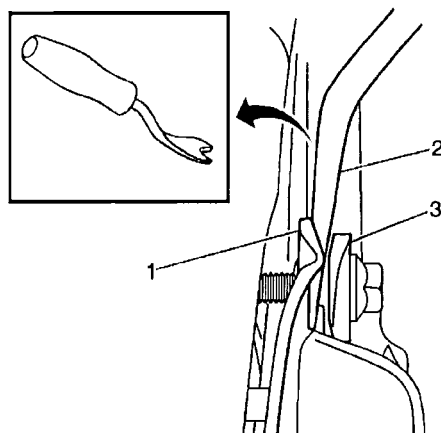
1537876

4. Place an interior trim removal type tool (2), or equivalent, between the support cable end (3) and the latch (1), and pry the two apart. As the two spread apart, the toothed nut on the other side of the latch will begin to move towards the end of the bolt.
5. Once the toothed nut has moved away from the backside of the latch, use long nose pliers to grasp and twist it off of the bolt. Discard the toothed nut.
