TOYOTA CUSTOMER SERVICES

Volume: XIII
Number: TC06-003
Date: 03/28/2006
 Action
 Retain
 Information

SUBJECT: SPECIAL SERVICE CAMPAIGN (SSC) – 60B (SAFETY RECALL)
(SUPPLEMENTAL RESTRAINT SYSTEM (SRS) AIRBAG REPLACEMENT)

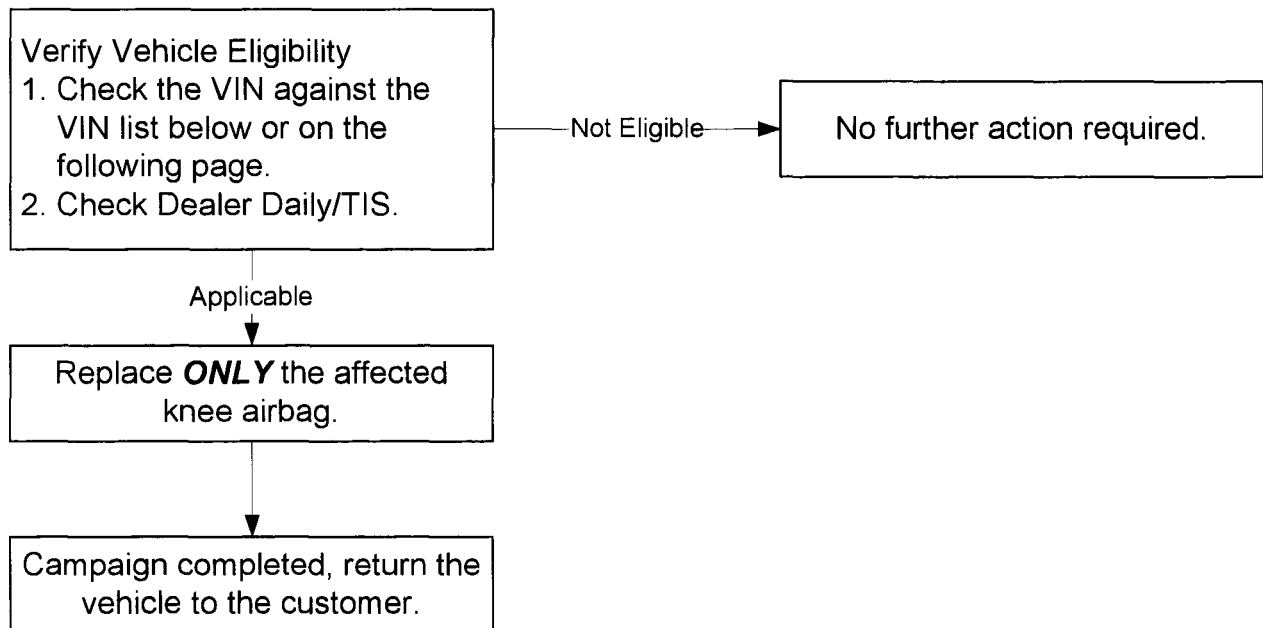
I. OPERATION FLOWCHART

Due to improper assembly of the airbag inflator, which is incorporated into the SRS airbag assembly (Side Airbag, Curtain Side Airbag or Driver Knee Airbag), some inflators were produced with an insufficient amount of the heating agents necessary for proper airbag deployment. In this condition, the expansion force of the gas may be insufficient to properly inflate the airbag when the SRS system is activated during a collision.

- A. Replace the driver knee airbag following the procedures outlined in the Supplemental Restraint System section of the appropriate Repair Manual for the vehicle you are working on.

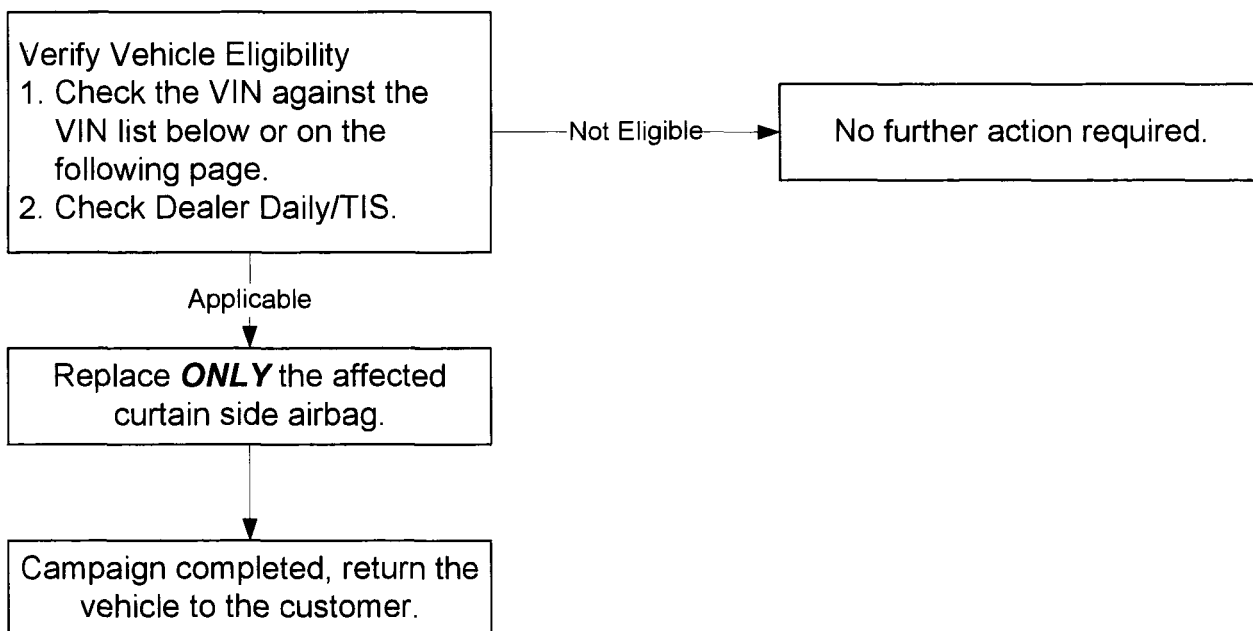
I. OPERATION FLOWCHART

Due to improper assembly of the airbag inflator, which is incorporated into the SRS airbag assembly (Side Airbag, Curtain Side Airbag or Driver Knee Airbag), some inflators were produced with an insufficient amount of the heating agents necessary for proper airbag deployment. In this condition, the expansion force of the gas may be insufficient to properly inflate the airbag when the SRS system is activated during a collision.

- A. Replace the curtain side airbag following the procedures outlined in the Supplemental Restraint System section of the appropriate Repair Manual for the vehicle you are working on.

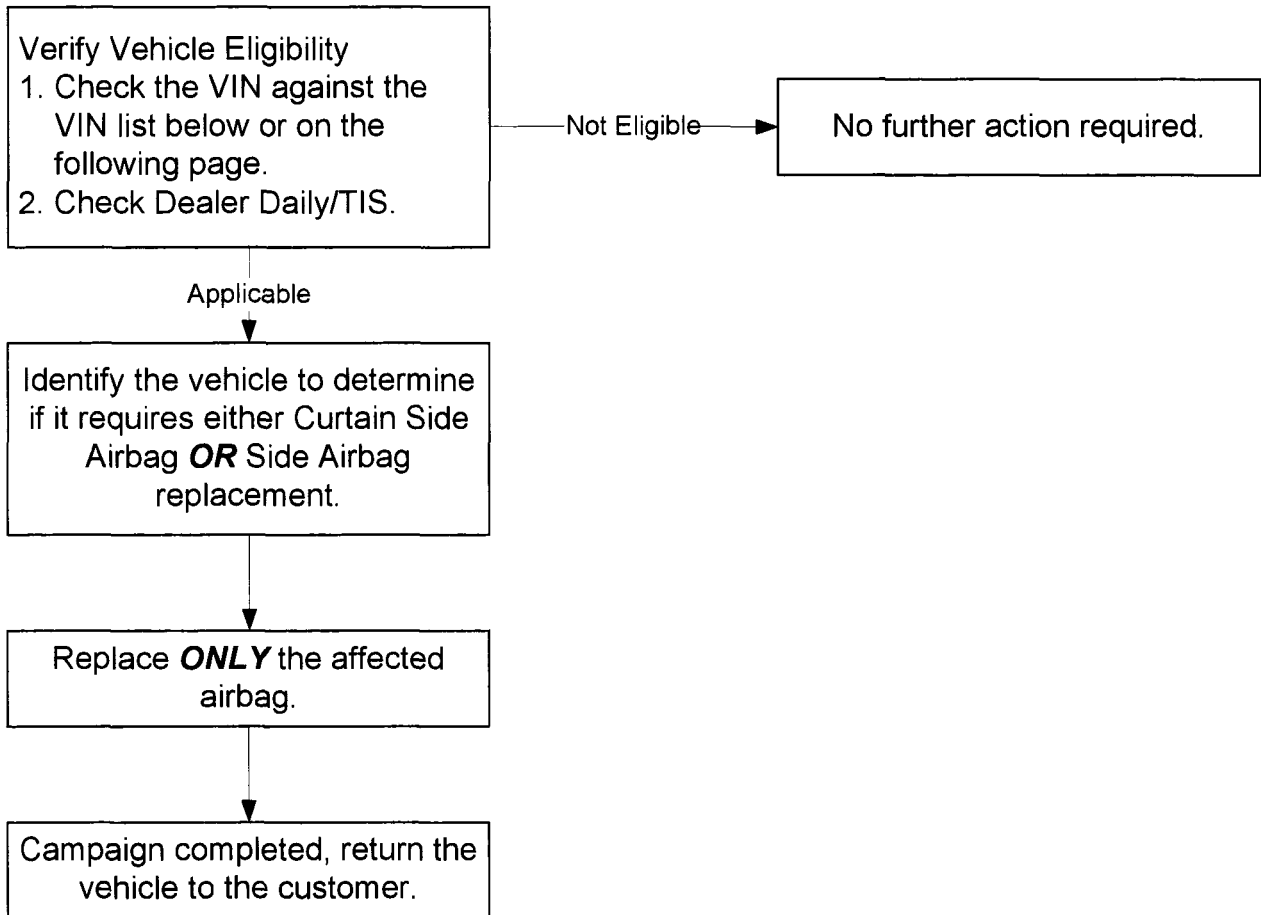
I. OPERATION FLOWCHART

Due to improper assembly of the airbag inflator, which is incorporated into the SRS airbag assembly (Side Airbag, Curtain Side Airbag or Driver Knee Airbag), some inflators were produced with an insufficient amount of the heating agents necessary for proper airbag deployment. In this condition, the expansion force of the gas may be insufficient to properly inflate the airbag when the SRS system is activated during a collision.

- A. Replace the curtain side airbag following the procedures outlined in the Supplemental Restraint System section of the appropriate Repair Manual for the vehicle you are working on.

- A. Replace the side airbag following the procedures outlined in the Seat: Front Seat section of the appropriate Repair Manual for the vehicle you are working on.

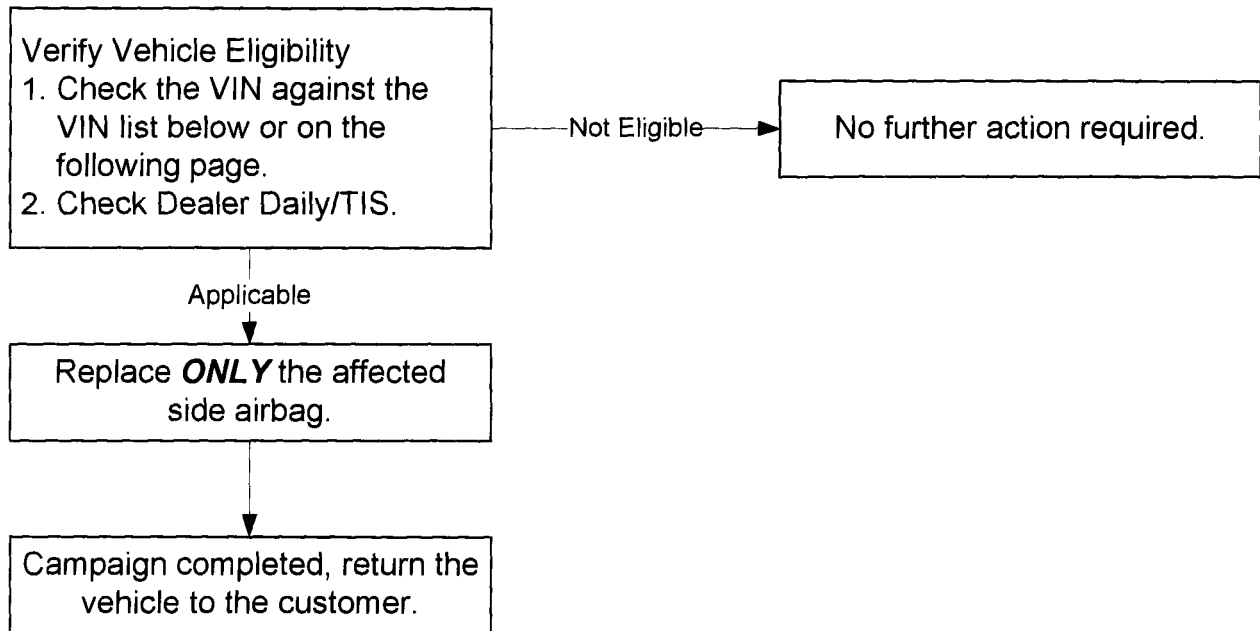
I. OPERATION FLOWCHART

Due to improper assembly of the airbag inflator, which is incorporated into the SRS airbag assembly (Side Airbag, Curtain Side Airbag or Driver Knee Airbag), some inflators were produced with an insufficient amount of the heating agents necessary for proper airbag deployment. In this condition, the expansion force of the gas may be insufficient to properly inflate the airbag when the SRS system is activated during a collision.

- A. Replace the side airbag following the procedures outlined in the Body: Front Seat section of the appropriate Repair Manual for the vehicle you are working on.

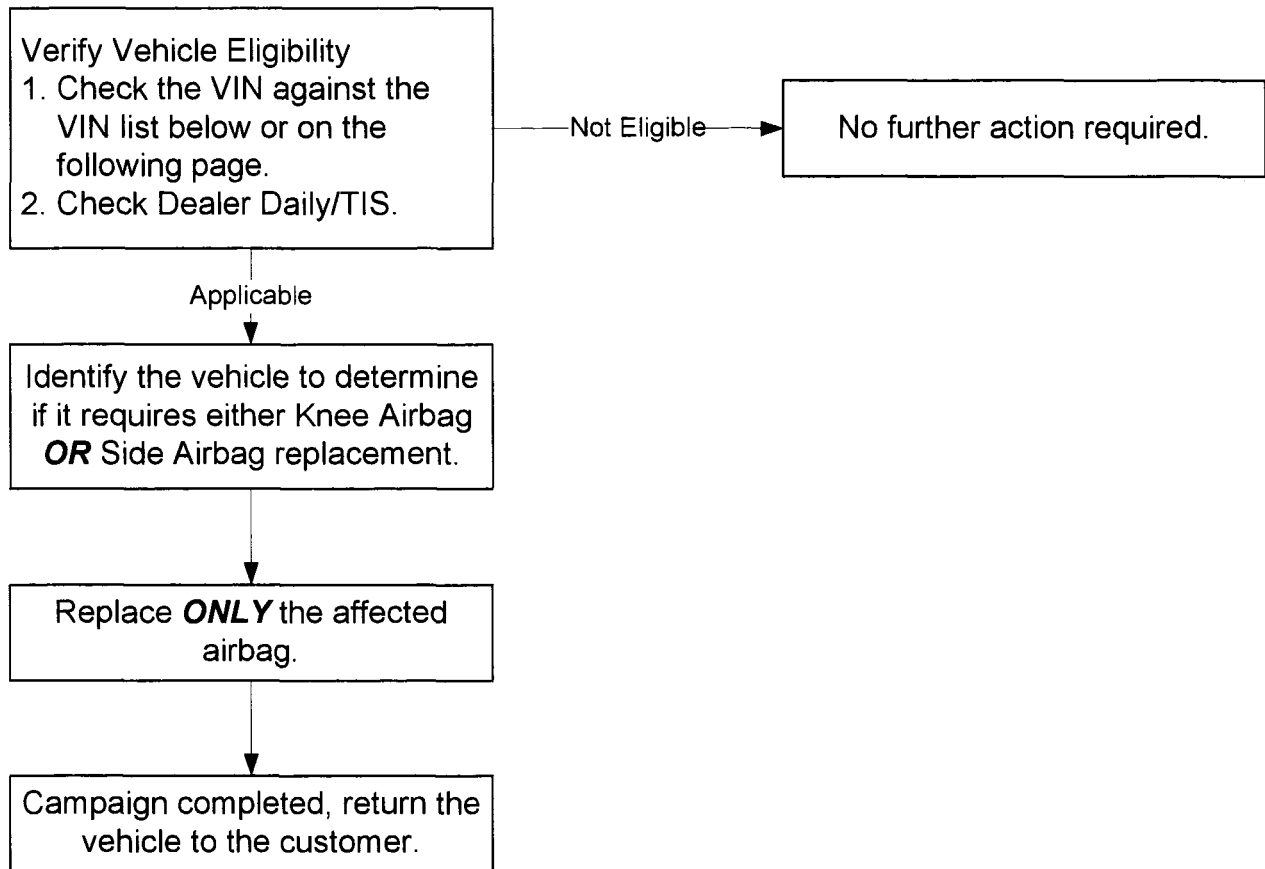
I. OPERATION FLOWCHART

Due to improper assembly of the airbag inflator, which is incorporated into the SRS airbag assembly (Side Airbag, Curtain Side Airbag or Driver Knee Airbag), some inflators were produced with an insufficient amount of the heating agents necessary for proper airbag deployment. In this condition, the expansion force of the gas may be insufficient to properly inflate the airbag when the SRS system is activated during a collision.

- A. Replace the driver knee airbag following the procedures outlined in the Supplemental Restraint System section of the appropriate Repair Manual for the vehicle you are working on.

- A. Replace the side airbag following the procedures outlined in the Seat: Front Seat section of the appropriate Repair Manual for the vehicle you are working on.

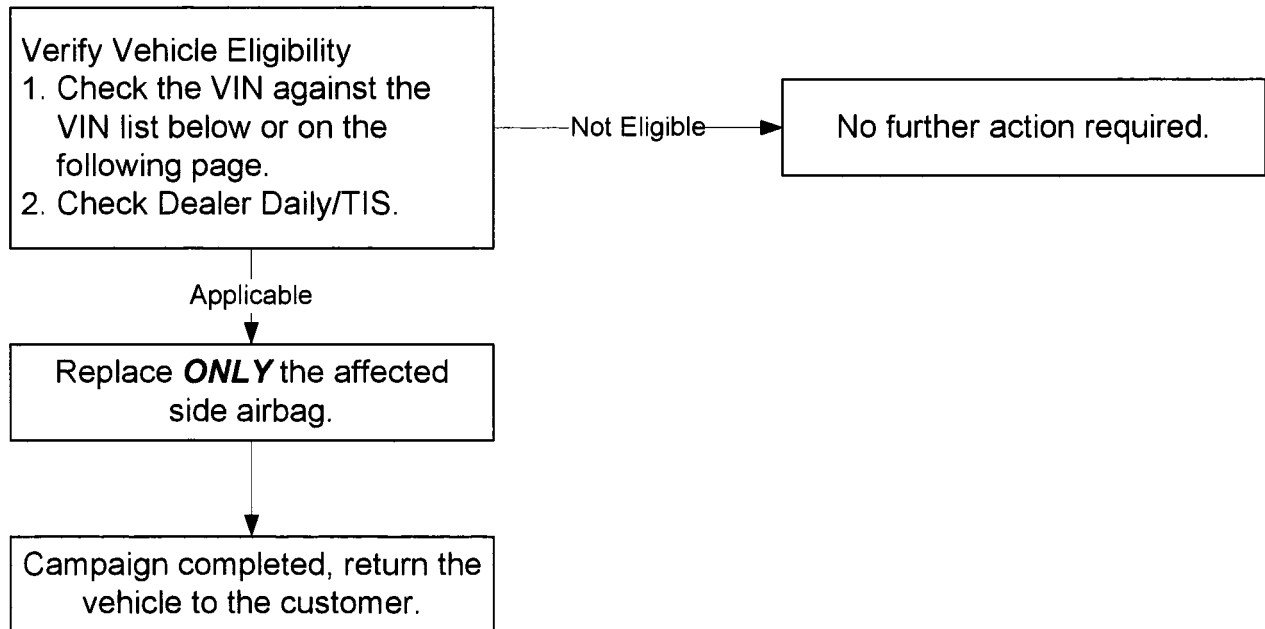
I. OPERATION FLOWCHART

Due to improper assembly of the airbag inflator, which is incorporated into the SRS airbag assembly (Side Airbag, Curtain Side Airbag or Driver Knee Airbag), some inflators were produced with an insufficient amount of the heating agents necessary for proper airbag deployment. In this condition, the expansion force of the gas may be insufficient to properly inflate the airbag when the SRS system is activated during a collision.
