Subject: Recall Campaign JN (06V-198)

Subject: Safety Recall JN
1998 – 2004 Audi A6 Sedan and Avant and
2001 – 2005 Audi allroad quattro Vehicles equipped with Halogen Low Beam
Rerouting of the Headlight Switch Wiring Harness with Installation of a
Jumper Wiring Harness

Safety Recall Circular

**Subject: 1998-2004 Audi A6 Avant and Sedan and
2001-2005 Audi allroad quattro equipped with Halogen Low Beam
Rerouting of the Headlight Switch Wiring Harness with Installation of
a Jumper Wiring Harness**

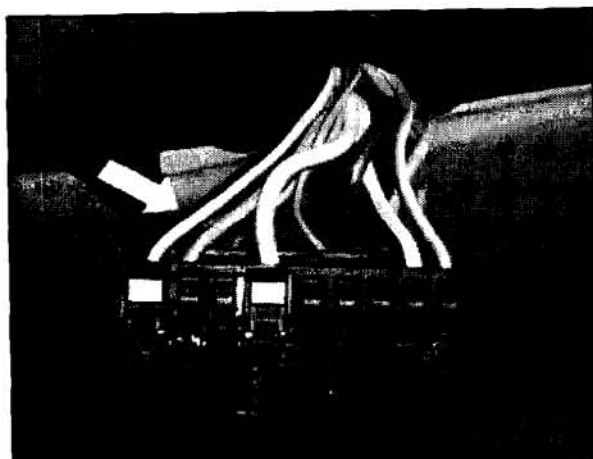
- ⇐ Pin out wire from terminal 1 of headlight switch connector -arrow- (yellow/black) using release tool VAS 1978/18

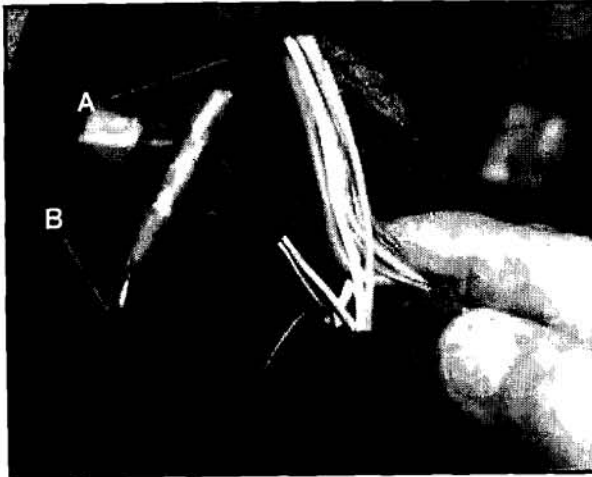
- ⇐ Connect wires -A- and -B- with butt connector (111 971 939 B), using crimping tool VAS 1978/1-1 and 1-2
- Shrink butt connector using hot air gun VAS 1978/14 and shrink tip VAS 1978/15
- Inspect headlight switch wiring harness connector (111 971 939 B) for any heat damage
 - If connector shows any heat damage, replace connector (111 971 939 B)
 - If connector shows NO heat damage DO NOT replace connector

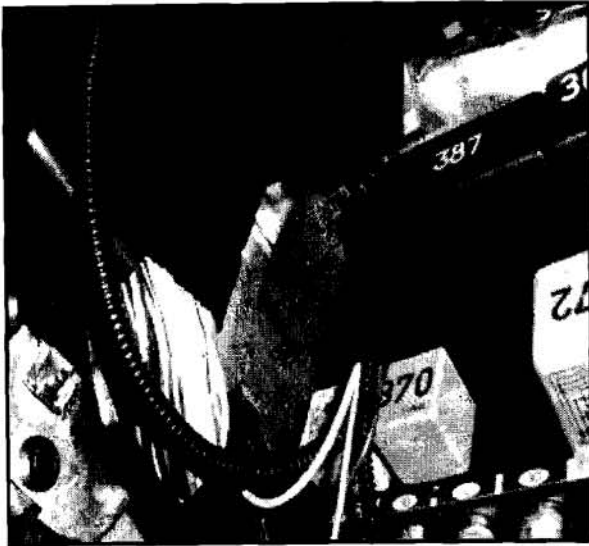
- Reinstall fuse box tighten to 3 Nm (26 in. lbs.)
- ◀ Stow relay from jumper wiring harness behind the fuse box
- If **either** of the wires at terminal 1 or terminal 4 of the headlight switch connector showed any discoloration, replace headlight switch with (4B1 941 531 J B98 for MY 1998 - 2000) or (4B1 941 531 K 5PR for MY 2001 -2005)
- If **neither** of the wires at terminal 1 or terminal 4 of the headlight switch connector showed any discoloration, reinstall original headlight switch
- Reinstall fuses 20, 21, and 36
- Reinstall A pillar, tighten screws to 2.5 Nm (22 in. lbs.)
