RECALL CAMPAIGN BULLETIN

NTB06-082a

VOLUNTARY RECALL CAMPAIGN VOLUNTARY SERVICE CAMPAIGN ALTIMA AND SENTRA QR25DE ENGINE OIL CONSUMPTION

CAMPAIGN I.D. # PB023

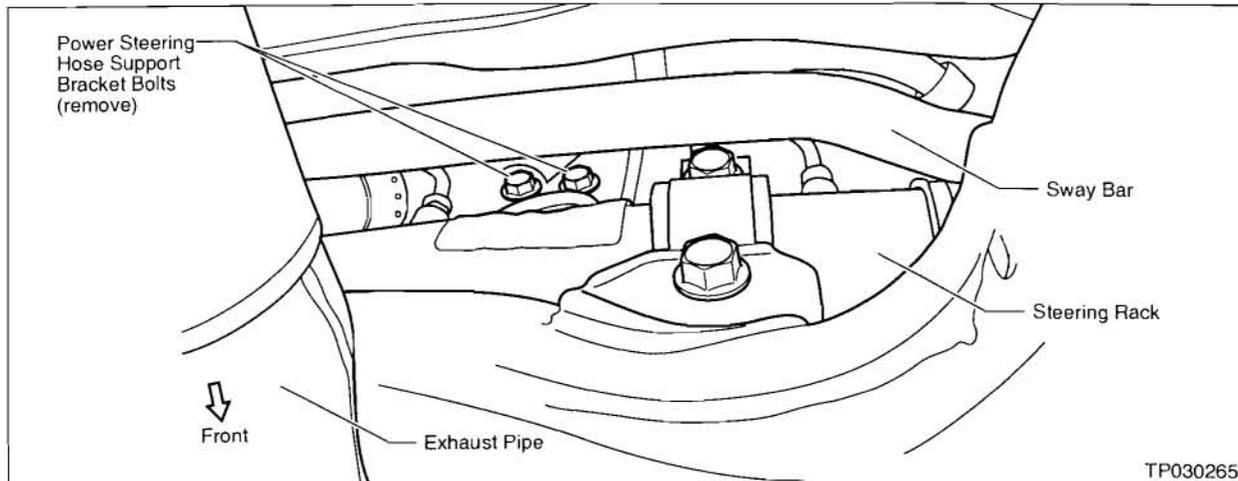
Figure F5

Power Steering Hose Support Bracket Bolts (Altima ONLY)

- Make sure to remove the Power Steering Hose Support Bracket Bolts before engine removal (see Figure F5).

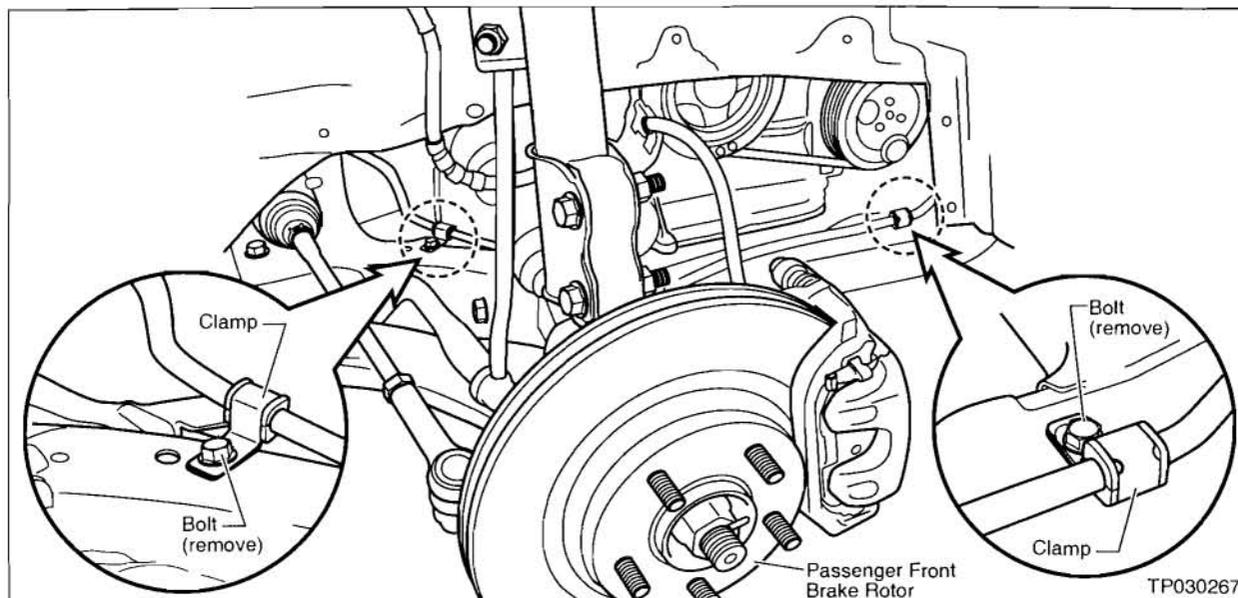
Figure F6

Power Steering Pipe Clamps (Altima ONLY)

- Remove the Power Steering Pipe Clamps on the engine cradle before removing the engine (see Figure F6).

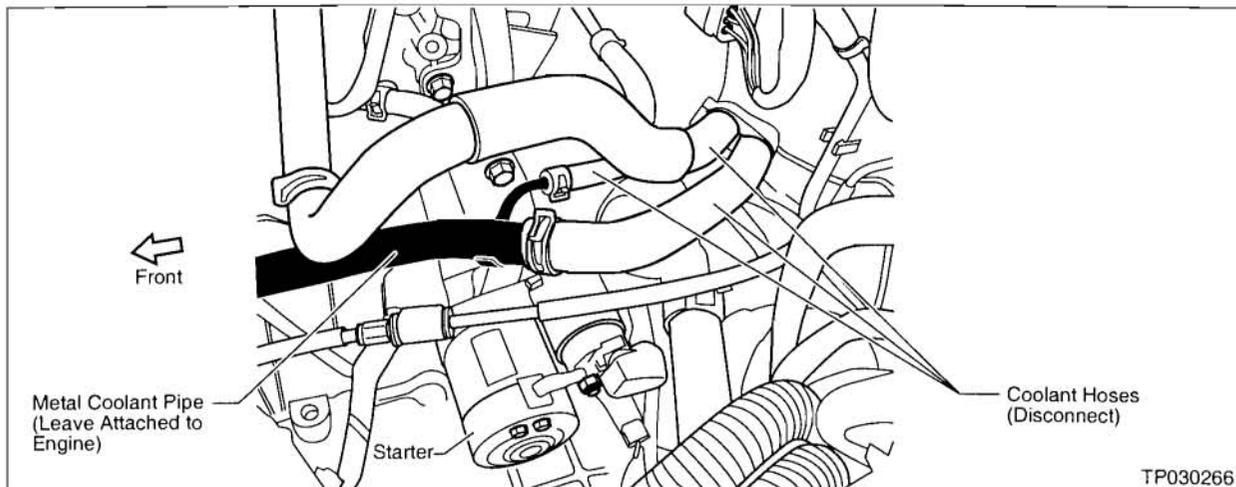
Figure F7

Coolant Pipe (Alitma ONLY)

- Disconnect the Coolant Hoses from the Metal Coolant Pipe, but leave the metal pipe on the engine (see Figure F7).

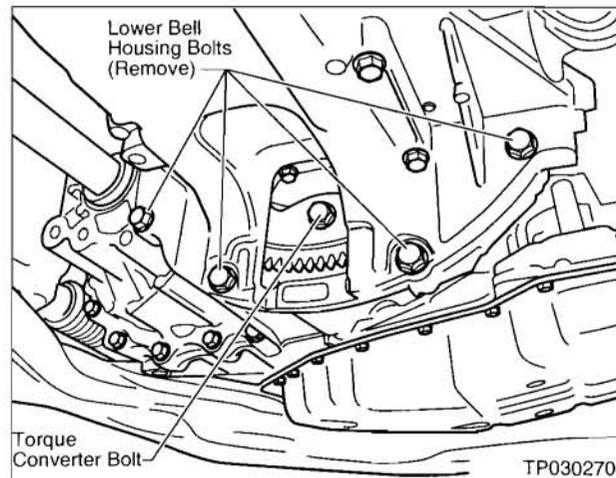
Figure F8

Torque Converter/Lower Bell Housing Bolts (Altima and Sentra)

- Remove the Torque Converter and **Lower** Bell Housing Bolts before removing the engine. It's easier to do this before the engine is out of the vehicle (see Figure F8).

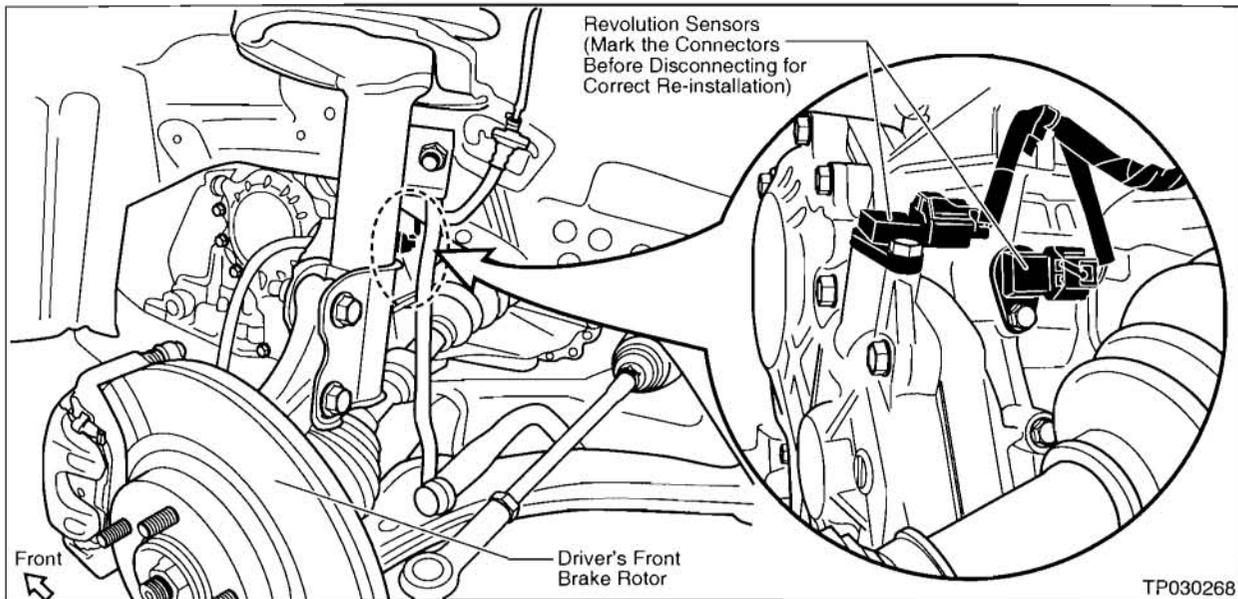
Figure F9

A/T Revolution Sensor Wire Harness Connectors (Altima and Sentra)

- Make sure you mark the A/T Revolution Sensor Wire Harness Connectors for proper re-installation (see Figure F9). If these connectors are “mixed up”, improper transmission shifting can occur.

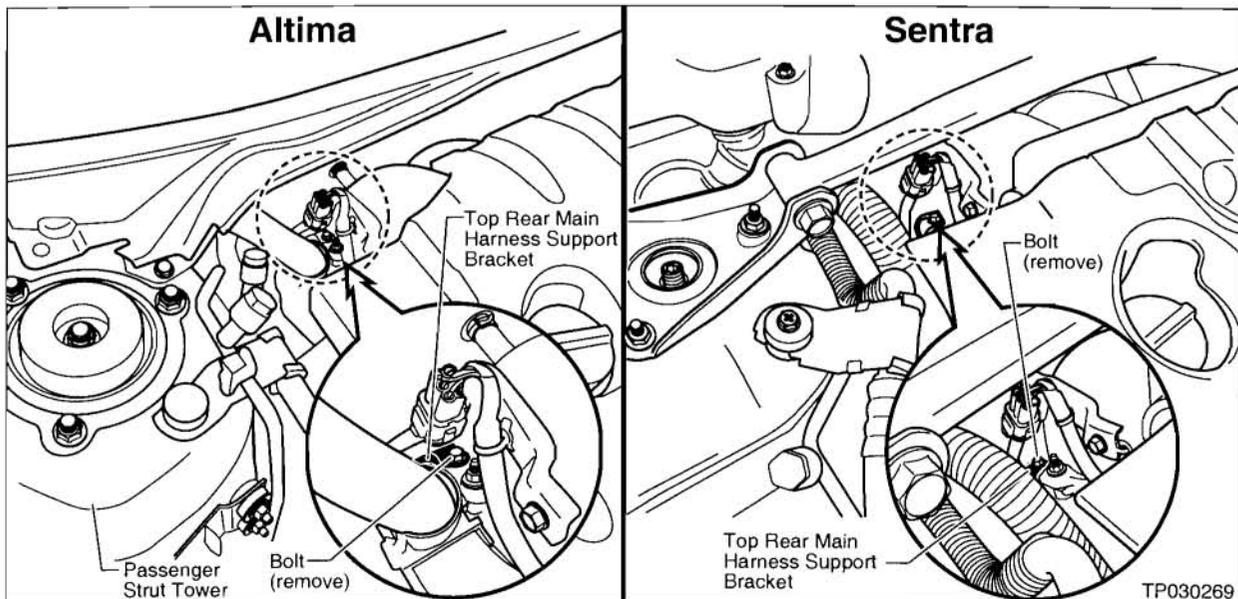
Figure F10

Top Rear Main Harness Support Bracket (Altima and Sentra)

- Remove the bolt that secures the Top Rear Main Harness Support Bracket to the engine before engine removal (see Figure F10).

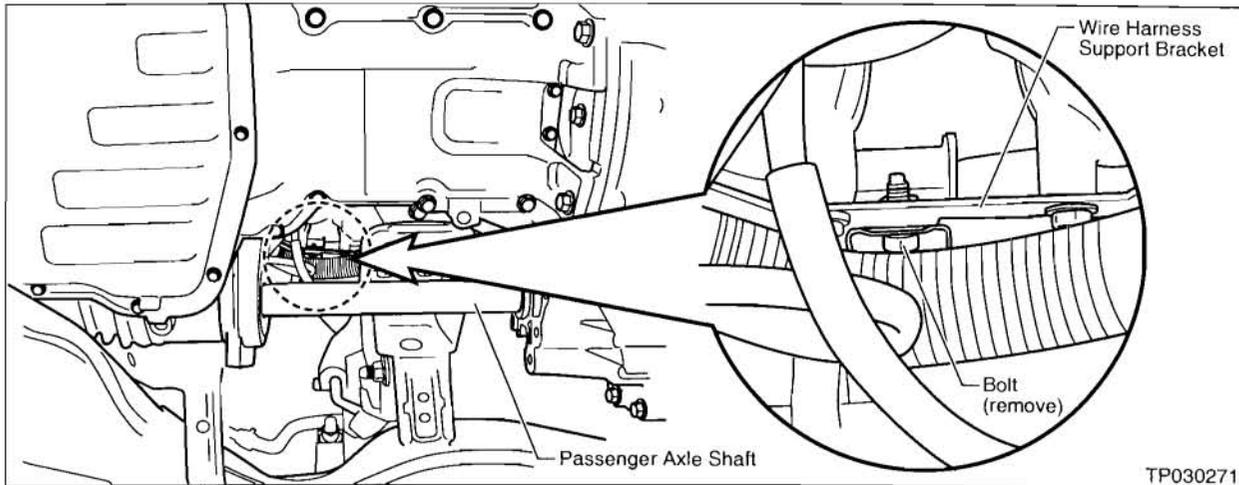
Figure F11

Wire Harness Support Bracket (Altima ONLY)

- Remove one bolt to release the Wire Harness Support Bracket (see Figure F11).

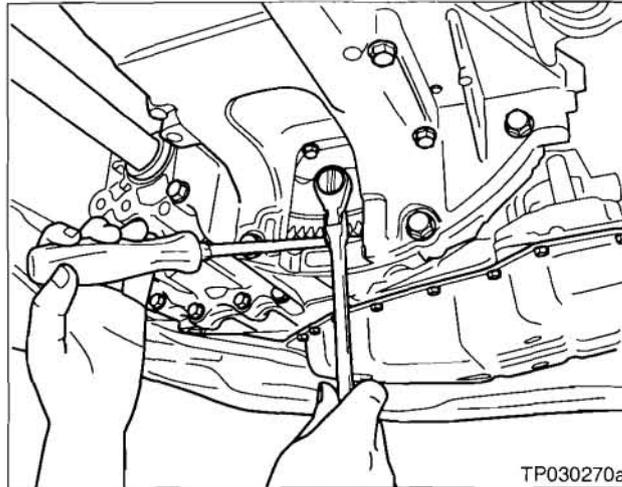
Figure F12

Torque Converter to Flex Plate Securing (Altima and Sentra)

- Use a screwdriver to move the Torque Converter up or down to align the Torque Converter bolt holes with the Flex Plate bolt holes (see Figure F12).
- Make sure the bolt “shoulder” is fully seated in the mounting hole.
