# HYUNDAI Technical Service Bulletin

Group	ELECTRICAL
Number	07-01-001
Date	JANUARY, 2007
Model	TUCSON

Subject  
**TUCSON**  
**DRIVER AIR BAG COVER MODULE REPLACEMENT**  
**(CAMPAIGN 079)**

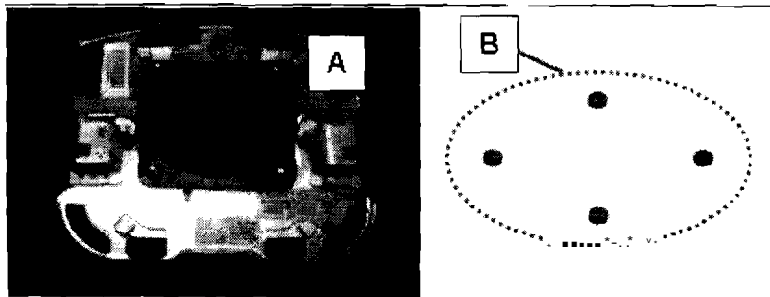
- The new DAB cover module includes the black plastic air bag inflator opening shipping protection cover (A) and four inflator mounting nuts (B) only. It does not include the inflator. Therefore, the existing inflator must be re-installed onto the new DAB cover module. Refer to the following Service Procedure.
