ECO WHEEL CORPORATION

Index of Supplied Documents To:
Consumer Safety Officer
Office of Defect Investigation/Recall Management
NHTSA-DOT

Defect and Noncompliance Report Guide for Equipment
PART 573 Defect and Noncompliance Report¹

Examination of Aluminum Wheel Smithers Scientific Services 4000M/0770

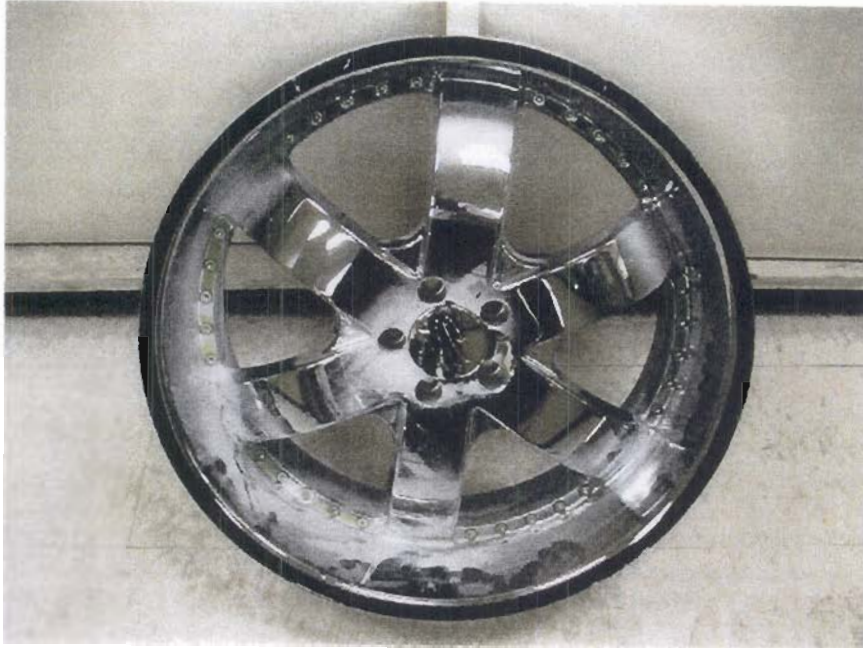
Figure 1
Cast Aluminum Wheel
22 x 9.5J
Face

Figures 1 through 9 show the wheel and associated identification markings on it. Figure 10 shows some identification marking that had been scribed on the mounting surface. The wheel was visually examined and was coated with smooth, shiny Cu – Ni – Cr plating on the curb side surfaces. Since there was no fracture of the wheel as result of the test, the drop center area where the 0756 wheel fractured was carefully examined. There was evidence of fine pits in the plating on the back side of the wheel as shown in a section of the drop center surface (Figure 11). In the bottom photograph the surface is magnified about 5 times and the bright spots appear to be pits in the surface that could have resulted from porous spots in the cast aluminum. Some typical shrinkage defects are shown in Figure 12 and 13, and were similar to those found in the 0756 wheel. The wheel was found to be about 0.25 - 0.26 inches thick at the drop center – similar to the 0756 wheel. The wheel weighed 44.7 lbs.

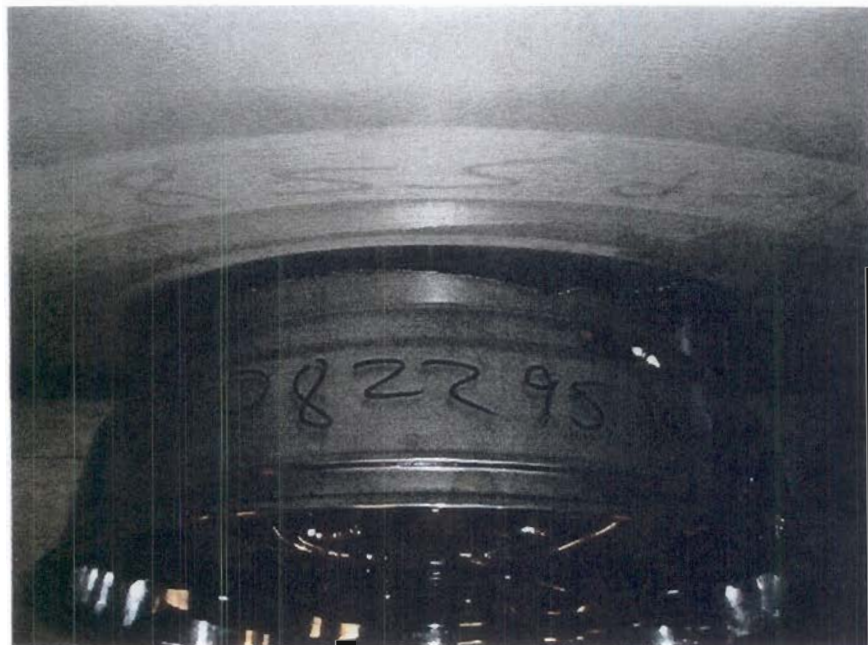
Figure 2
As Received Identification

Figures 1 through 9 show the wheel and associated identification markings on it. The fracture was in the area of the rear drop center radius and the wheel separated in two pieces as shown in the photographs. There was no evidence of any impact damage or and external marking on the wheel from contact with other suspension components. This would indicate that the tire held the two pieces together until the vehicle stopped. There was no evidence of significant deformation of the wheel in the area of the separation.
