07V-158  
(18 Pages)

**Subject: Part 573 Defect and Noncompliance Report: Polar model APX9-1000 and APX9-1200 semi-trailers with aluminum front endframe option.**

**Safety Defect and Noncompliance Report Guide for Vehicles**  
**PART 573 Defect and Noncompliance Report**

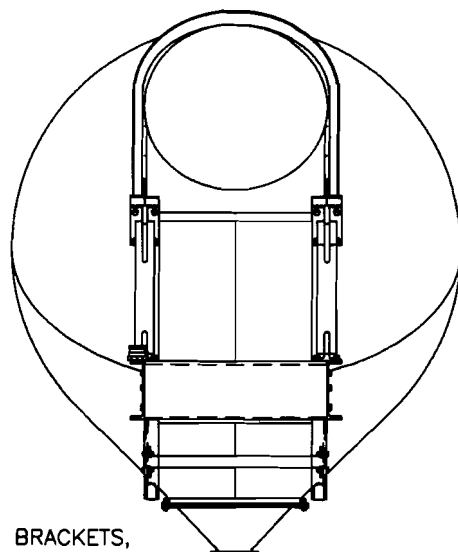
DWG. NO. B SK-4143

A crack may develop in the right front frame rail of the front frame, and eventually propagate through the frame.

This occurs because a small crack may start at the termination of a welded gusset, and propagate over time. If undetected, the crack will grow to the point of failure. See Figure B for a detail of the crack location.

- 1.) INSPECT THE CURBSIDE MAIN FRAME RAIL FOR ANY SIGN OF CRACKING. IF ANY CRACKING IS PRESENT, CALL THE WARRANTY DEPARTMENT AT POLAR BEFORE PROCEEDING. 800-826-6589
