RE: Defect Information Report

Safety Recall Bulletin

Model	TUCSON (JM)
Group	AIR BAG SYSTEM
Number	HT-6-57-P03-JM
Date	April 5, 2007
Area	See Vehicles Affected below
Type	SAFETY RECALL

DRIVER AIR BAG MODULE REPLACEMENT

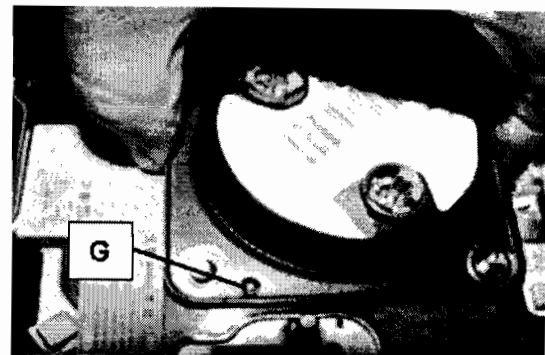
TUCSON (JM) driver air bag module had been produced with the **'I' shaped tear seam line (A)** on the cover. The driver air bag module must be replaced with new one with the **'Y' shaped tear seam line (B)** to increase the margin of compliance in the driver position fifth percentile female unbelted low risk deployment test.

6. Remove the existing air bag inflator, align its hole (G) with the protrusion on the back of newly redesigned air bag cover module and re-install the inflator onto the new air bag cover module using newly supplied nuts.

**Inflator fixing nuts tightening torque:
0.7~0.9kgf-m (5.1~6.5lbf-ft)**
