## **Re: Defect Information Report – Supplemental Report No. 4 07V-212, FL-496, TBB Warning Light Malfunction**

Subject: RECALL 07V-212 – Saf-T-Liner C2 Door Switch

Recall 07V-212

SUBJECT: IMPROVED AIR DOOR CONTROL OPERATION

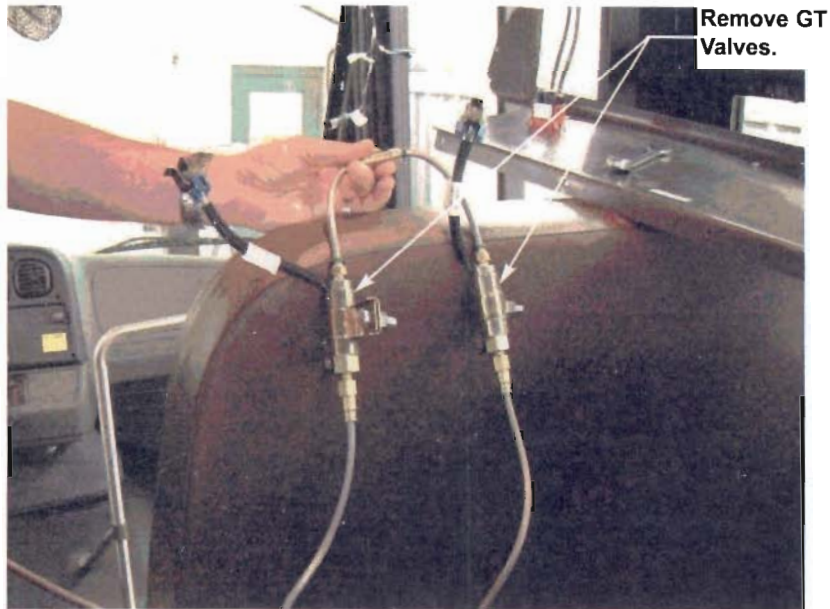
Figure 6

2. **If your unit is equipped with the GT Valve, perform the remainder of this bulletin. (Figure 6) These changes affect units with start date of 4/18/06 through 5/14/07.**

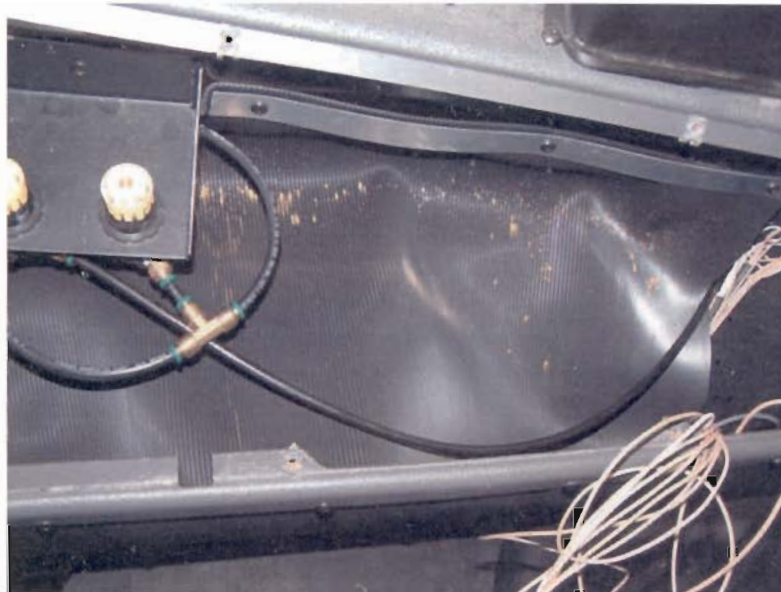
**Figure 1**

In an effort to help prevent water intrusion in the Switch Hub Module (SHM), the module is being repositioned. This will affect all units from start of production date of 12/1/03 through 5/14/07.

1. Disconnect batteries. Apply parking brake and chock tires.
2. Remove the switch panel and disconnect harness from switch hub.
3. Remove the rubber flap shown in **Figure 1**. Retain for reinstallation.
4. Using a 7/16 socket or wrench, remove the three (3) fasteners securing the SHM. **Do not** discard.
5. Making note of the harness connections, then disconnect all connectors in the switch module.
