General Motors Overseas Distribution Corporation (Singapore)

07V-482
(17 Pages)

Submission of Report 573

J200 IP HARNESS SPLICE PACK (S201) MELTING

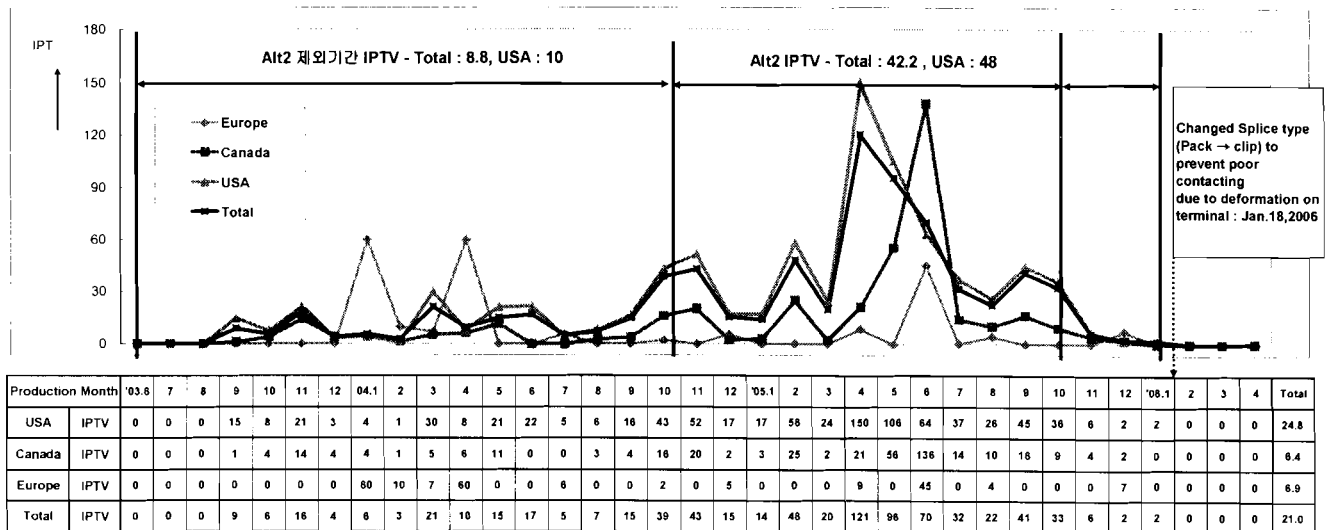
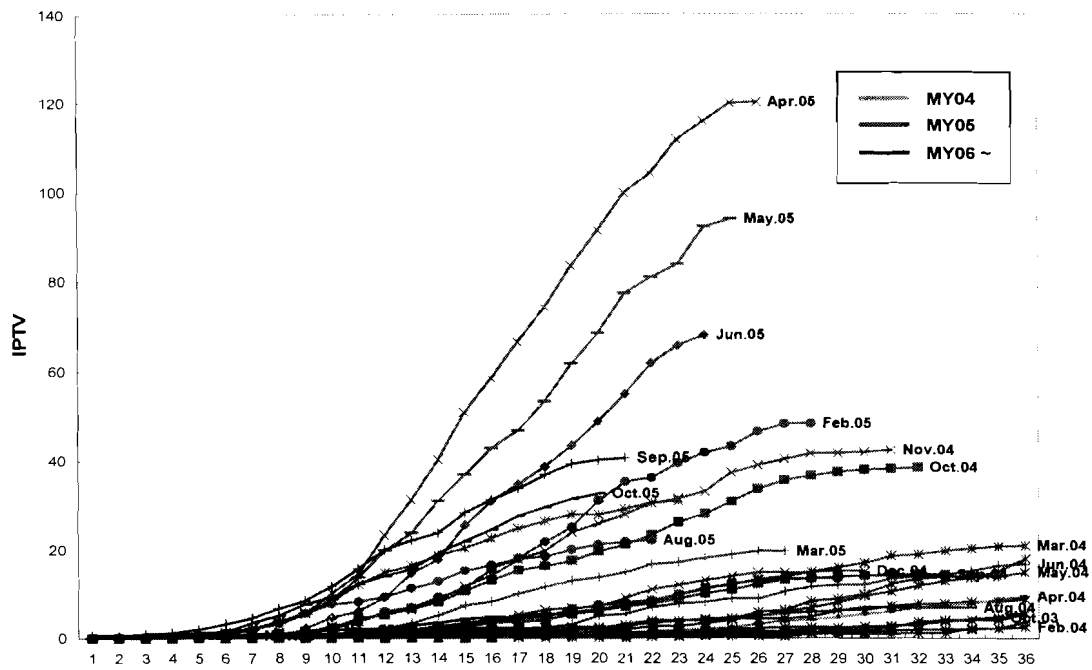
* IPTV comparison between Alt2 affected period and except period
(LHD & DRL & 2 bulb only)

Produced from Oct.1, 2004 to Oct.31, 2005 (High IPTV range)
