# TOYOTA CUSTOMER SERVICES

Volume: XIV  
Number: TC07-002  
Date: 01/18/2007  
 Action  
 Retain  
 Information

SUBJECT: SAFETY RECALL (SPECIAL SERVICE CAMPAIGN) – 70B  
(FRONT SUSPENSION LOWER BALL JOINTS)

**SPECIAL SERVICE CAMPAIGN 70B (SAFETY RECALL)**

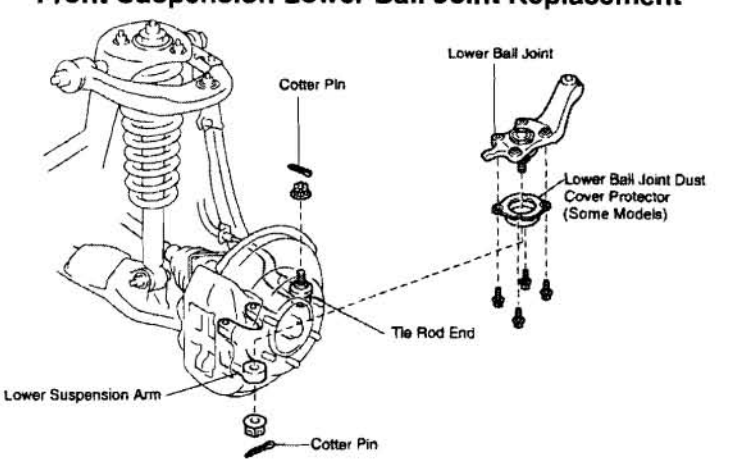
- **All 2004 vehicles involved in SSC 70B will require the replacement of the Front Suspension Lower Ball Joints. However, some early 2004 vehicles may fall under SSC 50J.**
- **All 2005 through early 2007 Sequoia and 2005 through late 2006 Tundra vehicles involved in SSC 70B will require the replacement of the Front Suspension Lower Ball Joints.**
- **Following Front Suspension Lower Ball Joint replacement, all vehicles will require an inspection, and if necessary, adjustment of the front wheel alignment.**

<div style="border: 1px solid black; padding: 5px; margin-bottom: 10px; text-align: center;">                 Replace* the <u>Front Suspension Lower Ball Joints</u>.             </div> <div style="text-align: center; margin-bottom: 10px;">↓</div> <div style="border: 1px solid black; padding: 5px; text-align: center;">                 Inspect and adjust the <u>Front Wheel Alignment</u>.             </div> <p style="font-size: small; margin-top: 20px;">* Some early 2004 MY front suspension lower ball joints may need to be replaced under SSC 50J.</p>	<p style="text-align: center;"><b>2004 - Early 2007 Model Year Sequoia or Tundra Front Suspension Lower Ball Joint Replacement</b></p>
