### **Subject: WVC-13 Passenger Front Seat Wiring Safety Recall**

Subaru of America, Inc. has initiated a voluntary Safety Recall to inspect and possibly repair the passenger front seat wiring on approximately 7,000 2006MY Forester and Impreza models. Campaign code WVC-13 has been assigned to this Safety Recall.

**APPLICABILITY:** 2006MY Subaru Forester & Impreza      **NUMBER:** WVC-13  
**SUBJECT:** Front Passenger Seat Wiring                      **DATE:** March 2007

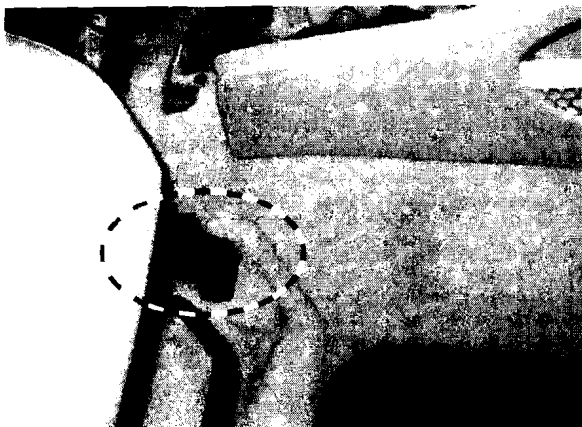
1. Slide the front passenger seat to the rear most position to expose the front of the slide rail.

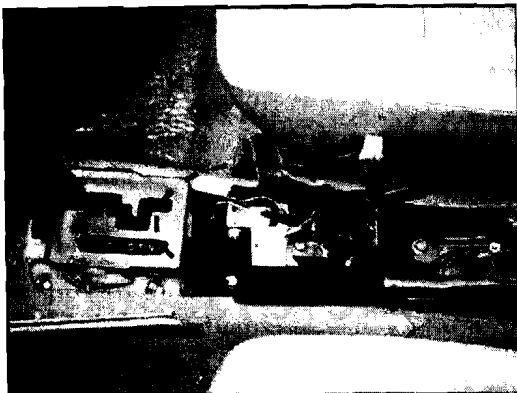
1. Remove the center console trim between the select lever and the parking brake lever. If necessary, refer to the applicable service manual for removal instructions.
2. Cut the cross section of floor carpet in the center and in front of the parking brake lever with scissors (as shown, below).

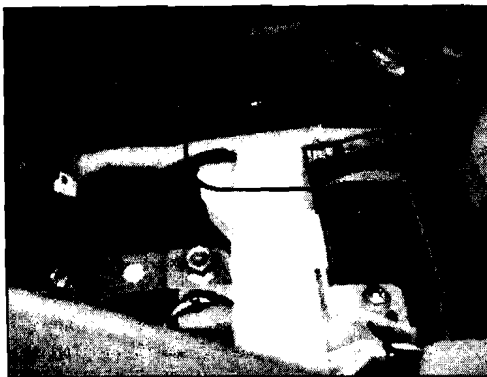
**Note: Be careful that the seat heater switch is not pinched by the parking brake lever during reinstallation.**

3. If the wire was found to be located properly (not pinched), no repair is necessary. Reinstall the floor carpet. Wrap the previously cut portion of carpet with 1.5 inch wide unwoven adhesive tape.
4. Reinstall the center console trim.

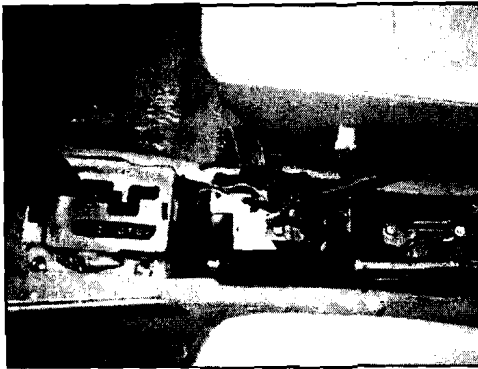
3. **Forester only:** Cut a cross section of floor carpet at the center in front of the parking brake lever with scissors as shown.
