SUBJECT: Vehicle Safety Recall - SC0318
Chalmers Suspension

SC318

Subject: Adjustable Torque Rod Replacement — Chalmers Rear Suspension

#20061110

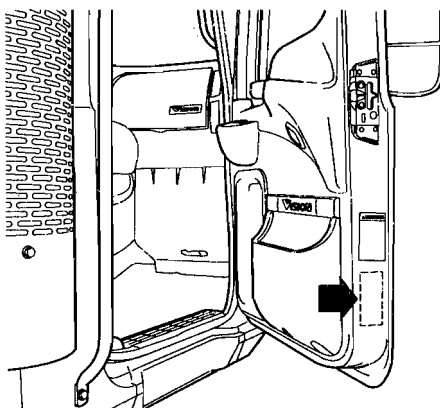
Figure 1 — Campaign Label Location

To signify that the campaign has been completed, use a permanent-type marker (such as a Sharpie®) to write the campaign number (SC318) and completion date in the spaces provided on the Campaign Completion label located on the lower edge (below the door latch) of the passenger-side door. If a label is not already affixed to the door, apply a label (part No. TS897) and supply the information as required. Campaign Completion labels are available in packs of 50 and can be ordered by faxing a completed BR313 to Pacesetters Business Services at 610-264-9465.
