TO: All Mazda Dealership General Managers, Service Managers, and Parts Managers

DATE: August 2008

SUBJECT: 2001-2004 Mazda Tribute Anti-Lock Brake System Voluntary Safety Recall 4507C
RENOTIFICATION

2001-2004 TRIBUTE - ABS MODULE ELECTRICAL CONNECTOR [RECALL 4507C]

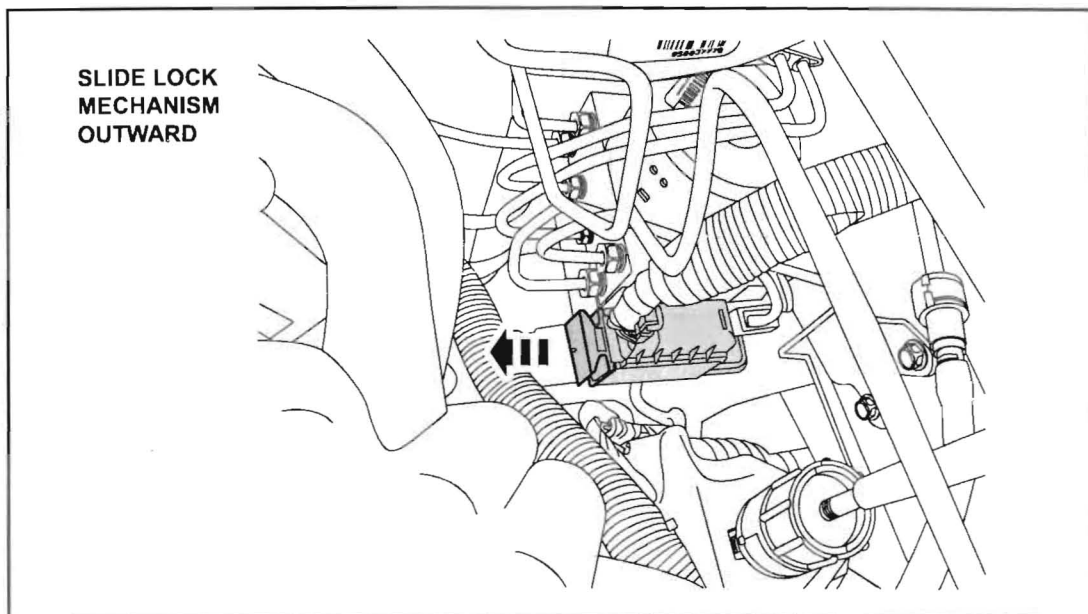
4507C7

4. Disconnect ABS module 25-pin connector by sliding lock mechanism out (towards passenger side of vehicle) and pulling connector off module.

NOTE: When disconnecting the ABS module connector, be sure the blue connector lock stays engaged with the harness connector and does not remain in the module. Remove it from the module if necessary and make sure the white O-ring seal is properly installed.

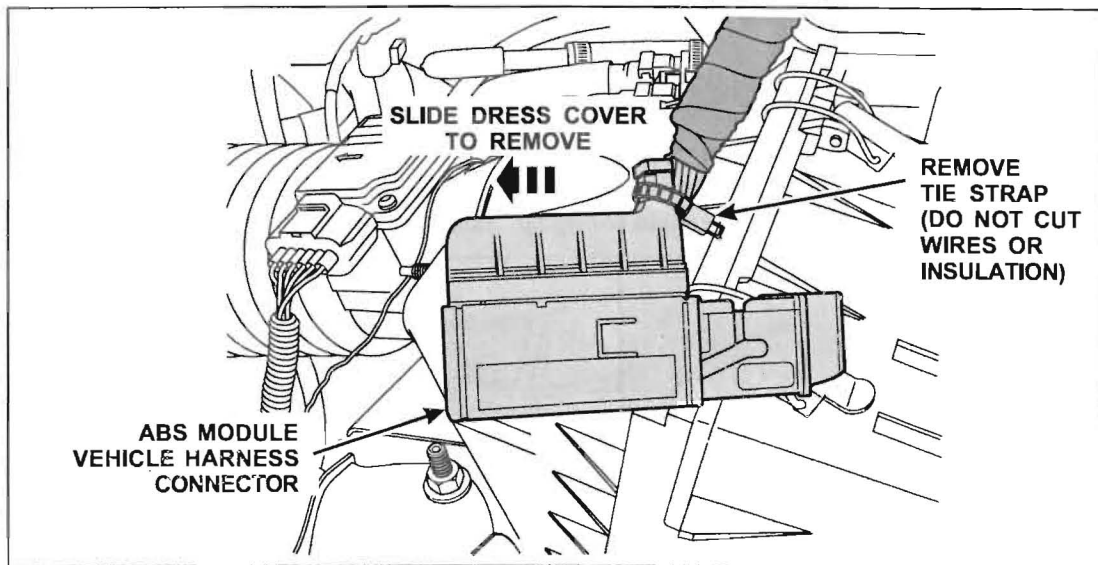
4507Cc

7. Remove the tie strap from the connector dress cover, then slide the cover off the connector.
- CAUTION:** Do not cut any of the harness wires or the wire insulation when cutting off the tie strap.

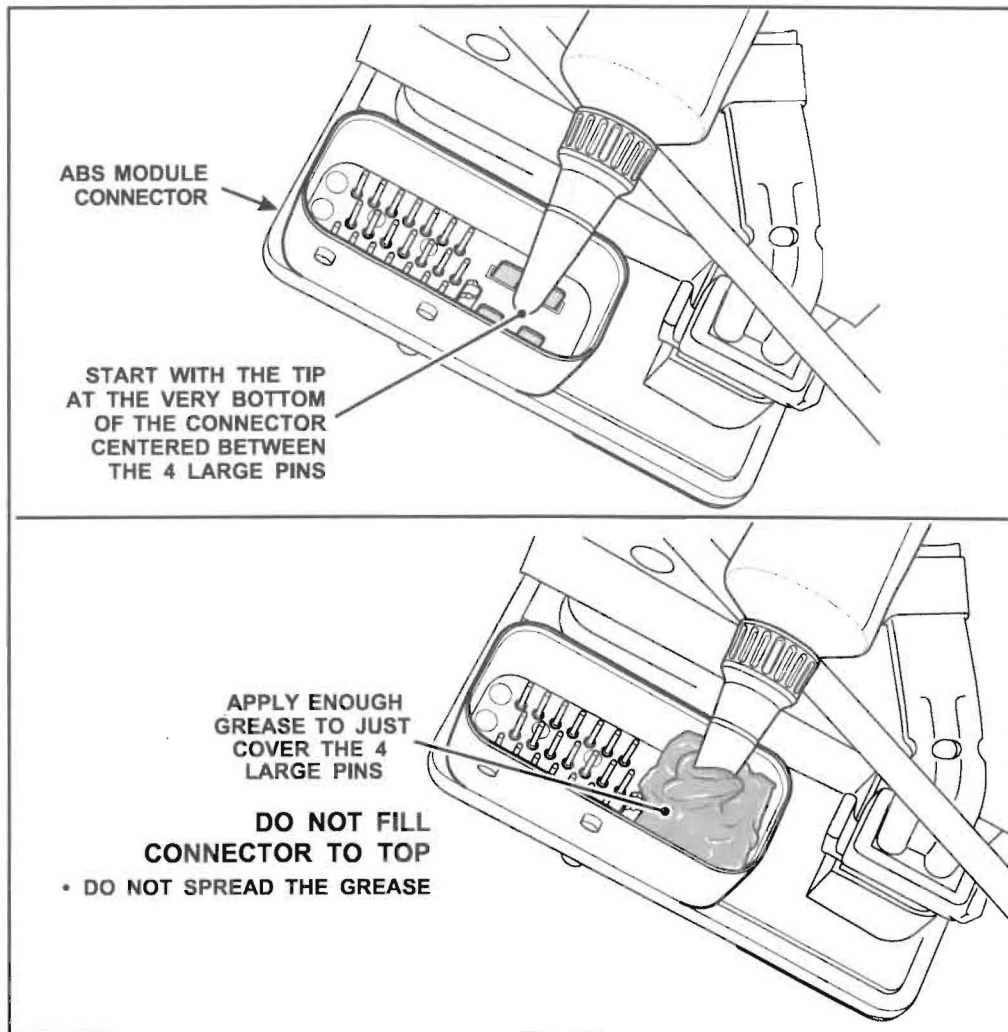
4507QR

NOTE: DO NOT spread the grease around the connector. Applying an excess amount of grease into the connector cavity will cause a “hydro lock” condition which will not allow the connector to fully seat or lock in place.

9. Reinstall dress cover and use electrical tape to secure the cover at the same location where the original tie strap was removed. Apply dielectric grease to the ABS module connector, position and connect the harness as follows:
 - a) Reinstall dress cover.
 - b) Use **ONLY** dielectric grease.
 - With the tip of the applicator tube snipped off, position the end of the tip between the four (4) large flat pins at the bottom of the ABS module connector. Squeeze out enough grease to completely cover the four (4) flat pins.

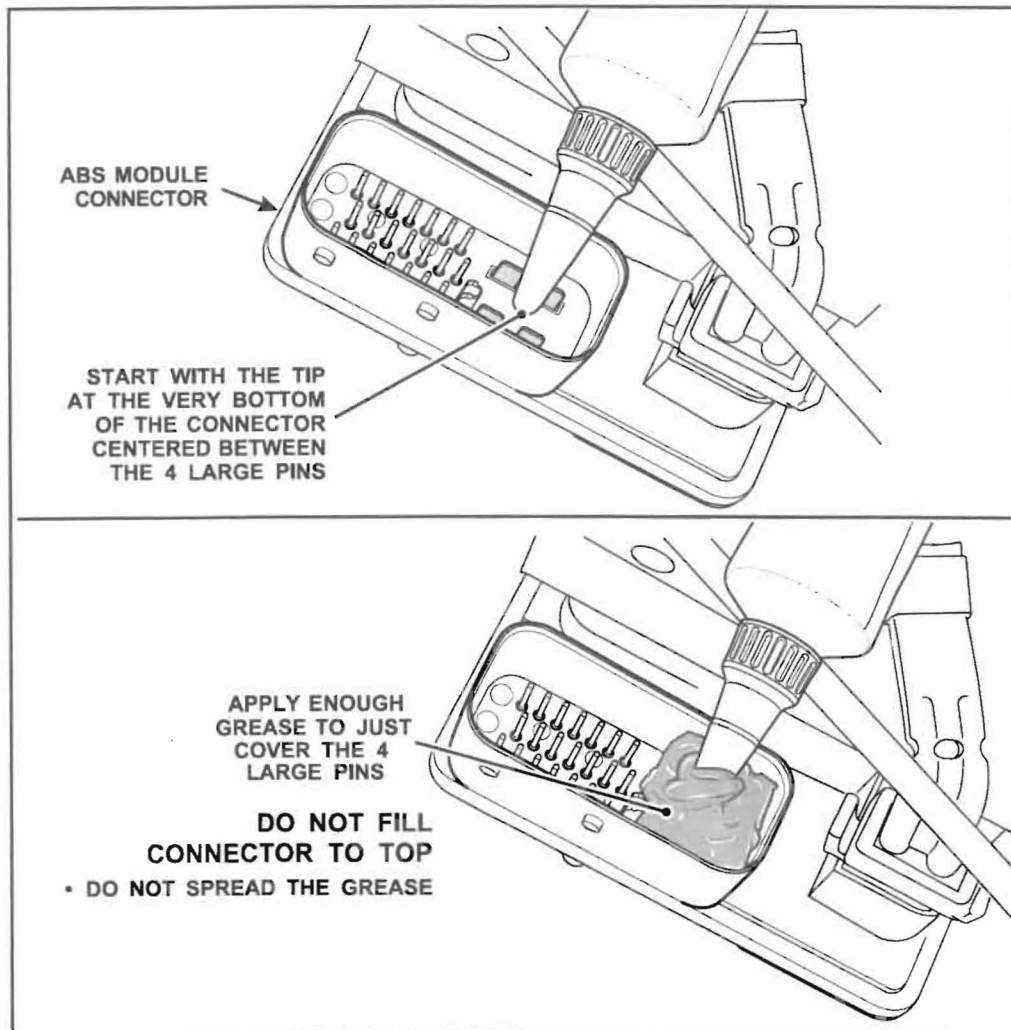
4567Ch

NOTE: DO NOT spread the grease around the connector. Applying an excess amount of grease into the connector cavity will cause a “hydro lock” condition which will not allow the connector to fully seat or lock in place.

9. Reinstall dress cover and use electrical tape to secure the cover at the same location where the original tie strap was removed. Apply dielectric grease to the ABS module connector, position and connect the harness as follows:
 - a) Reinstall dress cover.
 - b) Use **ONLY** dielectric grease.
 - With the tip of the applicator tube snipped off, position the end of the tip between the four (4) large flat pins at the bottom of the ABS module connector. Squeeze out enough grease to completely cover the four (4) flat pins.

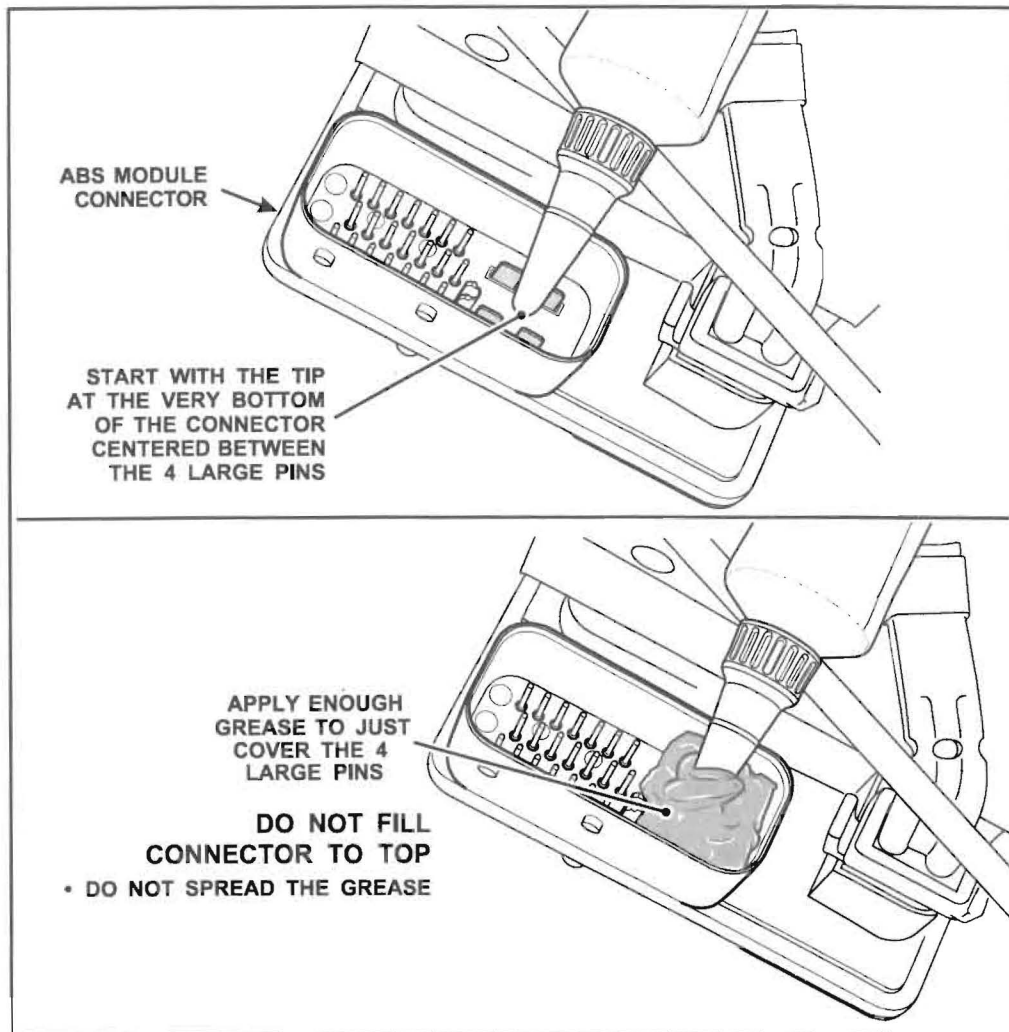
4507C

NOTE: DO NOT spread the grease around the connector. Applying an excess amount of grease into the connector cavity will cause a “hydro lock” condition which will not allow the connector to fully seat or lock in place.

2. Reinstall dress cover and use electrical tape to secure the cover at the same location where the original tie strap was removed. Apply dielectric grease to the ABS module connector, position and connect the harness as follows:
 - a) Reinstall dress cover.
 - b) Use **ONLY** dielectric grease.
 - With the tip of the applicator tube snipped off, position the end of the tip between the four (4) large flat pins at the bottom of the ABS module connector. Squeeze out enough grease to completely cover the four (4) flat pins.
