SUBJECT: 2001-2004 Mazda Tribute Anti-Lock Brake System Voluntary Safety Recall 4507C

2001-2004 TRIBUTE - ABS MODULE ELECTRICAL CONNECTOR [RECALL 4507C]

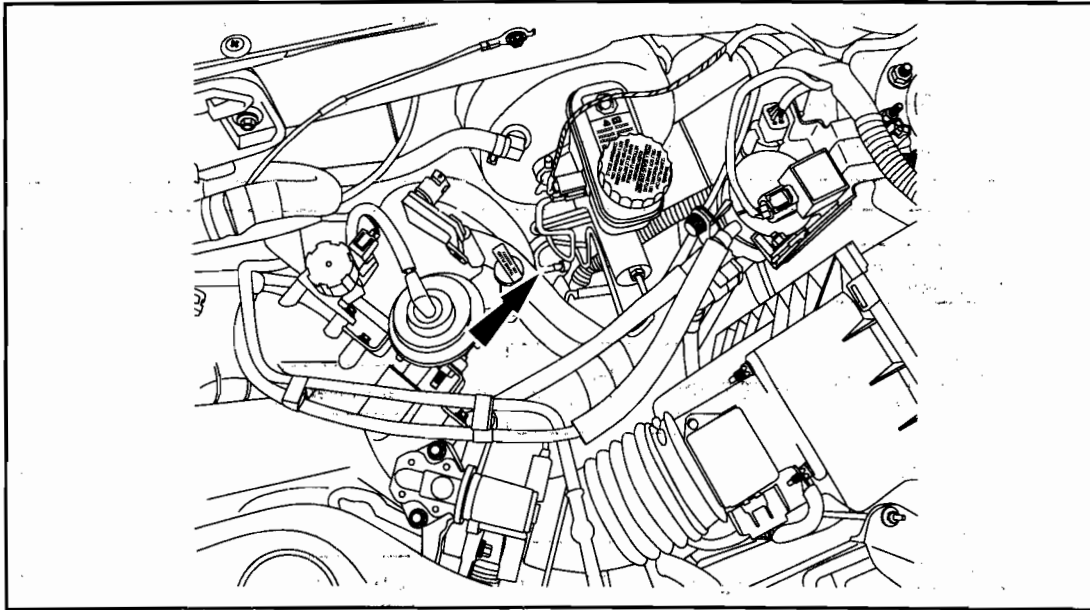
4507Cq

1. Record customer's pre-set radio stations.
2. Disconnect negative battery cable.
3. Locate ABS module connector under brake master cylinder.

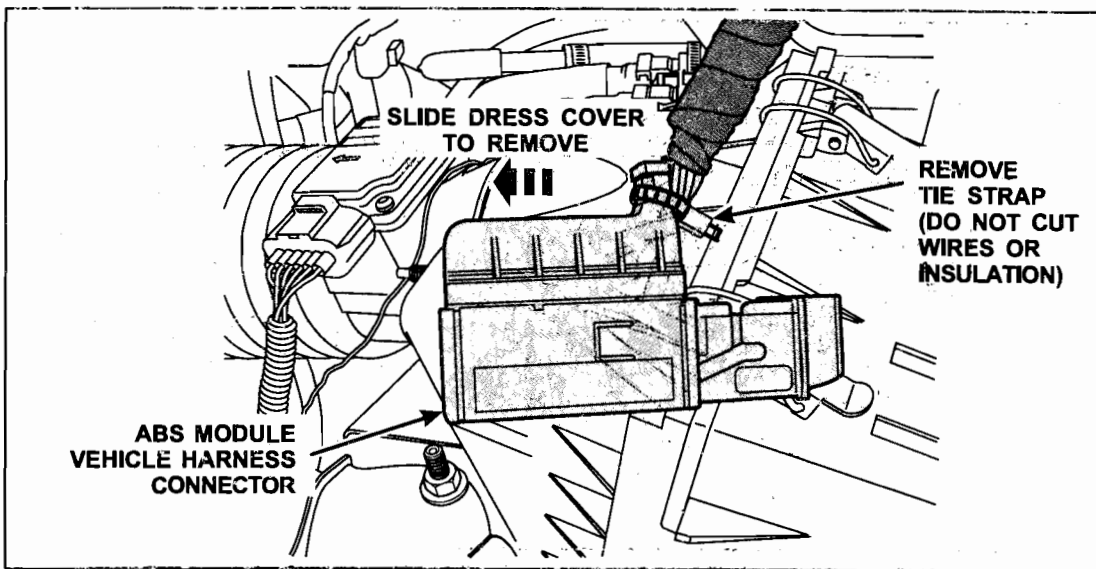
4507Cc

8. Verify the wire seals are present on the four (4) heavier gauge wires.
