Safety Recall

Subject: Fuel Pipe Bracket

Bulletin: R0020

Campaign #: A5371

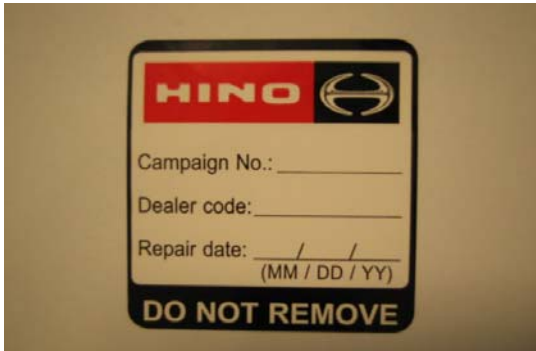
Fill out the Recall Completion sticker as shown in the picture to the left. This sticker should be attached to the left door jam above the V.I.N. Plate.

Once Recall is completed
