TO: ALL VOLVO RETAILERS
RE: RECALL 180

VOLVO				TITLE:		GROUP:	NO:	
				Recall 180: Adjust Driver's Door Bowden Cable		83	180	
Service Manager Bulletin				2007 C70		ISSUING DEPARTMENT:		
						Warranty		
				REFERENCE BULLETINS:		CARMARKET:		
				TNN# 83-180		United States, Canada		
Service Personnel: read and initial.	SERVICE MANAGER	SERVICE WRITER	WARRANTY ADMINISTRATOR	DATE:		YEAR	MONTH	DAY
				2007 06 14				
				Page 1 of 3

SUBJECT: Recall 180: C70 Bowden Cable Attachment
REFERENCE: VIDA, Service Manager Bulletin 83-180

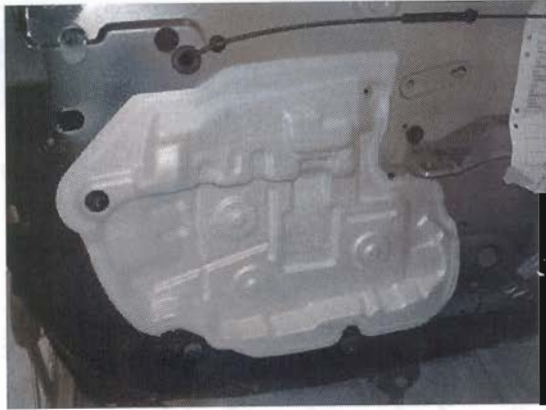
1.

Note! Only adjust the Bowden cable attachment in the left door.

Adjust the left door Bowden cable attachment according to the instructions below.
