**Subject: Update to Recall Campaign N4 (07V-063) and
Recall Campaign N8 (07V-284)**

Safety Recall Circular

Code: **N8**

**Subject: 2006 Jetta with 2.5L Gasoline Engine
Remove Plastic Tab from Windshield Washer Fluid
Reservoir, Inspect and, if Necessary, Replace
Underhood Fuel Supply Line**

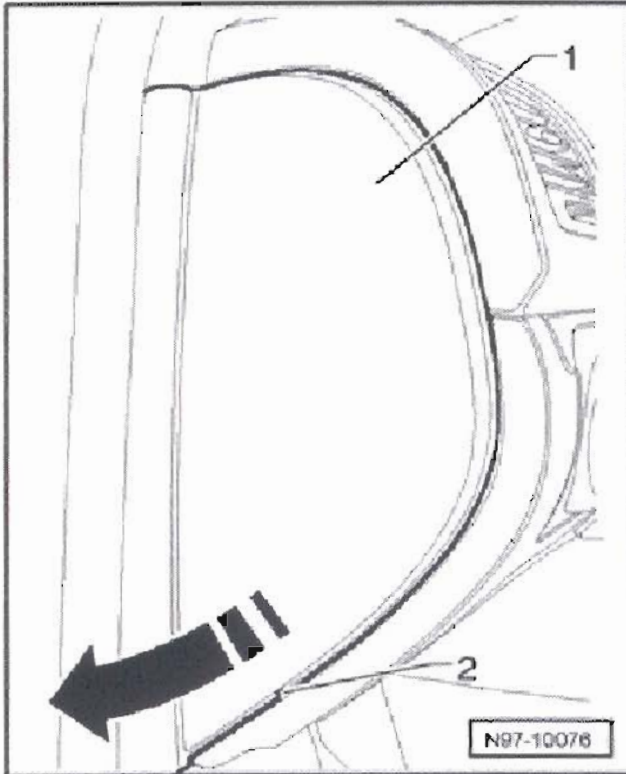
⚠ WARNING
Prior to starting work on fuel system
remove two fuses to prevent activation of
fuel pump

⇐ Remove left instrument panel side cover -1- by
inserting screwdriver into recess -2- and pry off
cover -1- in -direction of arrow-

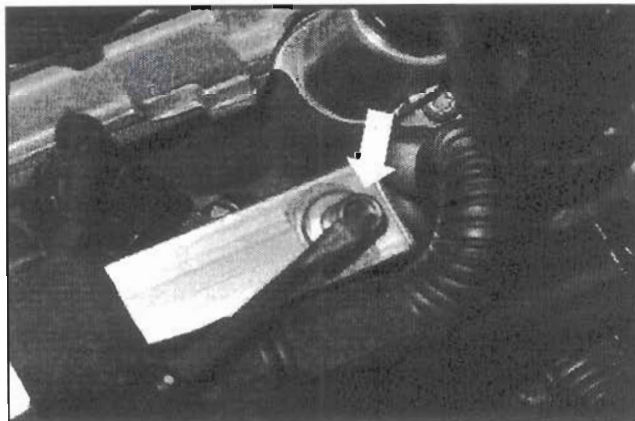
WARNING
 Fuel supply line is under pressure! **Wear eye protection and protective clothing in order to avoid injuries from contact with fuel.** Before relieving pressure put a cloth over the connection. Release pressure by carefully pushing on schrader valve. **Observe rules for cleanliness**

- ← Relieve fuel system pressure by pressing on schrader valve -arrow- and place shop rag over valve to contain fuel being released
