Technical Bulletin

Section Title: Restraint
 TSB No. TS 04 07277

SUBJECT: SAFETY RECALL CAMPAIGN “KY” FRONT SEAT BELT BUCKLE ASSEMBLY REPLACEMENT

MODEL(S): FORENZA, FORENZA WAGON, RENO (RQ420)

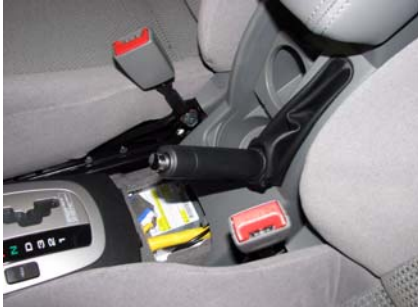
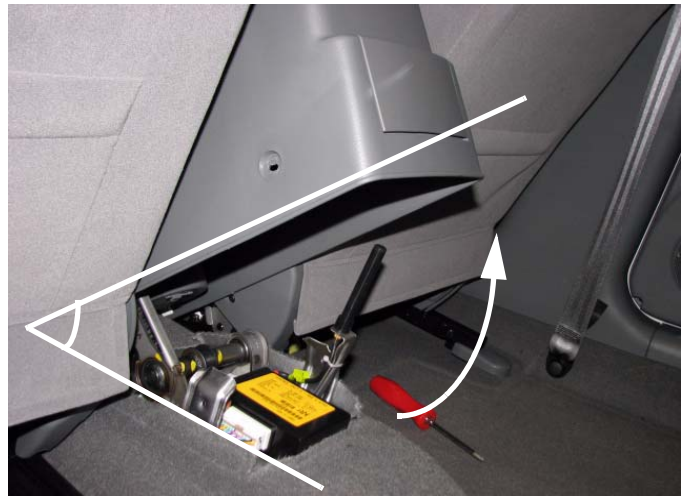
Front view of console raised

3. With the parking brake set lift the center console from the rear as high as it will go without excessive force.
