**Subject:** NHTSA Toyota Sienna Rampvan rear axle beam mounting (Recall Number 07V-546)

## Service Bulletin 34238

Instructions for Rear Axle Beam Assembly  
Evaluation and Securement  
Applicable for **2004-2007 Toyota Sienna  
Side Entry Rampvan® Conversions**

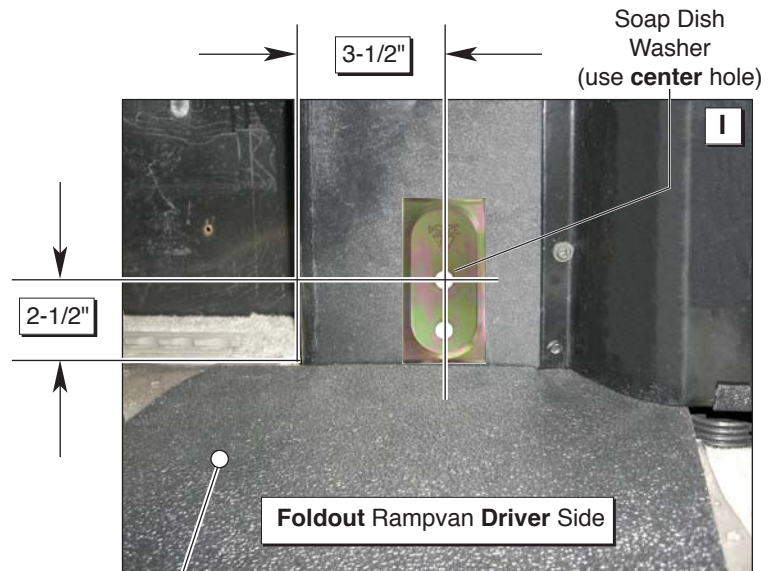
**Caution:** Be aware of depth. **Do not** drill into OEM axle components.

**Carefully** drill a 1/2" diameter mounting hole (watch depth).

**Caution:** Provide carpet protection.
