RE: NHTSA Recall Number 08E-064; Supplemental to SKF's Notice dated October 16, 2008

# SAFETY RECALL NOTICE TO END USERS

NHTSA Recall #08E-064 of SKF BR930361 hub bearing assembly; SKF Recall # PRO 08-029US/CA

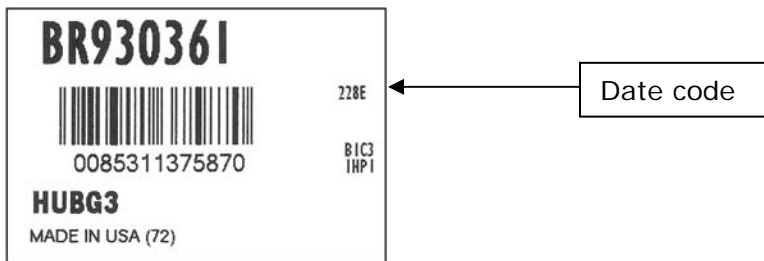
This recall involves SKF part number BR930361 that is identified by the following packaging date codes: 155E, 161E, 170E, 171E, 185E, 213E and 228E. This part was sold exclusively in the aftermarket for use on the vehicle identified. **Important note: Only parts with one of these date codes are covered by this campaign.** The box part number label is shown below.

The date code appears on the upper right hand side of the part number label.
