08V-129  
(37 Pages)

Re: Title 49 U.S.C. Chapter 301 Safety Recall; Big Bear American Made Choppers, Inc.

**PART 573 Defect and Noncompliance Report**

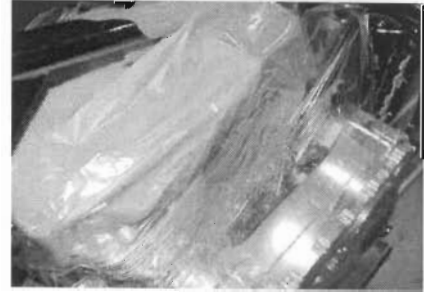
Photograph showing protective covering on the motor and primary

Take appropriate steps to fully protect ALL engine, frame and control components from grinding sparks, dust, and tools.

Ensure that the rear of the vehicle, seat, stored handlebars, and the rear fender are also protected.
