**Regarding: 2005– 2007 Model Year Yamaha YP400 and
2006 – 2007 CP250 Fuel Pump Coupler Factory Modification Campaign**

Technical BULLETIN

RECALL

2006~2007 CP250 (Morphous); 2005~2007 YP400 (Majesty) FACTORY MODIFICATION CAMPAIGN – Fuel Pump Harness

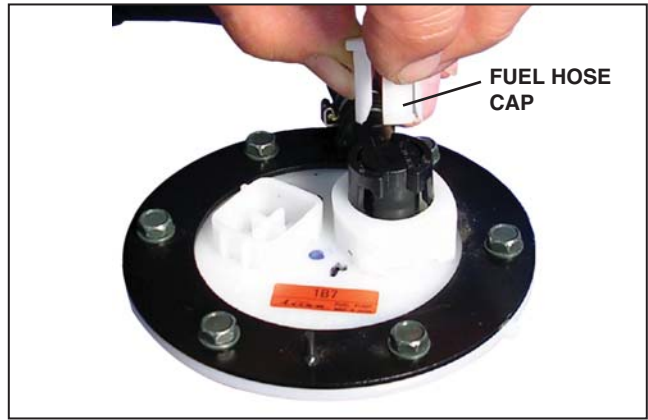
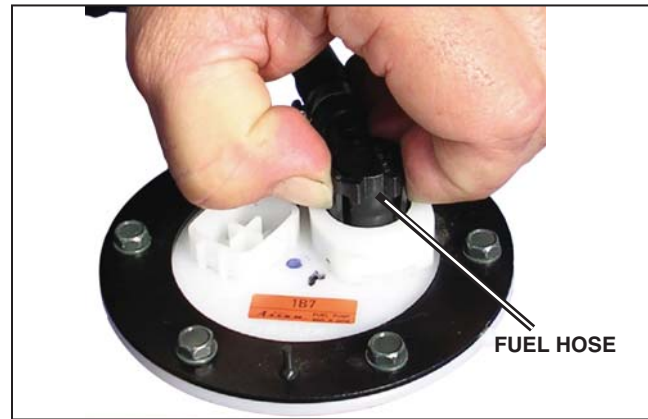
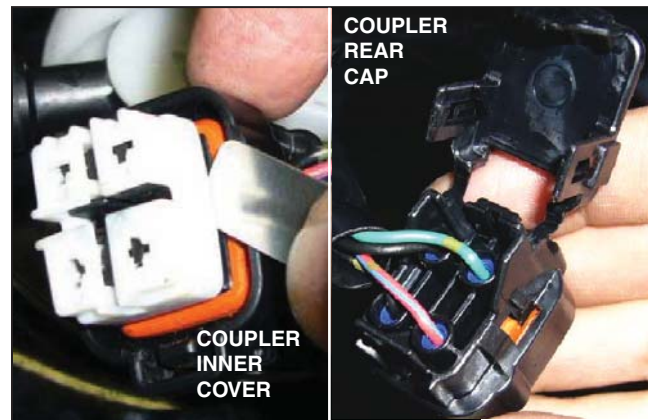
3. Clean the area around the fuel pump thoroughly to prevent any dirt or debris from entering the fuel tank or fuel hose during removal.
4. Inspect the terminals on the harness connector and on the fuel pump. If there is corrosion, replace the main wire harness and/or fuel pump as necessary. Refer to the Service Manual (LIT-11616-19-48) for wire-harness replacement. For tips on replacing the fuel pump, see the procedures given in Technical Bulletin M2007-011R which covers fuel pump seal replacement. If the coupler is wet, but not corroded, dry it with compressed air.

5. Using the wide end of the special terminal removal tool, remove the coupler inner cover and rear cap.
