SUBJECT: G4500 TAG AXLE ARM ASSEMBLY ASSEMBLIES

Ref.: **NHTSA # 08V-121**
TRANSPORT CANADA # 08-093
MCI Service Bulletin 289

Service Bulletin No. 289

MODEL G Series Coaches	TYPE Field Change Program	SECTION/GROUP 2--Tag Axle	DATE Mar. 18, 2008
SUBJECT TAG AXLE RETROFIT			
CONDITIONS

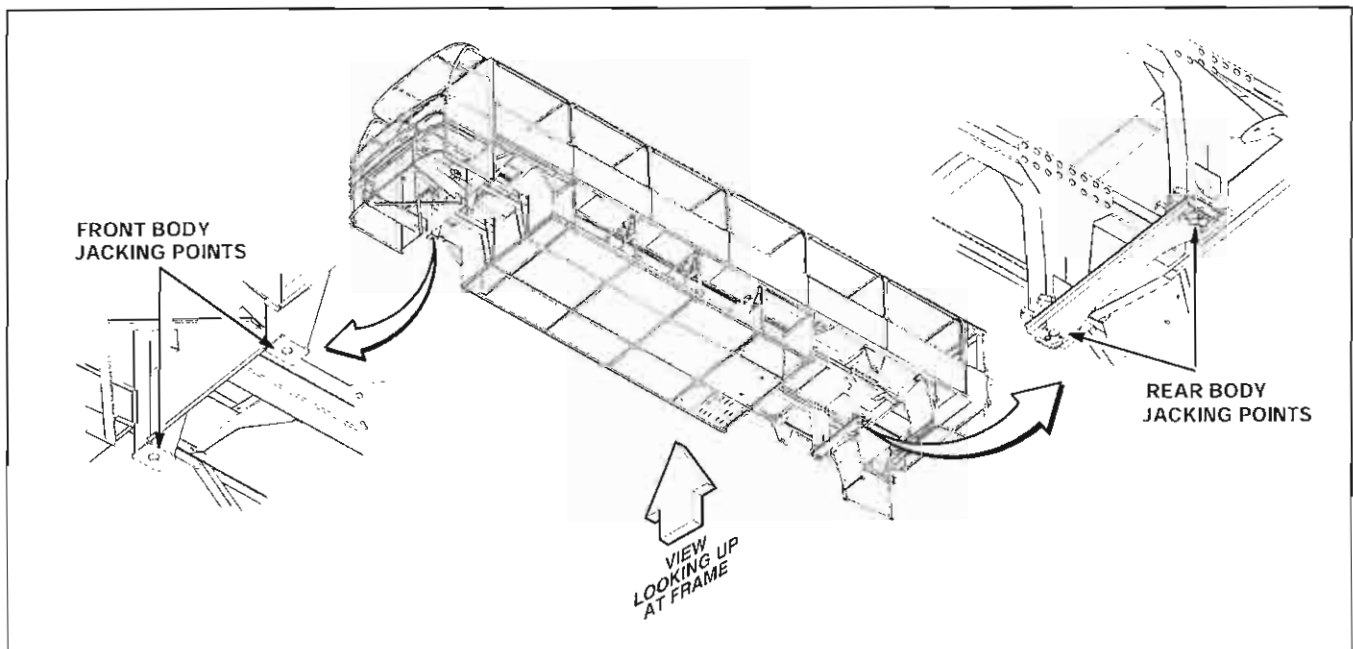
Figure 1. Underframe Jackstand Support Points (Section 3H / Maintenance Manual)

Raise the coach to the desired height. Position jackstands at the front and rear frame support points, according to Figure 1, to ensure that the coach is securely supported before attempting work underneath the coach.

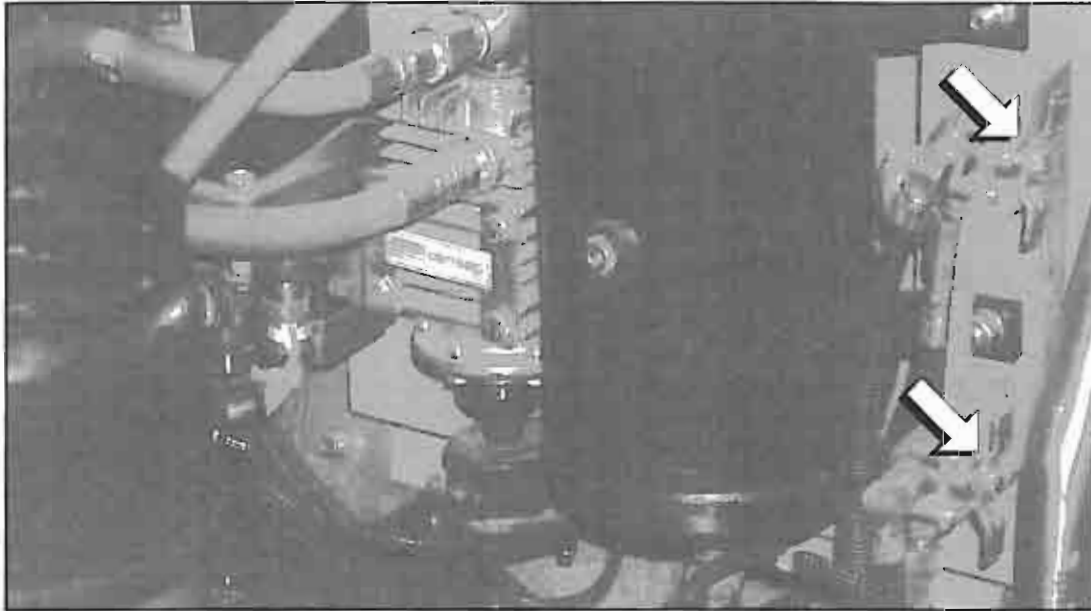
Figure 2.

The tag axle should be lifted only when the tag axle's suspension air bellows are exhausted. Close the tag axle suspension shut-off valves, located in the RH, rear service compartment (Figure 2).

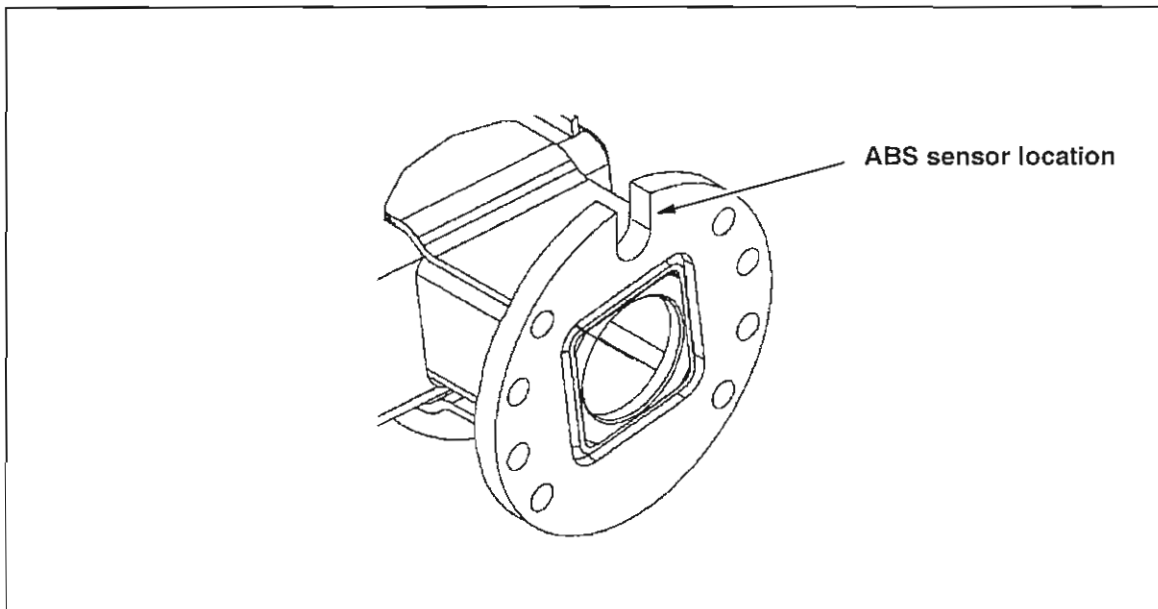
Figure 5.

The ABS sensor must slide freely in and out of the mounting sleeve bore. Operating the vehicle with seized components will damage the speed sensor and the tone ring.

47. Push the ABS sensor completely into sensor bushing by hand until it stops against the tone ring. The ABS sensor is properly installed and adjusted when it is touching the tone ring (Figure 5).
