SAFETY RECALL BULLETIN

SUBJECT: FLOOR HARNESS SAFETY RECALL		No: SR-08-002
		DATE: March, 2008
		MODEL: 2007 - 08 Outlander
CIRCULATE TO:	<input type="checkbox"/> GENERAL MANAGER	<input checked="" type="checkbox"/> PARTS MANAGER
<input checked="" type="checkbox"/> SERVICE ADVISOR	<input checked="" type="checkbox"/> SERVICE MANAGER	<input checked="" type="checkbox"/> TECHNICIAN
	<input checked="" type="checkbox"/> WARRANTY PROCESSOR	<input checked="" type="checkbox"/> SALES MANAGER

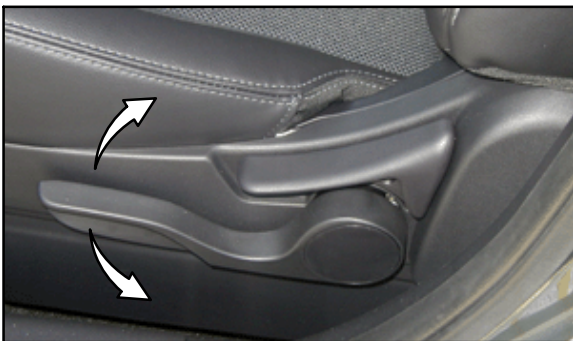
2. Raise the driver's seat (shown) to its highest point using the seat height adjustment lever. Pump the lever several times until the seat stops at its highest position.
