Recall Circular

Code: **26E5/R5**

Subject: 1999-2005 Passat & Passat Wagon (5th Generation)

Install Underbody Heat Shield(s); Inspect/Replace

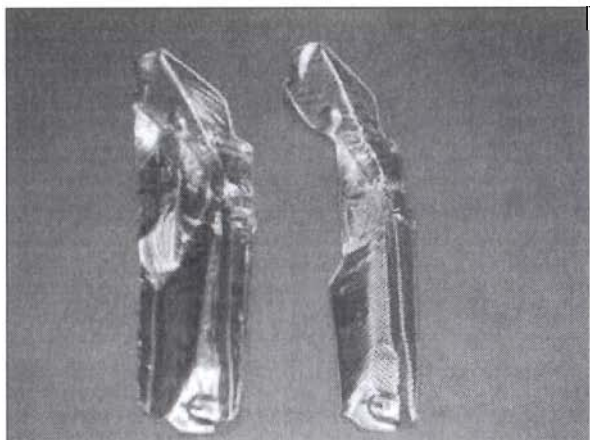
Note: There are two different-looking versions of new passenger side heat shield (3B0 825 676). Either version can be used for this campaign.

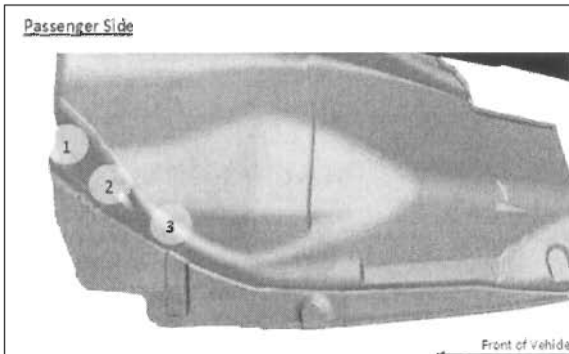
- ⇐ After the sub-frame and exhaust have been put back in place, ensure there is at least 20mm of clearance between new heat shield and exhaust pipe in locations 1,2,3 and A,B,C

! Note: If clearance is not at least 20mm, use flat end of a pry bar to adjust the heat shield for proper clearance

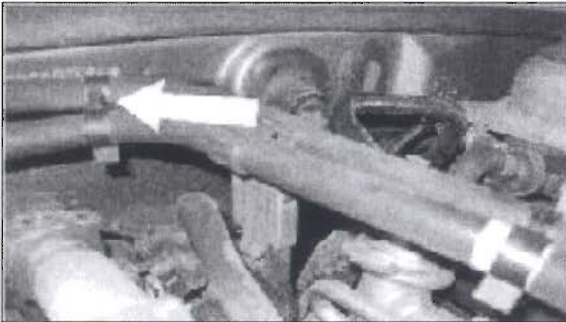
- ⇐ Remove plastic fuel line retainer -arrow- to relieve fuel line tension

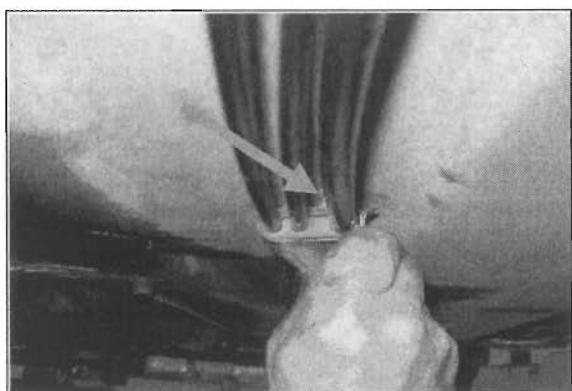
⚠ Note: Ensure that fuel lines are not touching together and are positioned free and clear of vehicle body

⇐ Secure new fuel line clips in place by pushing clip onto existing stud -arrow-

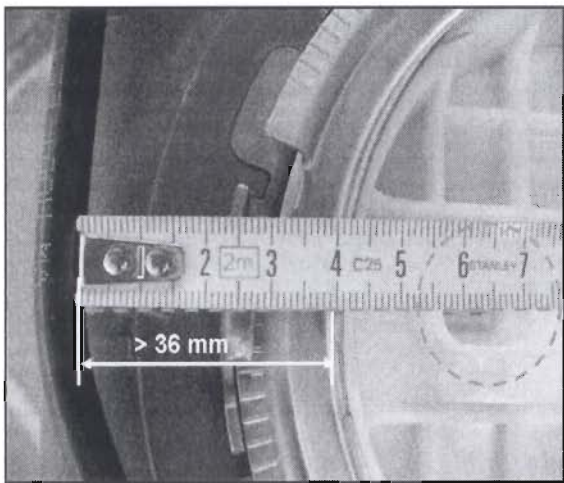
- ⇐ Using measuring tape centered over electrical connector -dotted circle-, measure distance between vent line and fuel sender retainer ring -arrow-, it should be at least 36mm
 - If the measurement is 36mm or greater, reinstall cover for fuel sending unit and rear seat bottom

- If the measurement is less than 36mm, **proceed to Section F** to perform visual inspection/vent line measurement check of surrounding surfaces for signs of fuel leak

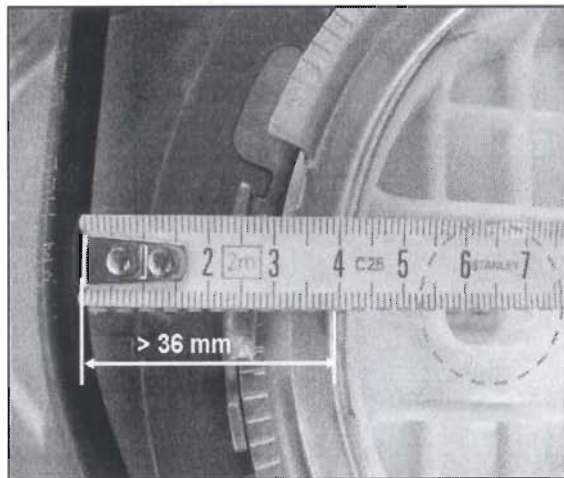
- ⇐ Using measuring tape centered over electrical connector -dotted circle-, measure distance between vent line and fuel sender retainer ring -arrow-, it should be at least 36mm
- If measurements are within specification, reinstall fuel tank straps, exhaust hangers, bolts for heat shield, sending unit cover and seat bottom
 - 1.8T 4Motion with automatic transmission **go to Section K**
 - All other models **Work is complete**
