Regarding: 08V-180

Technical BULLETIN

RECALL

2006~2007 CP250 (Morphous); 2005~2007 YP400 (Majesty) FACTORY MODIFICATION CAMPAIGN – Fuel Pump Harness

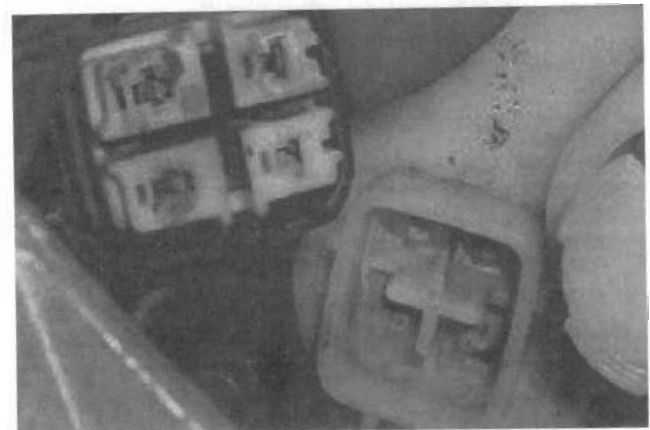
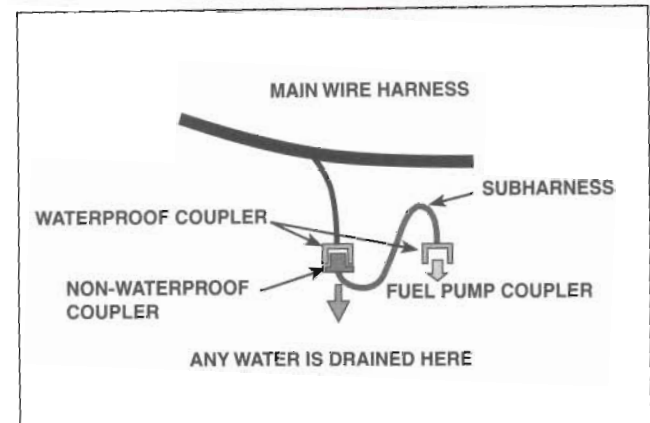
Yamaha Motor Corporation, U.S.A., has determined that a defect which relates to motor vehicle safety exists in all 2006 and certain 2007 CP250 (“Morphous”) and all 2005, 2006, and certain 2007 YP400 (“Majesty”) scooters. In affected scooters, the engine could stall and be difficult to restart because the wire terminals in the fuel pump wire coupler have corroded. This is because water can enter from the main wire harness end and run through the harness to the fuel pump coupler. If the water remains in the coupler for an extended period of time, the terminals can become corroded, which can prevent the fuel pump from operating properly. If this corrosion affects fuel pump operation while the scooter is being ridden, there could be an accident resulting in injury or death.

To correct this defect, Yamaha is initiating a Factory Modification Campaign. Affected scooters must have a sub-harness installed which is designed to allow any water between the wire harness and the fuel pump to drain out before it reaches the fuel pump. If either the main wire harness connector or the fuel pump connector is already corroded, the corresponding assembly(ies) must also be replaced.
