Volume: XV
Number: TC08-018
Date: 12/10/08
 Action
 Retain
 Information

SUBJECT: **Non-Compliance Recall (Special Service Campaign) – 80D**
2008 Model Year Highlander and Highlander HV equipped with Third Row Seat

**SPECIAL SERVICE CAMPAIGN 80D (NON-COMPLIANCE RECALL)
THIRD ROW SEAT BUCKLE BRACKET REPLACEMENT**

2008 MODEL YEAR HIGHLANDER & HIGHLANDER HV

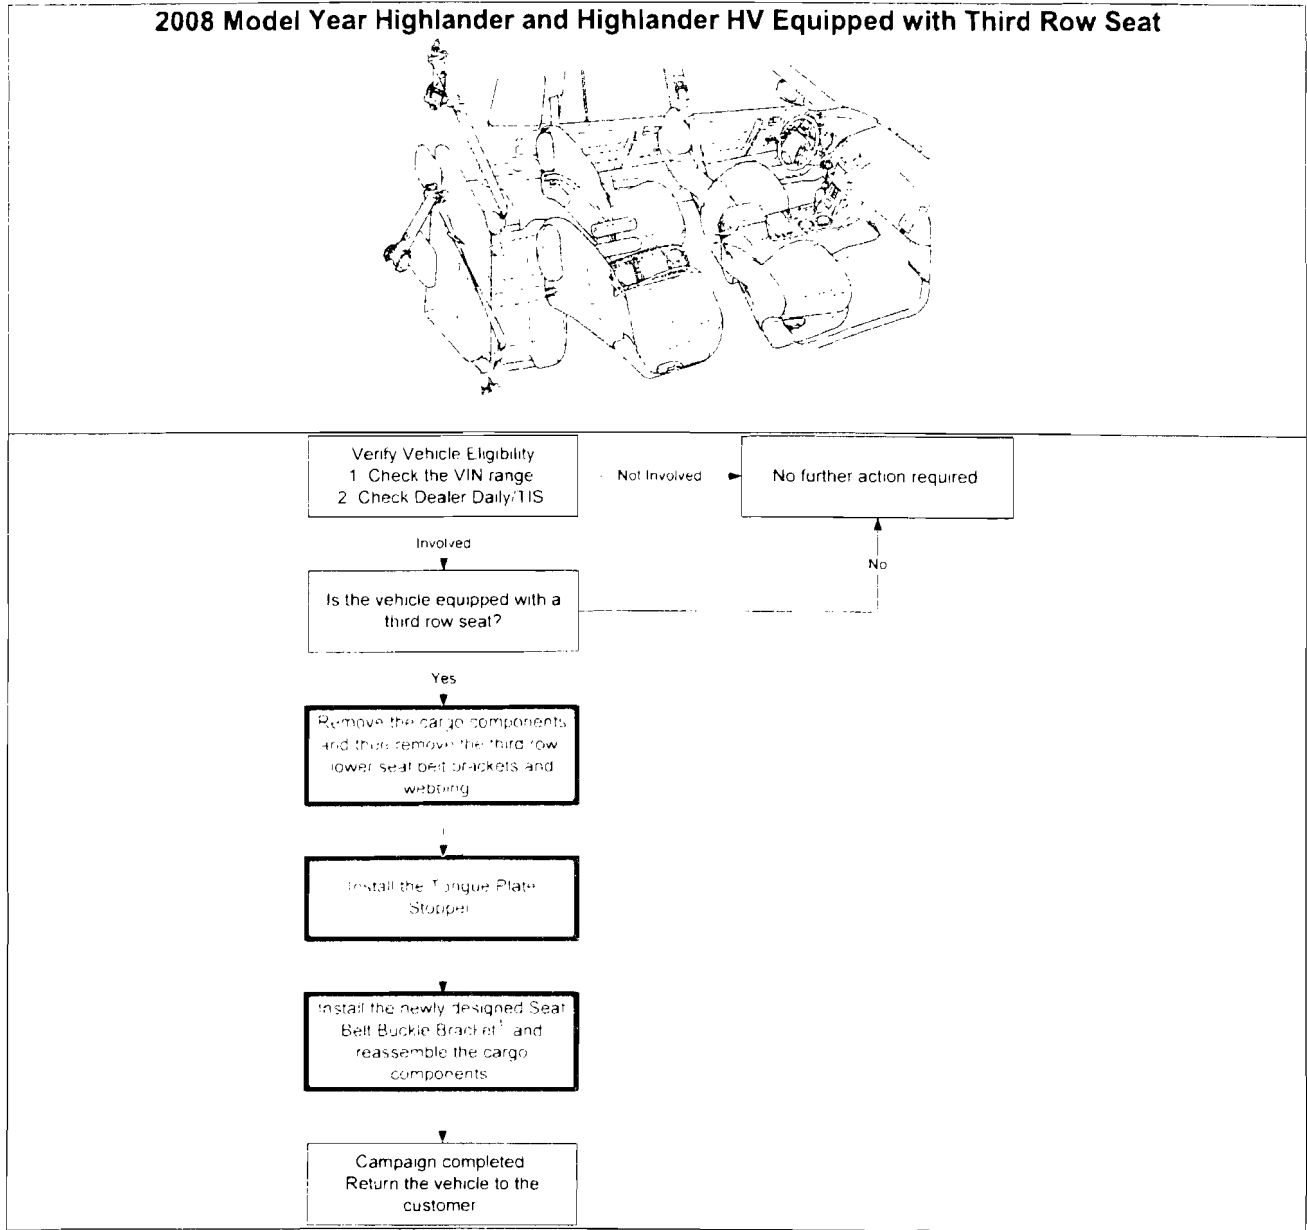
1. TIS refers to this part as the Rear No. 2 Seat.
2. TIS refers to this part as the Rear Seat Lap Type Belt Assembly.
3. Part ordering name: BELT KIT,REAR NO.2 SEAT, LAP TYPE.

SSC #	Op. Code	Description	Flat Rate Hour
80D	8510D3	Replace the third row lap type belt assembly both sides	0.6 Hr/Veh
